VEHICLE INSPECTION REPORT

KM06MAZ

Nissan Navara DCI OUTLAW 4X4 SHR SWB DCB

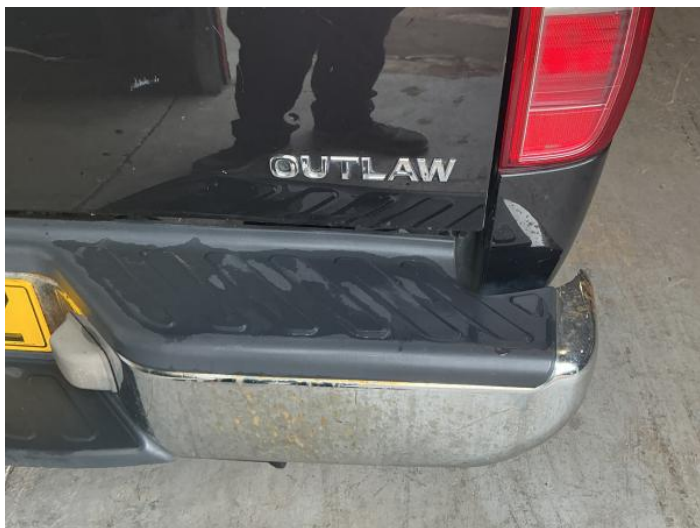
1: Bumper Rear
Scratched
Over 100mm Thru Paint

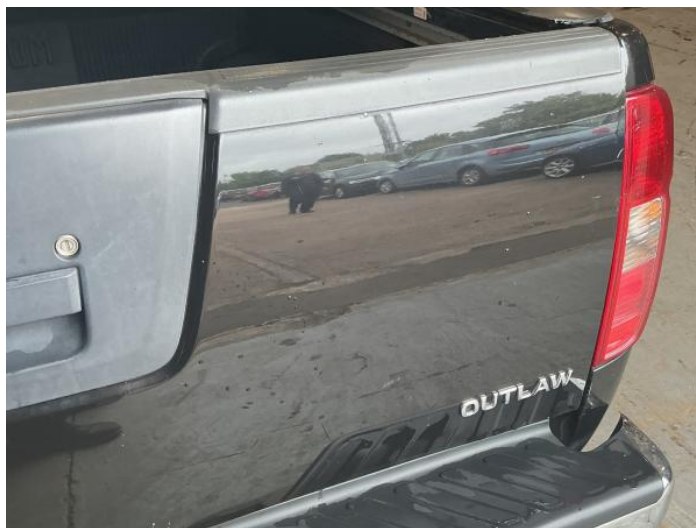
2: Boot Lid
Dented
With Paint Damage

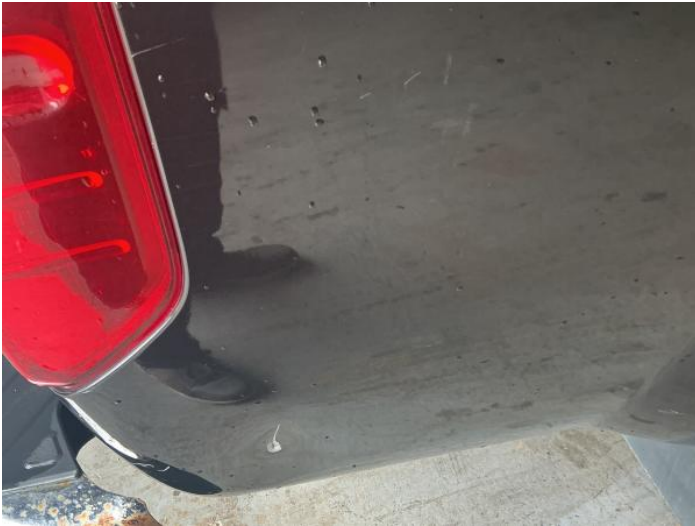
3: Qtr Panel osr
Dented
With Paint Damage

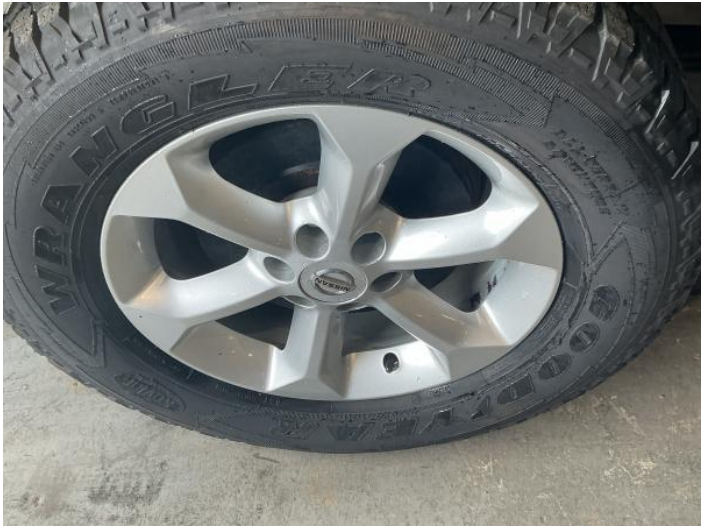
4: Wheel osr
Scratched
Over 50mm

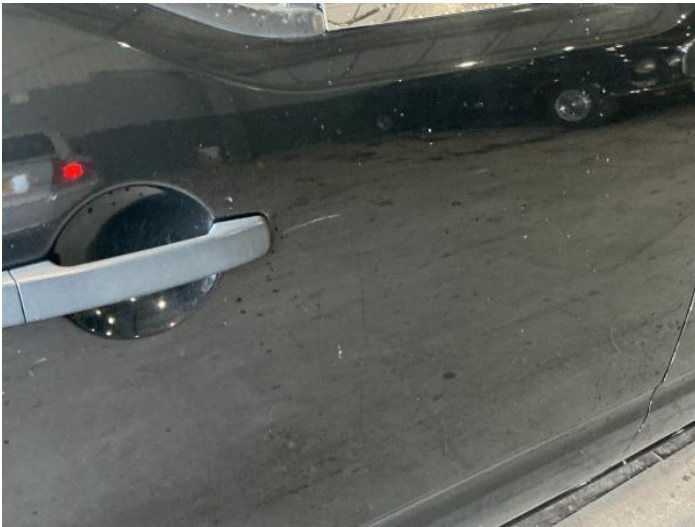
5: Door osr
Chipped
1 To 5

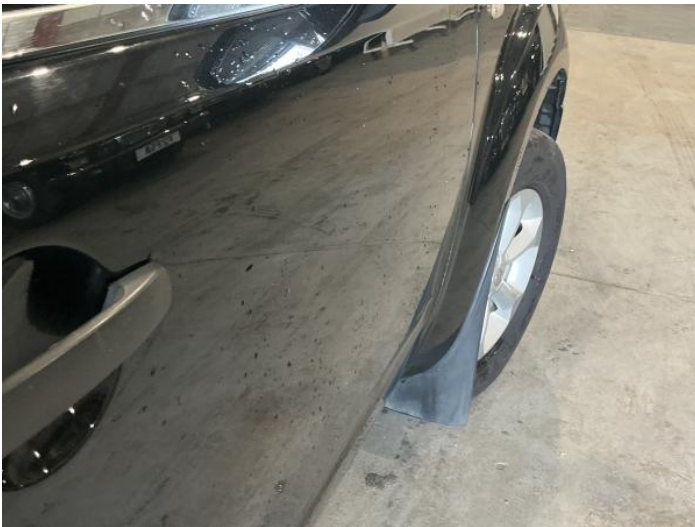
7: Door osf
Dented
Between 10mm + 30mm

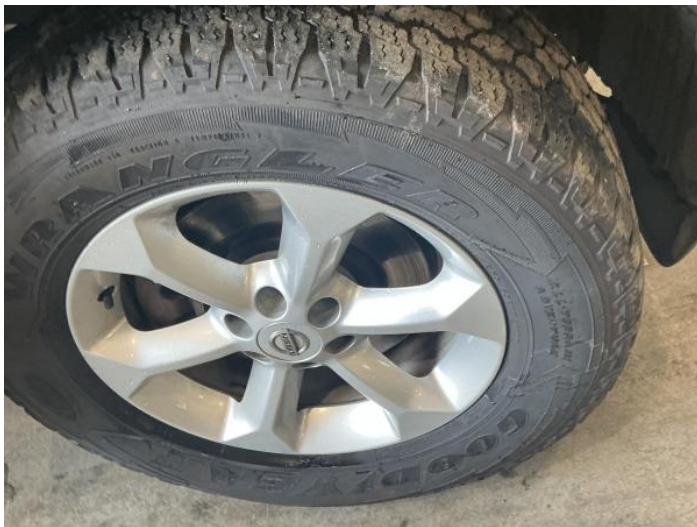
9: Wheel osf
Scratched
Over 50mm

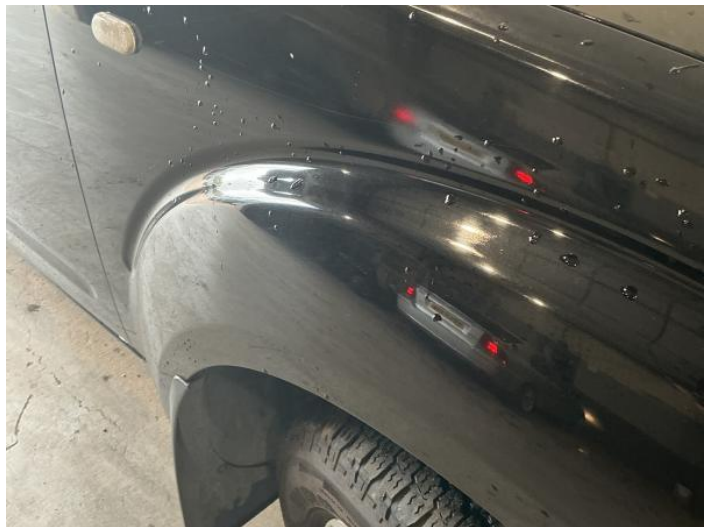
10: Wing osf
Poor Previous Repair
Poor Paint

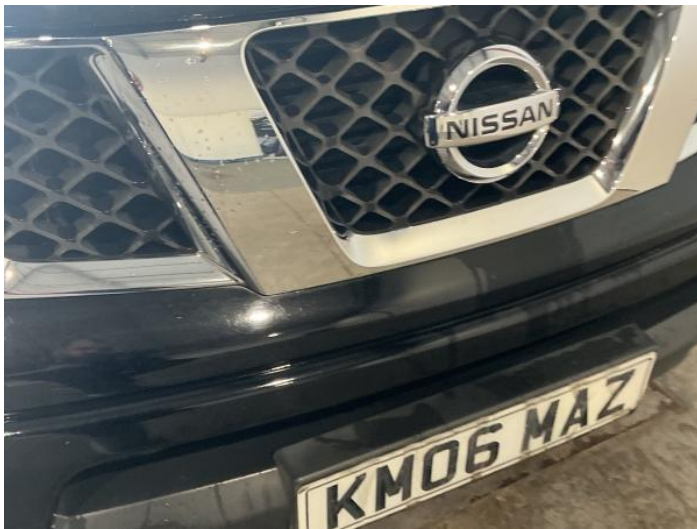
11: Bumper Front
Poor Previous Repair
Poor Paint

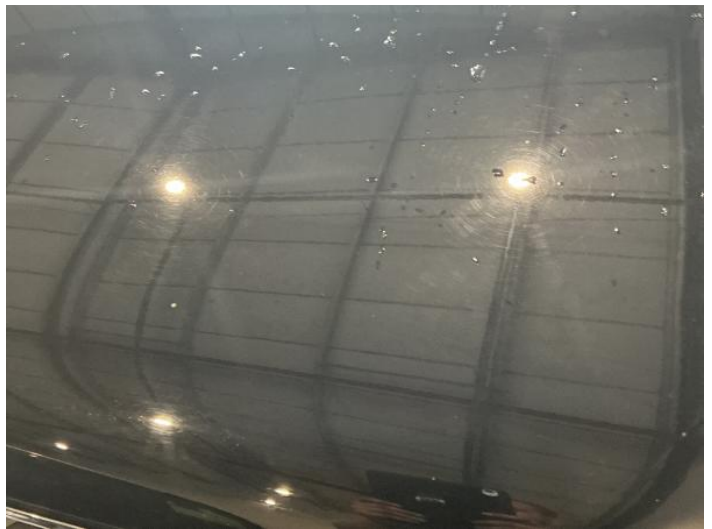
12: Bonnet
Chipped
1 To 5

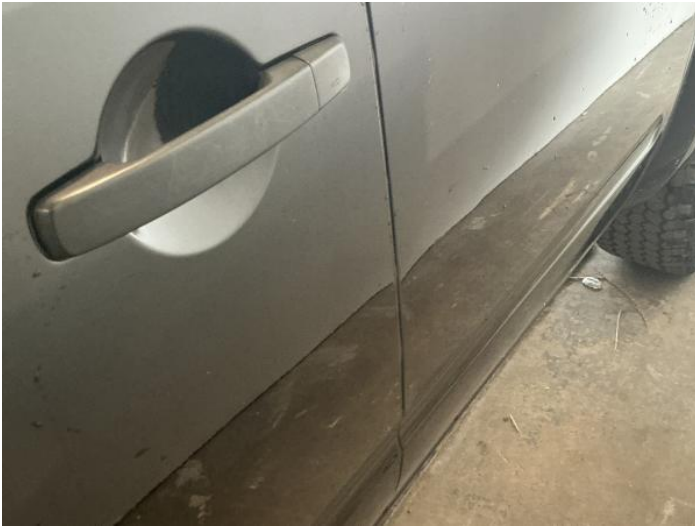
15: Door nsf
Dented
Between 10mm + 30mm

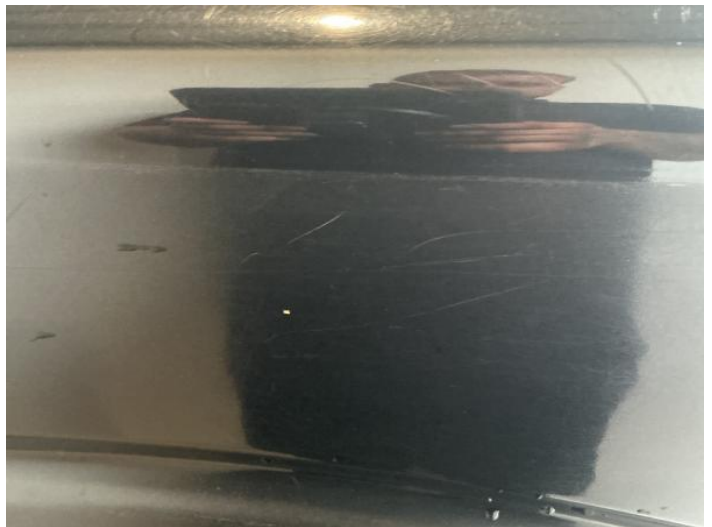
18: Qtr Panel nsr
Poor Previous Repair
Poor Paint

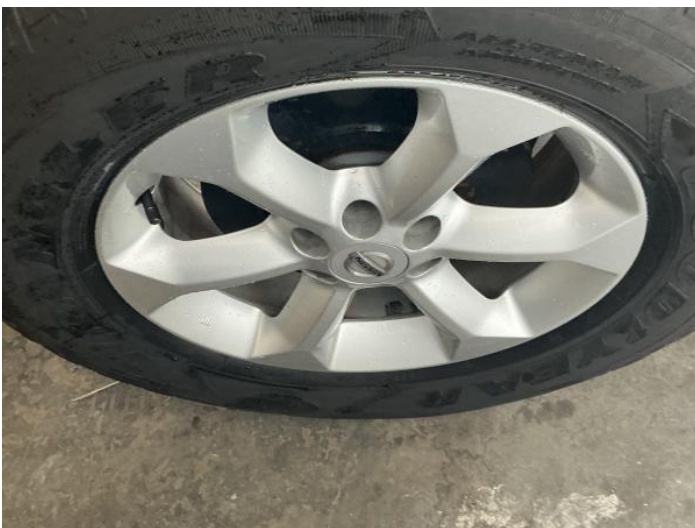
19: Wheel nsr
Scratched
Over 50mm

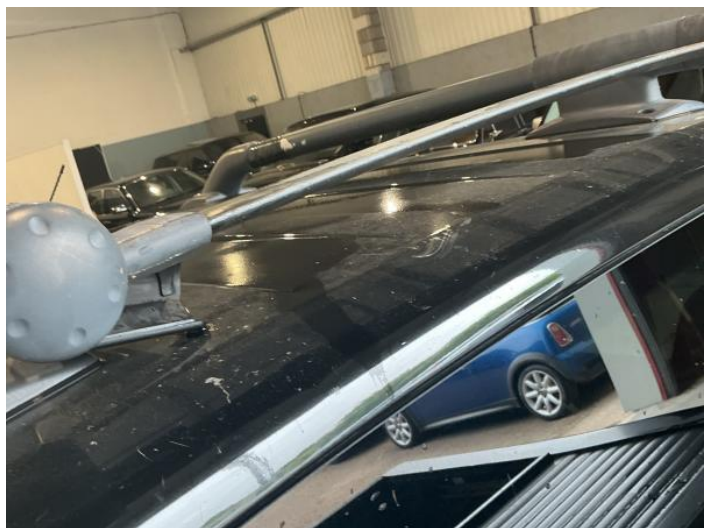
20: Roof
Dented
With Paint Damage

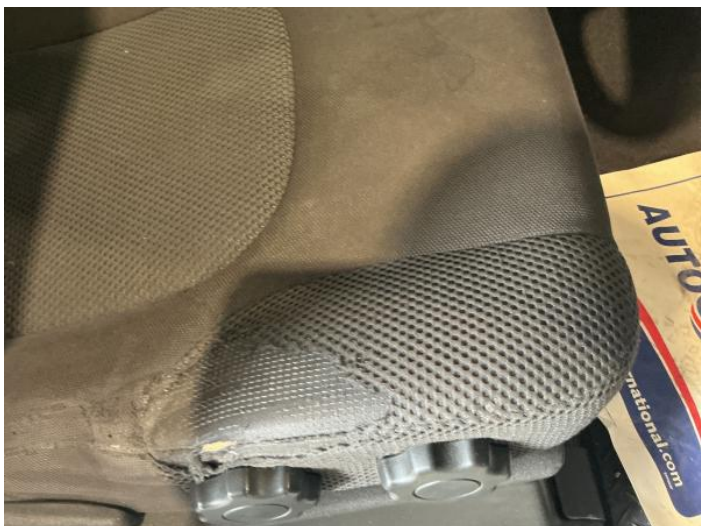
21: Seat Base Cover osf
Torn
Over 3mm

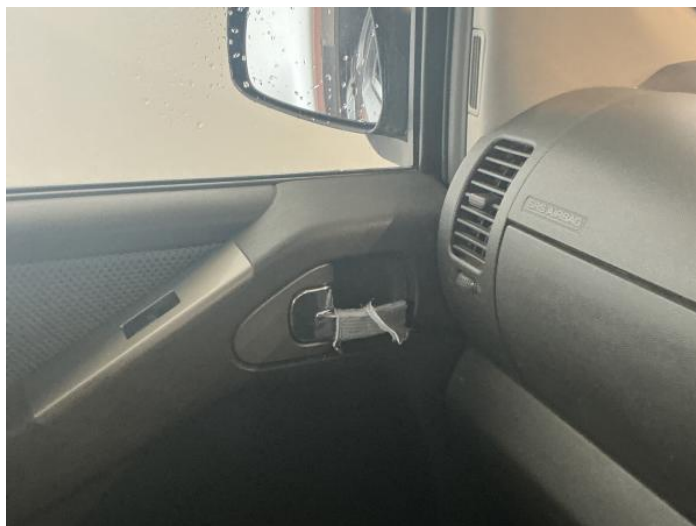
22: Handle Inner nsf
Damaged
Replace
