VEHICLE INSPECTION REPORT

KR14ADO

Nissan Qashqai 1.2 DiG-T Acenta Premium 5dr

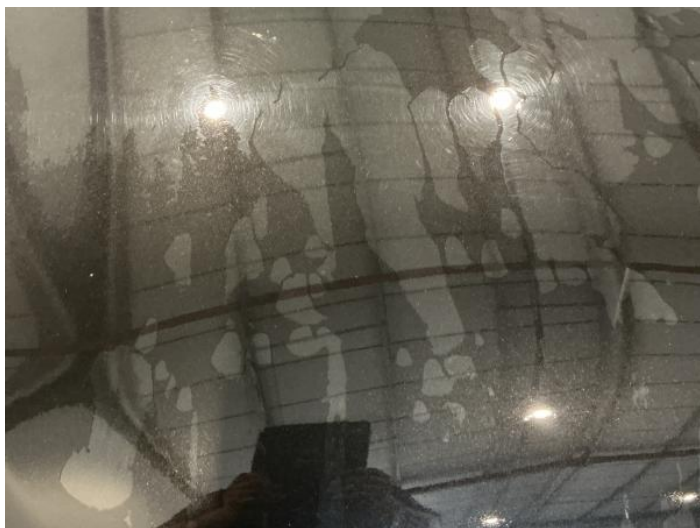
1: Bonnet
Chipped
Multiple Chips

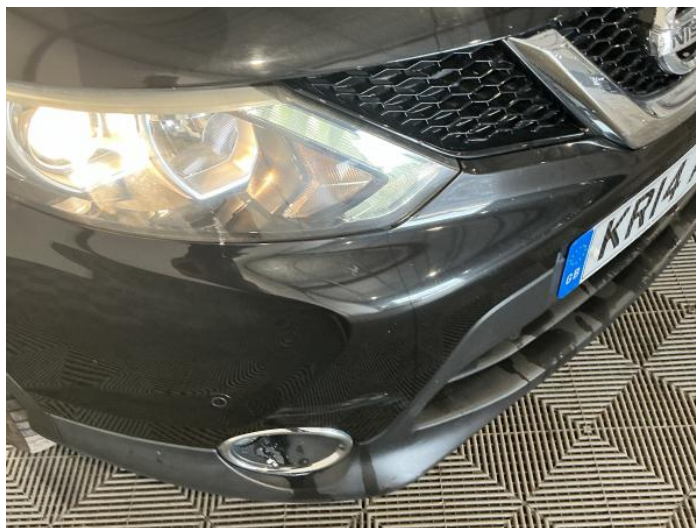
2: Bumper Front
Scratched
Over 100mm Thru Paint

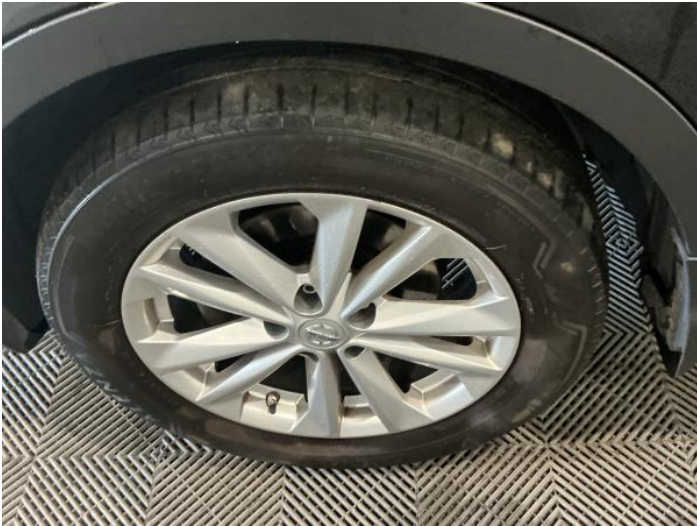
3: Wheel nsf
Scratched
Up To 50mm

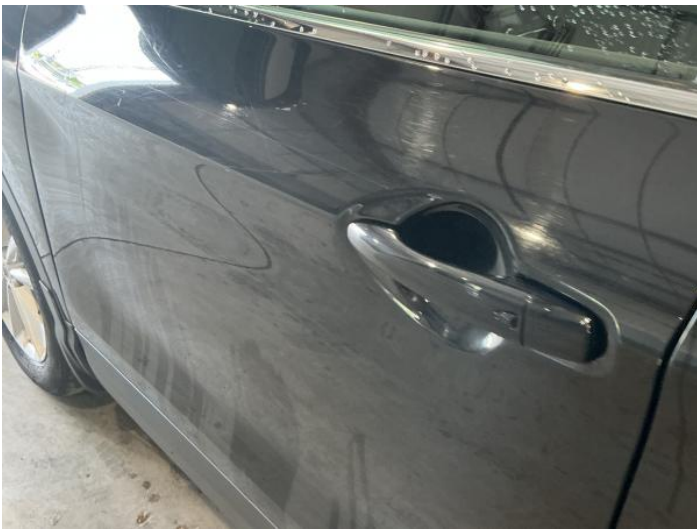
5: Door nsf
Chipped
1 To 5

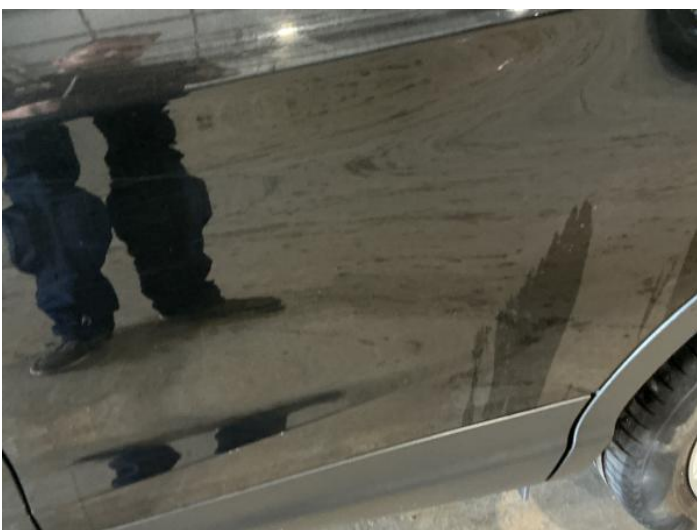
7: Door nsr
Chipped
1 To 5

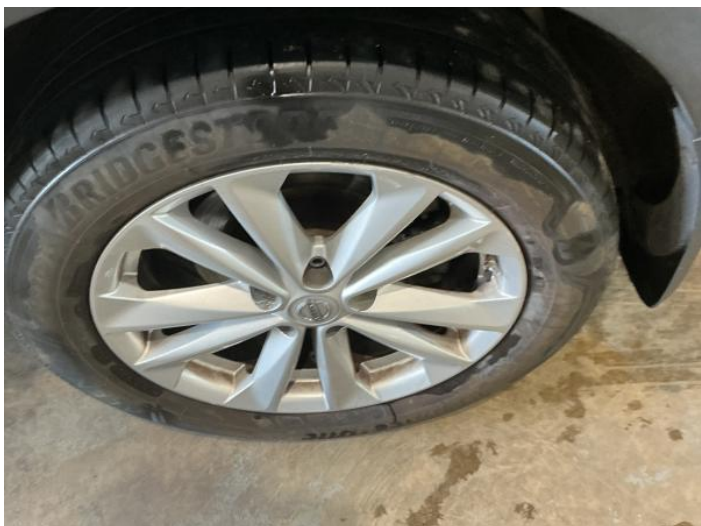
9: Wheel nsr
Scratched
Over 50mm

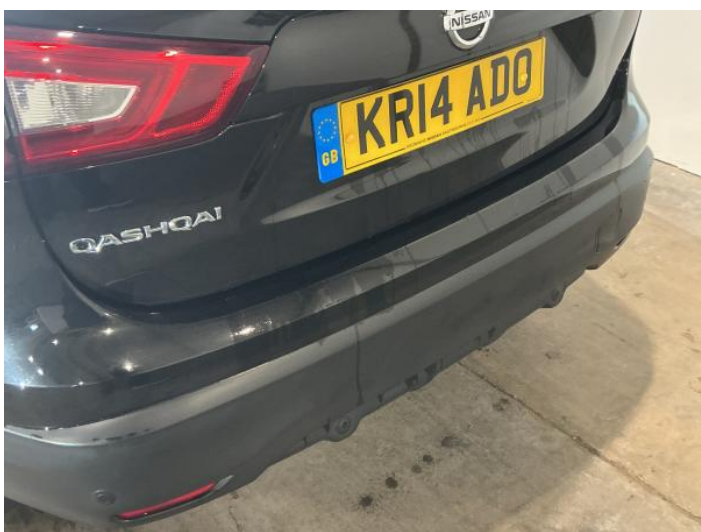
11: Bumper Rear
Scratched
25 to 100mm Thru Paint

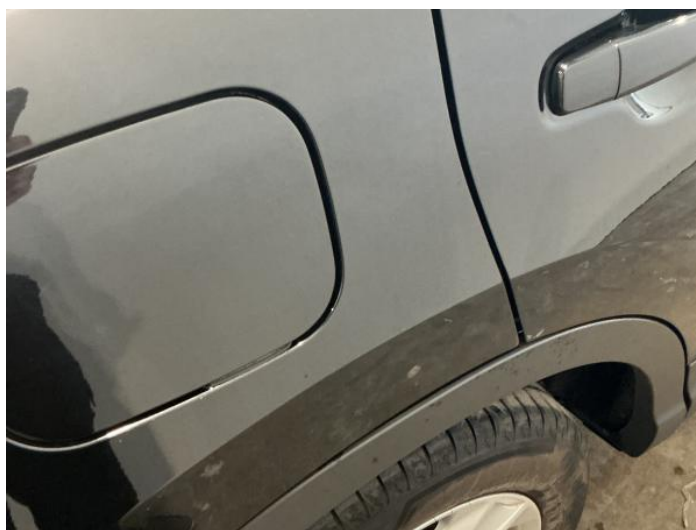
14: Qtr Panel osr
Chipped
1 To 5

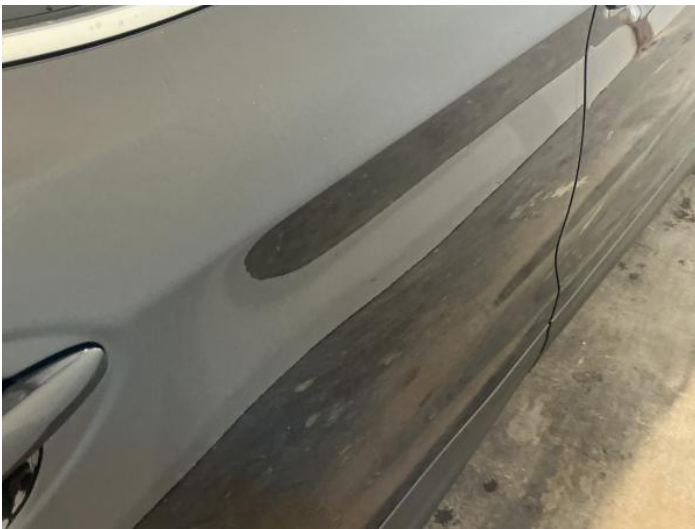
17: Door osr
Dented
Over 2 UpTo 10mm
