# VEHICLE INSPECTION REPORT

**KM12YJU**

## Seat Exeo 2.0 TDI CR SE Tech 5dr [143]

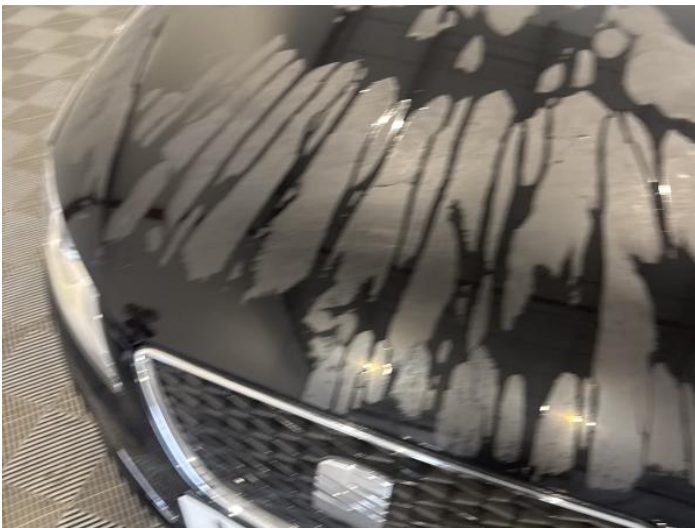
1: Bonnet  
Poor Previous Repair  
Poor Paint

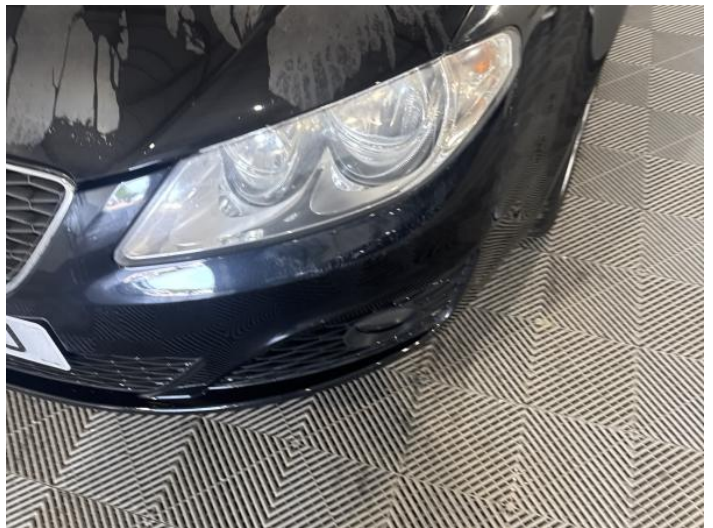
2: Bumper Front  
Scratched  
25 to 100mm Thru Paint

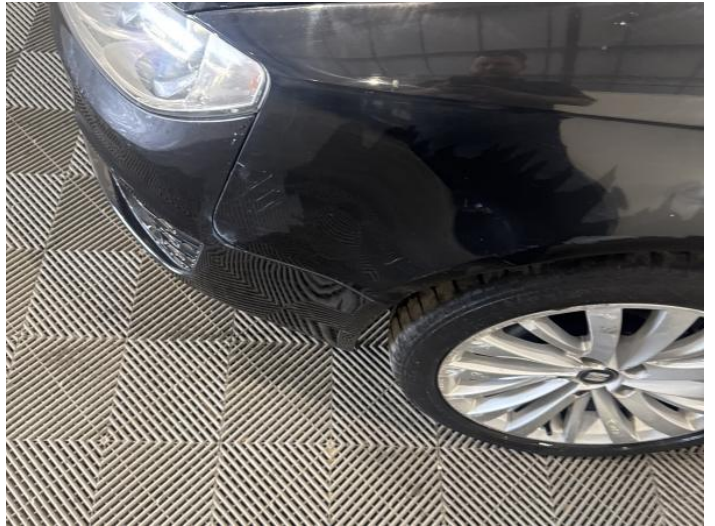
3: Bumper Front  
Scratched  
Over 25mm Not Thru Paint

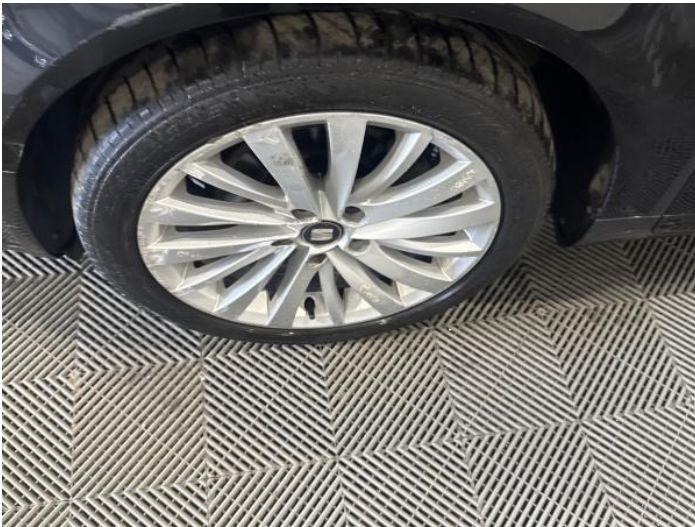
5: Wheel nsf  
Scratched  
Over 50mm

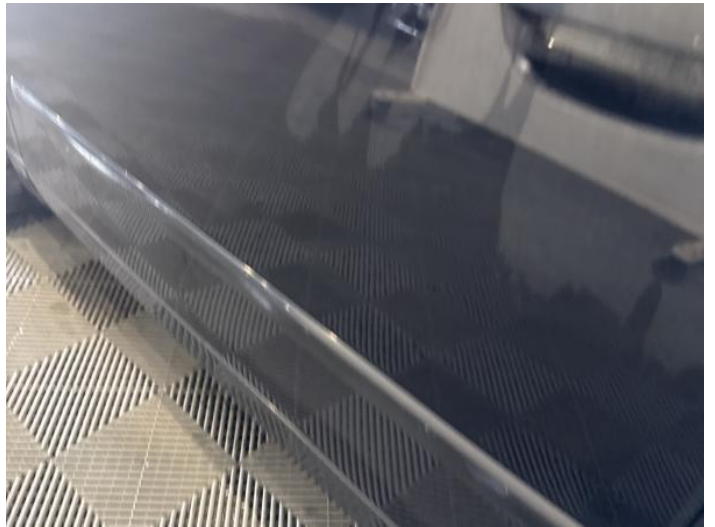
6: Door nsf  
Chipped  
1 To 5

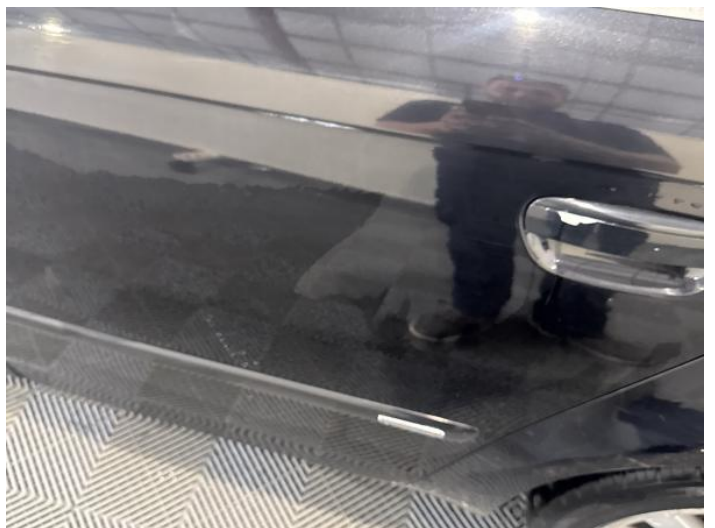
7: Door nsf  
Scratched  
Over 25mm Not Thru Paint

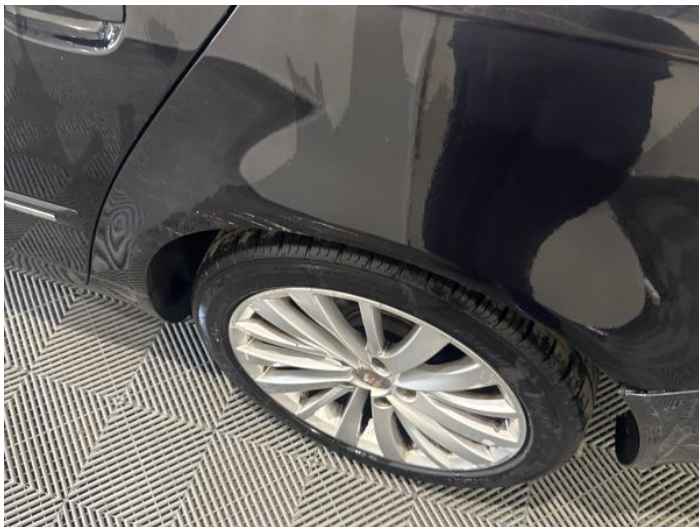
9: Qtr Panel nsr  
Dented  
With Paint Damage

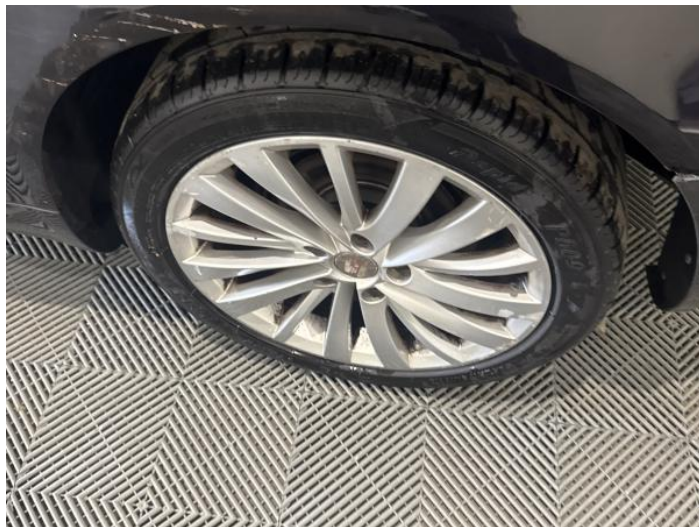
10: Wheel nsr  
Scratched  
Over 50mm

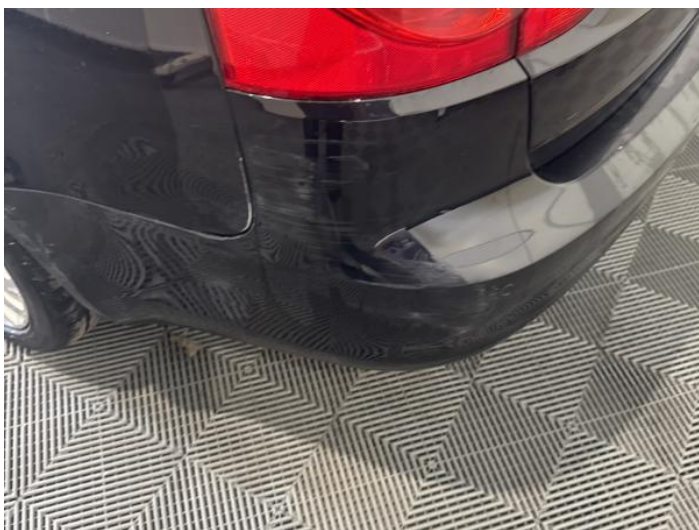
11: Bumper Rear  
Scratched  
Over 100mm Thru Paint

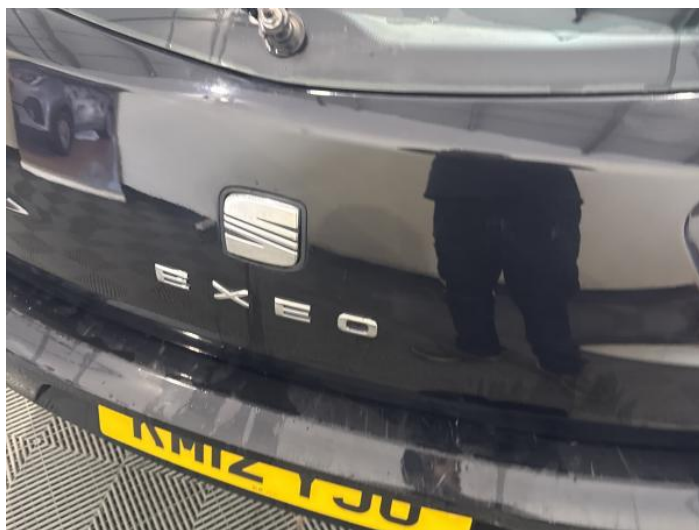
12: Boot Lid  
Chipped  
1 To 5

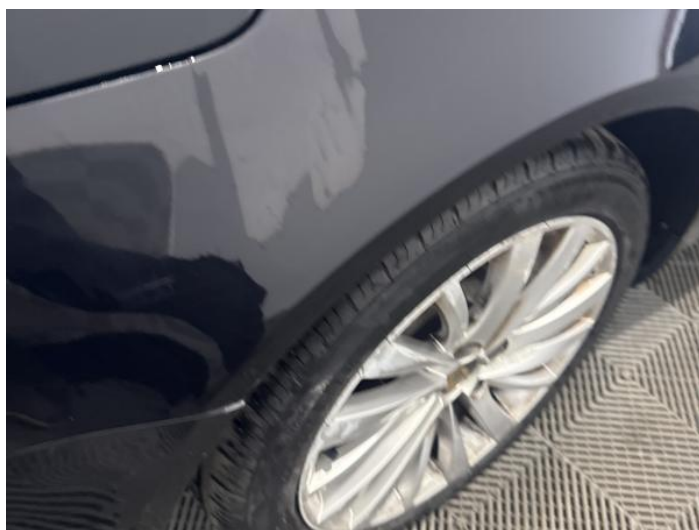
14: Qtr Panel osr  
Scratched  
UpTo 25mm Thru Paint

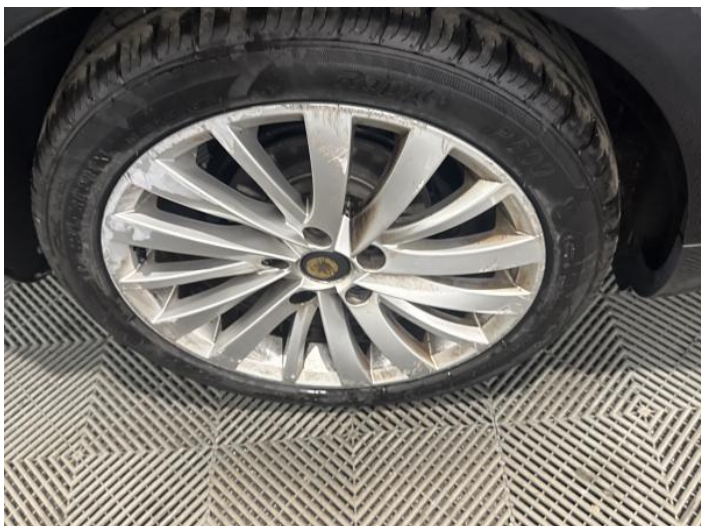
15: Wheel osr  
Scratched  
Over 50mm

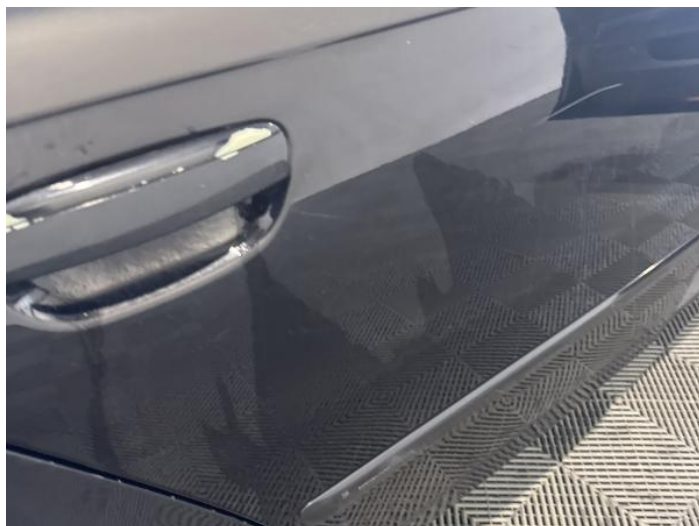
16: Door osr  
Scratched  
Over 25mm Thru Paint

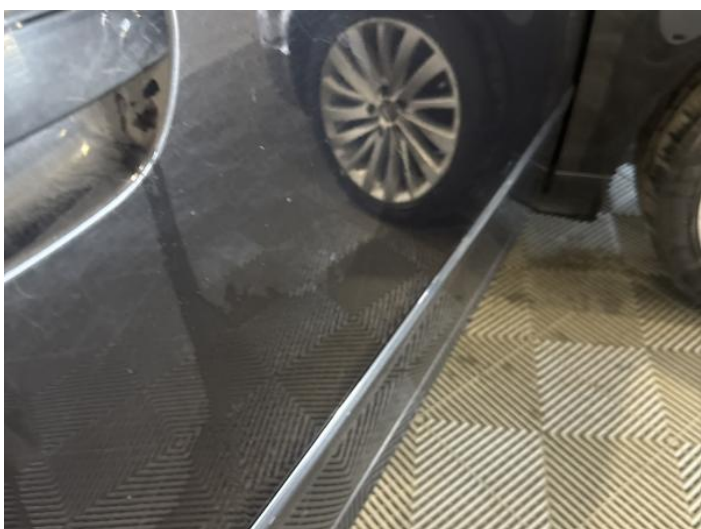
17: Door osf  
Chipped  
1 To 5

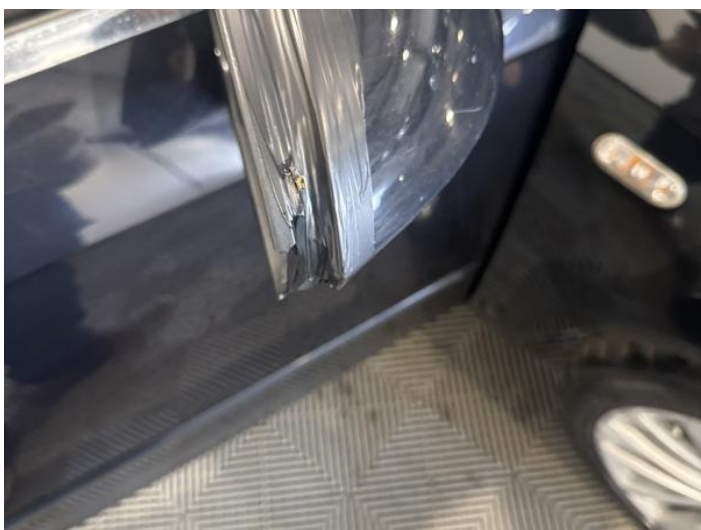
19: Door Mirror Assy osf  
Broken  
Replace

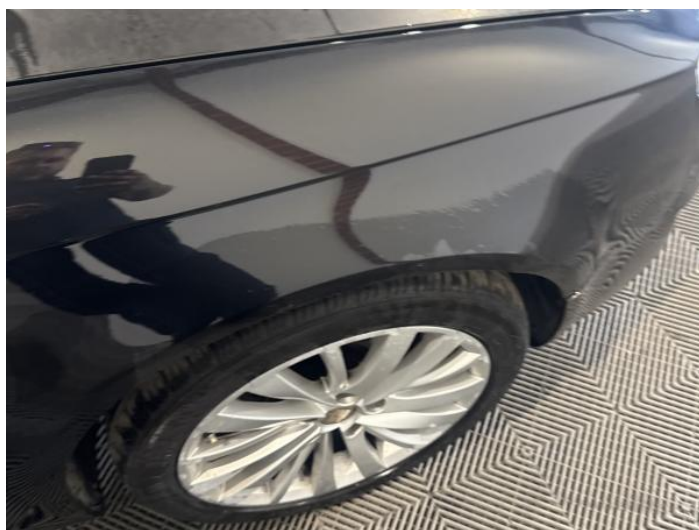
20: Wing osf  
Chipped  
1 To 5

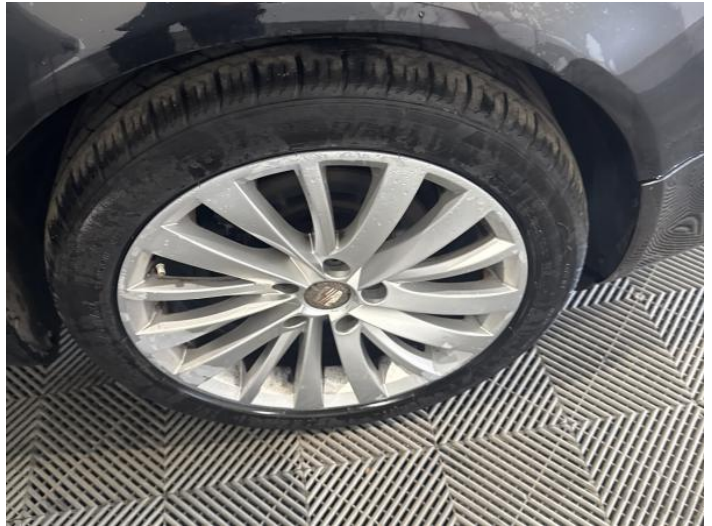
21: Wing osf  
Scratched  
Over 25mm Not Thru Paint
