VEHICLE INSPECTION REPORT

SJ11YJB

Seat Ibiza 1.2 TDI CR Ecomotive SE 5dr

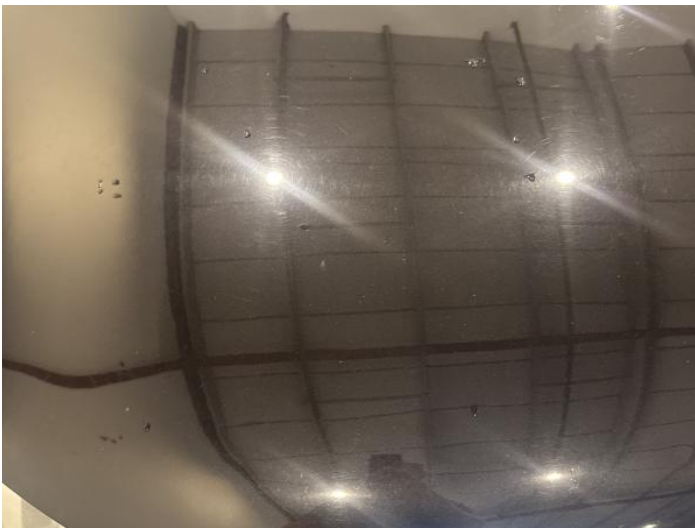
1: Bonnet
Chipped
1 To 5

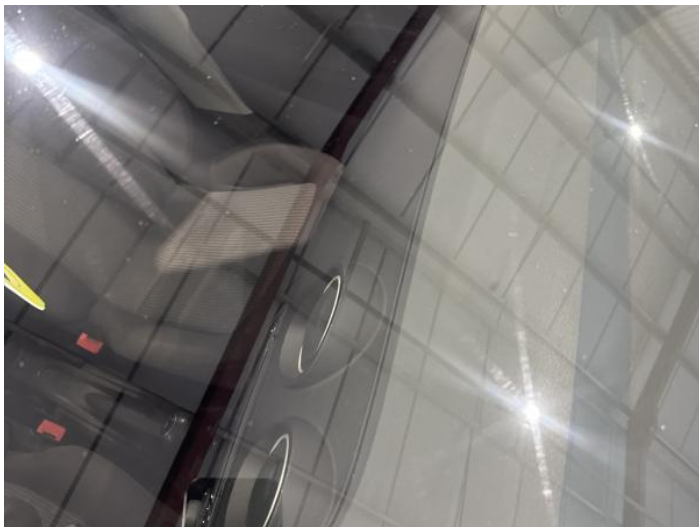
3: Screen Front
Chipped
UpTo 10mm

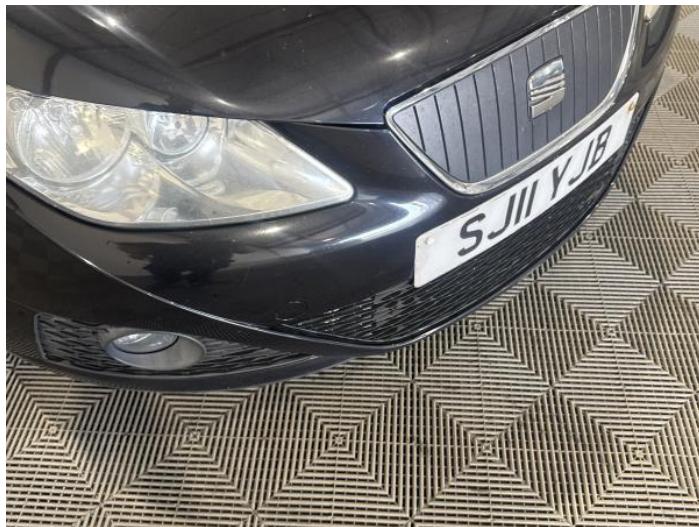
4: Bumper Front
Poor Previous Repair
Poor Paint

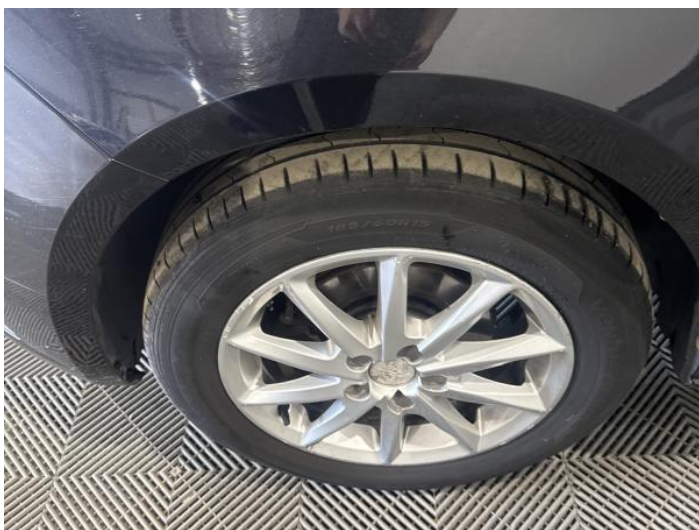
5: Wheel nsf
Scratched
Over 50mm

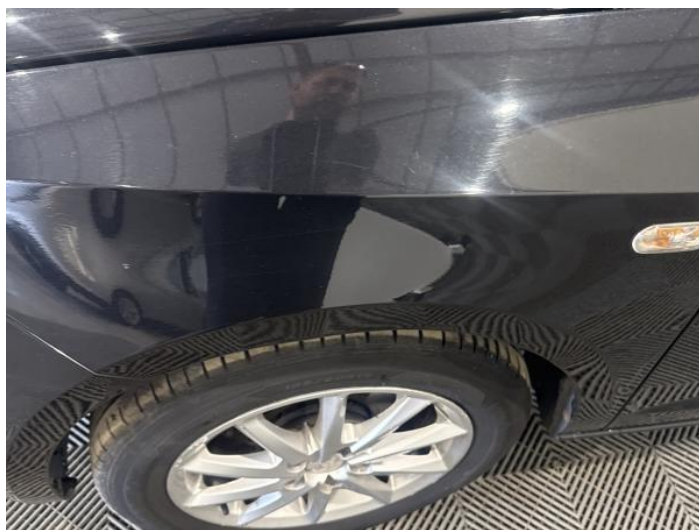
6: Wing nsf
Chipped
1 To 5

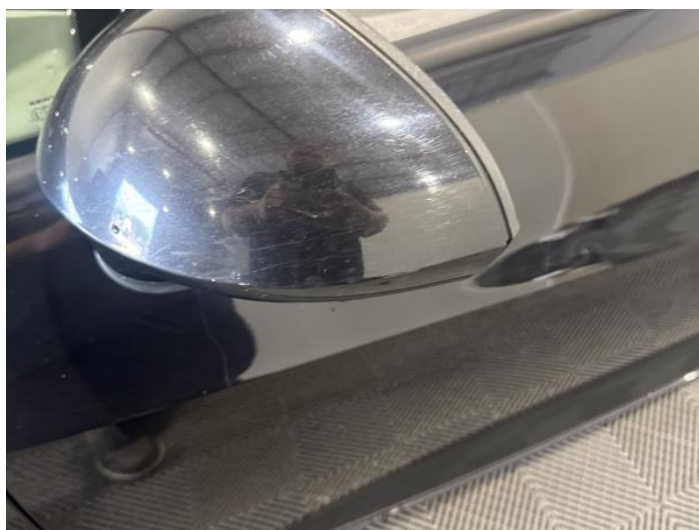
8: Door Mirror Assy nsf
Scratched (Painted)
Over 25mm Thru Paint

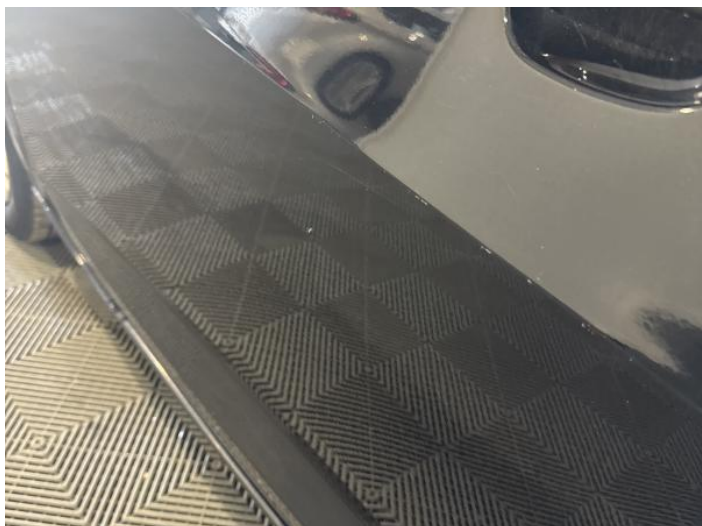
9: Door nsf
Dented
With Paint Damage

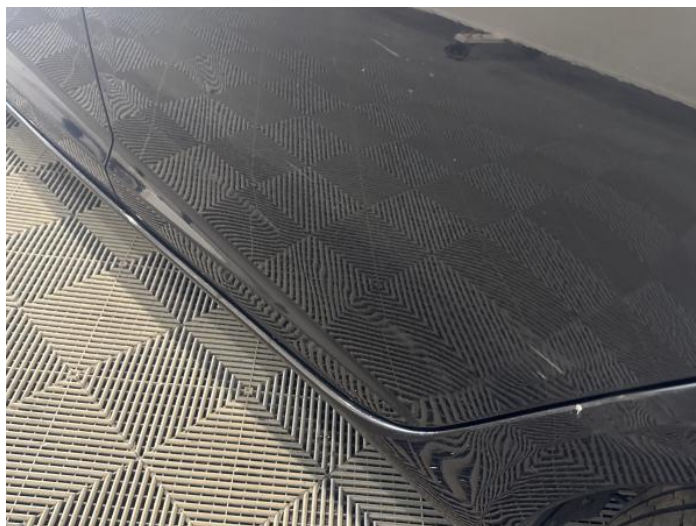
10: Door nsr
Dented
With Paint Damage

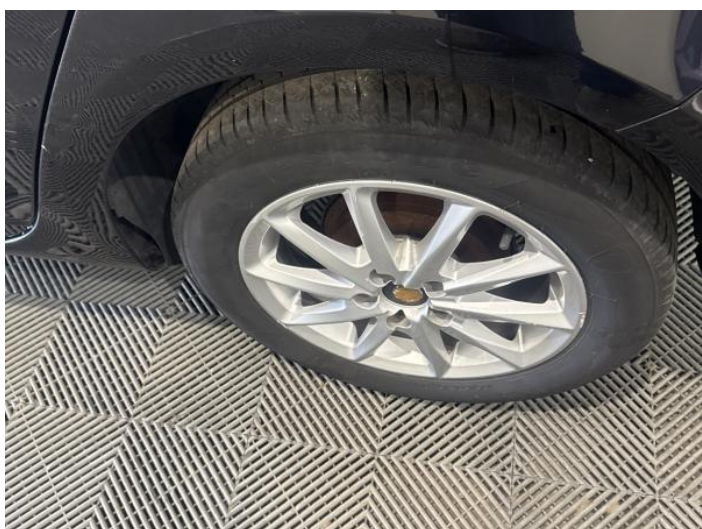
11: Wheel nsr
Scratched
Over 50mm

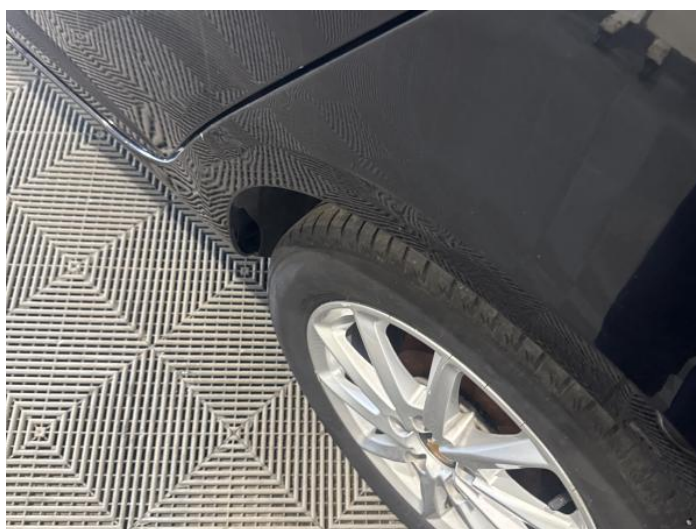
12: Qtr Panel nsr
Dented
With Paint Damage

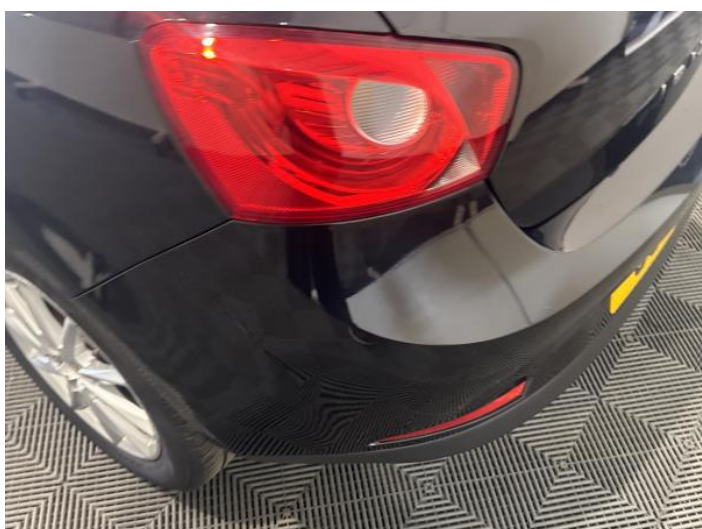
13: Bumper Rear
Scratched
Over 100mm Thru Paint

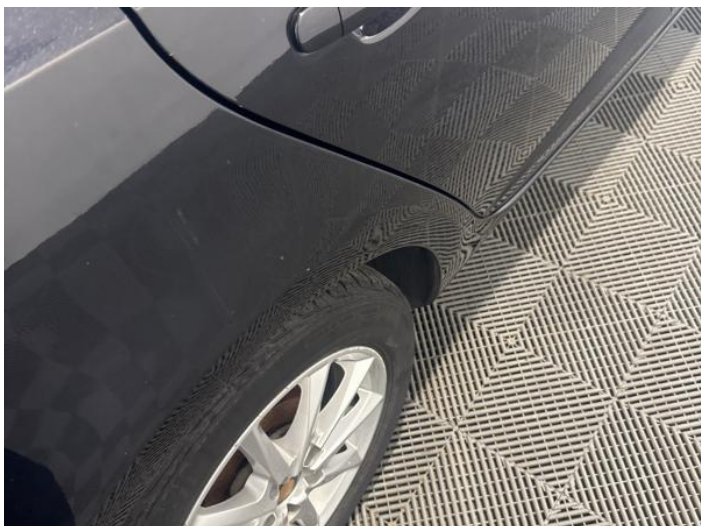
15: Qtr Panel osr
Dented
Over 30mm

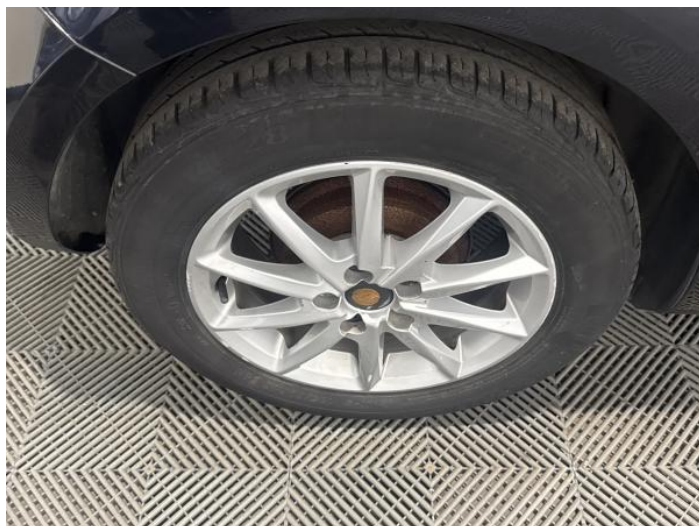
16: Wheel osr
Scratched
Over 50mm

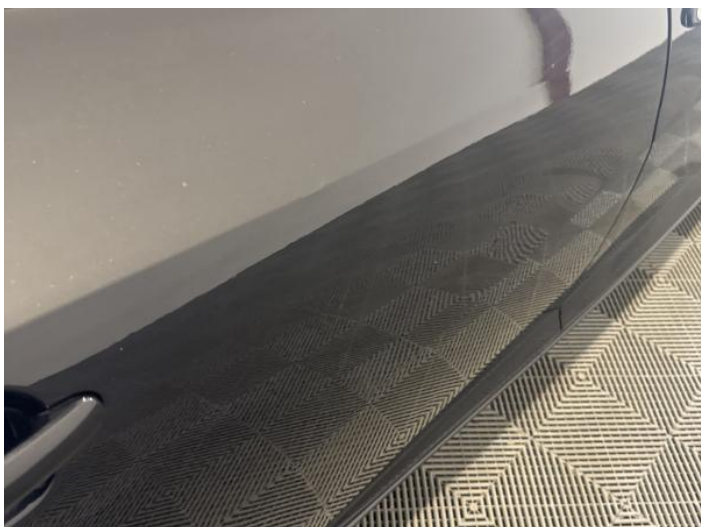
17: Door osr
Dented
With Paint Damage

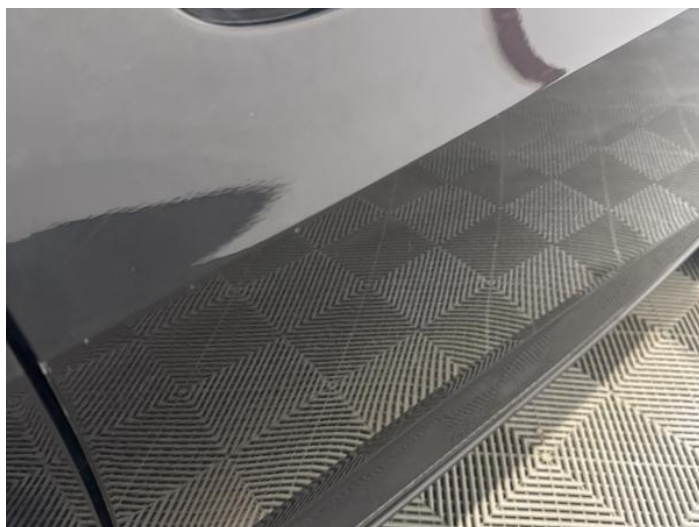
18: Door osf
Chipped
1 To 5

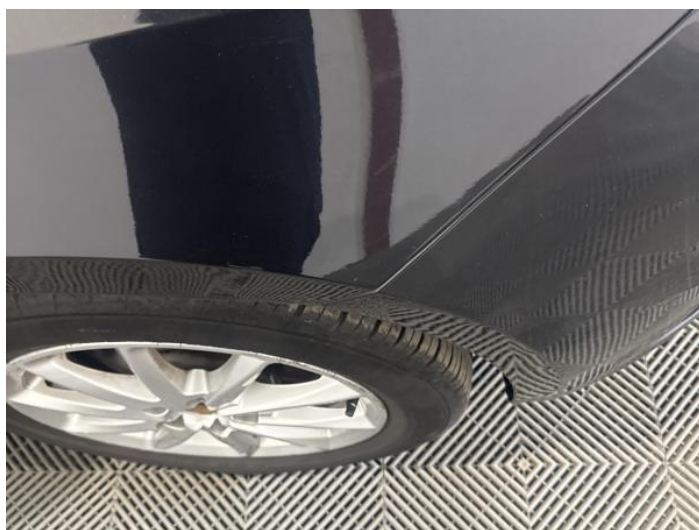
20: Wing osf
Chipped
1 To 5

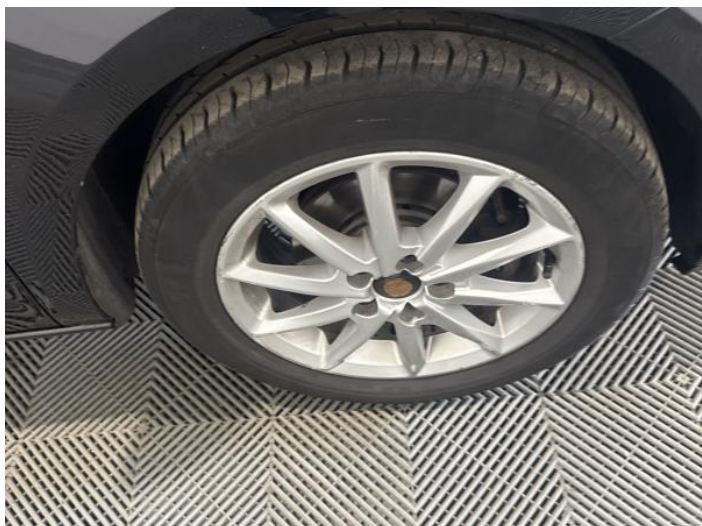
21: Wheel of
Scratched
Over 50mm
