VEHICLE INSPECTION REPORT

GU10CYS

Nissan Qashqai+2 1.5 dCi N-Tec 5dr

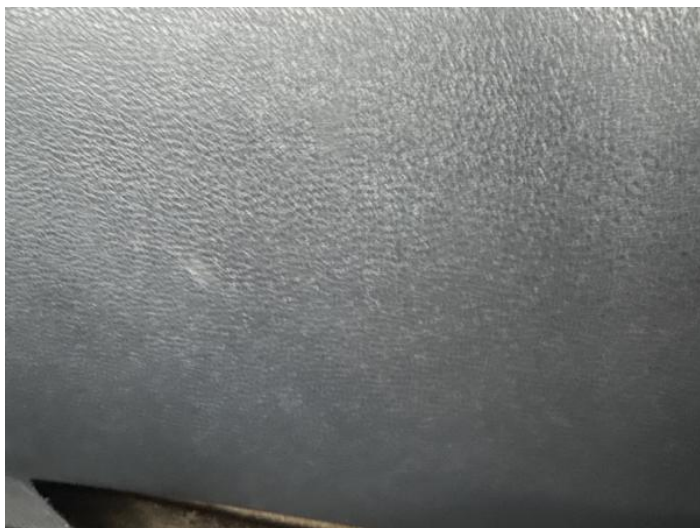
1: Door Pad osf
Torn
Over 10mm

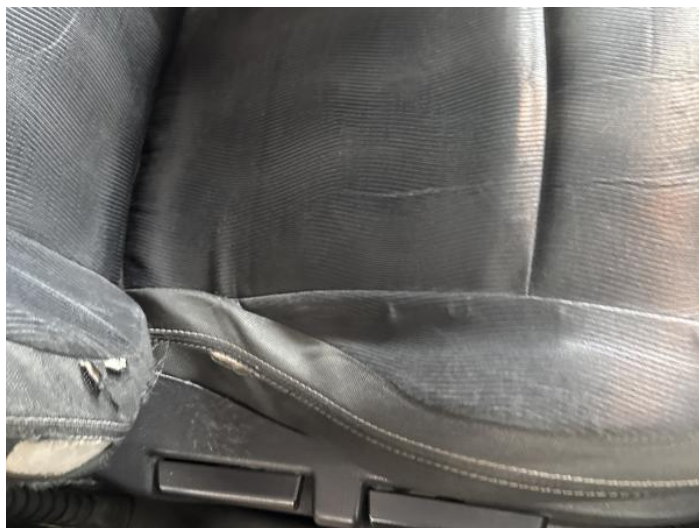
2: Seat Base Cover osf
Torn
UpTo 3mm

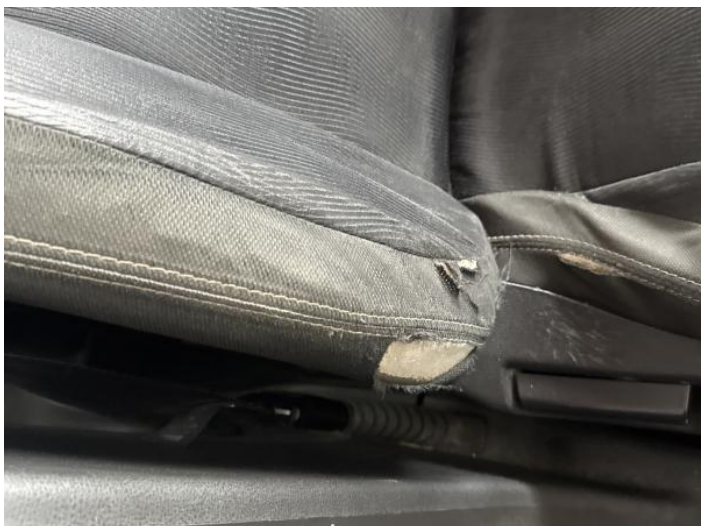
3: Seat Back Cover osf
Torn
Over 3mm

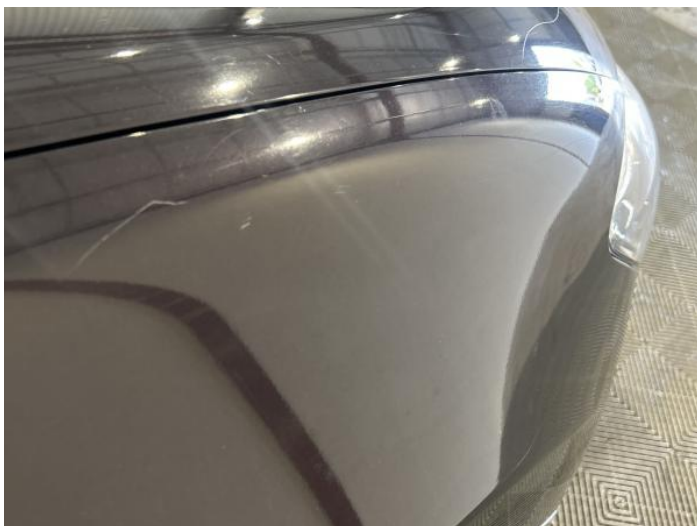
4: Wing osf
Scratched
Over 25mm Not Thru Paint

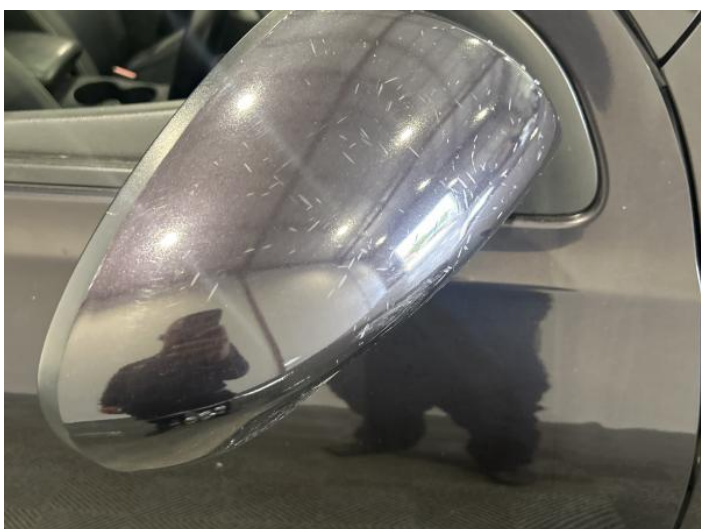
5: Door Mirror Assy osf
Scratched (Painted)
Over 25mm Thru Paint

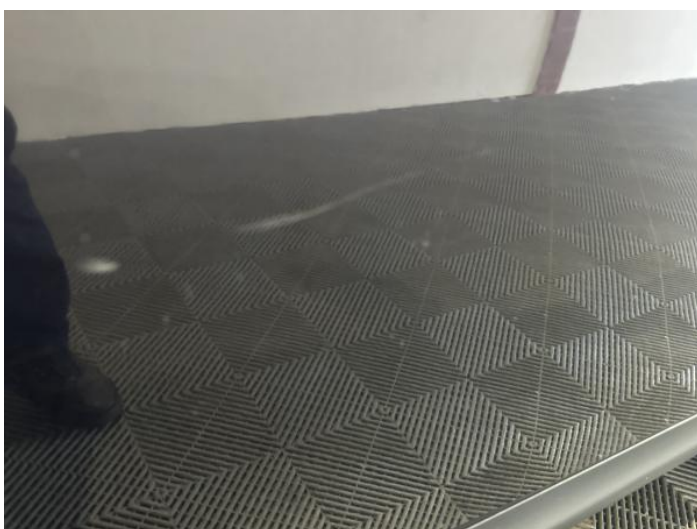
6: Door osf
Scratched
Over 25mm Thru Paint

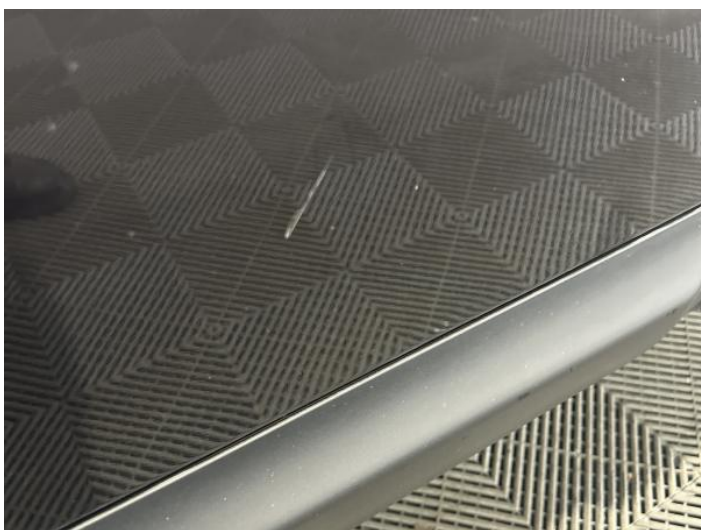
7: Door osr
Scratched
UpTo 25mm Thru Paint

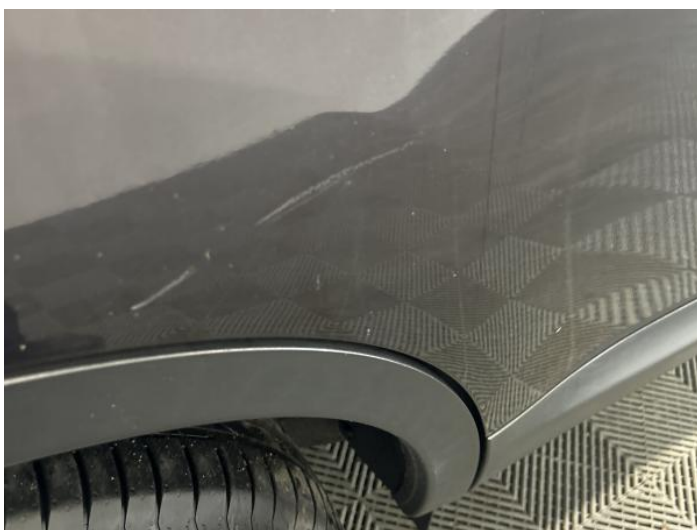
8: Door osr
Scratched
Over 25mm Not Thru Paint

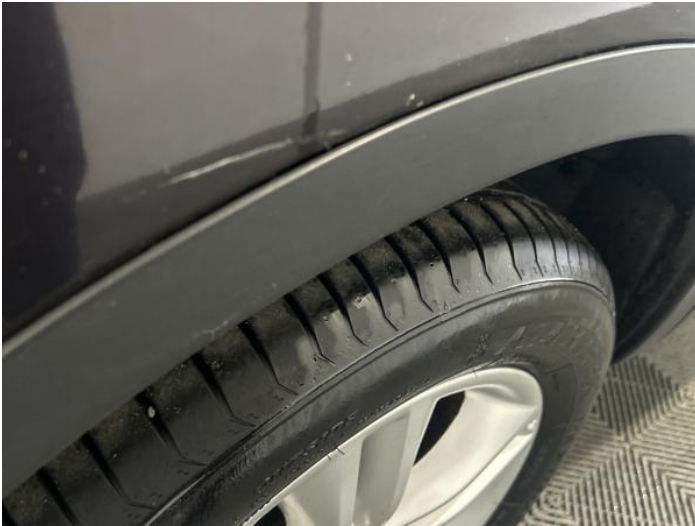
9: Qtr Panel osr
Scratched
Over 25mm Thru Paint

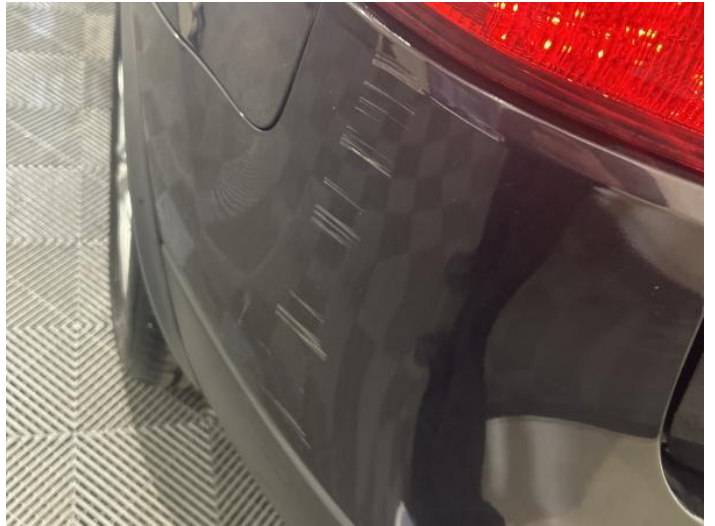
10: Bumper Rear
Scratched
Over 100mm Thru Paint

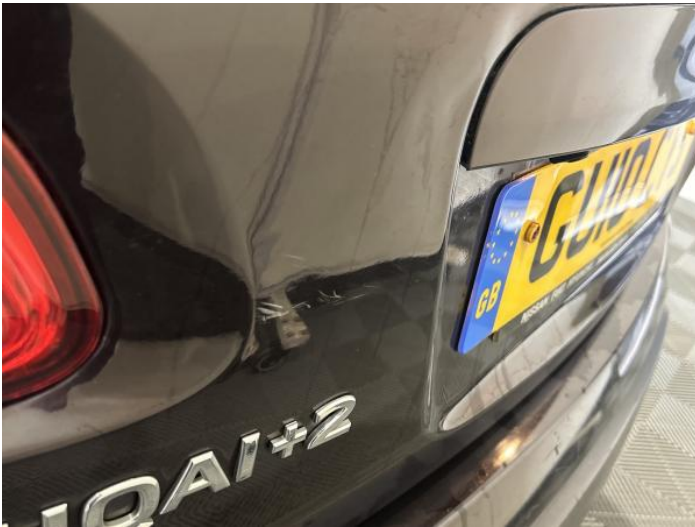
11: Tailgate
Dented
With Paint Damage

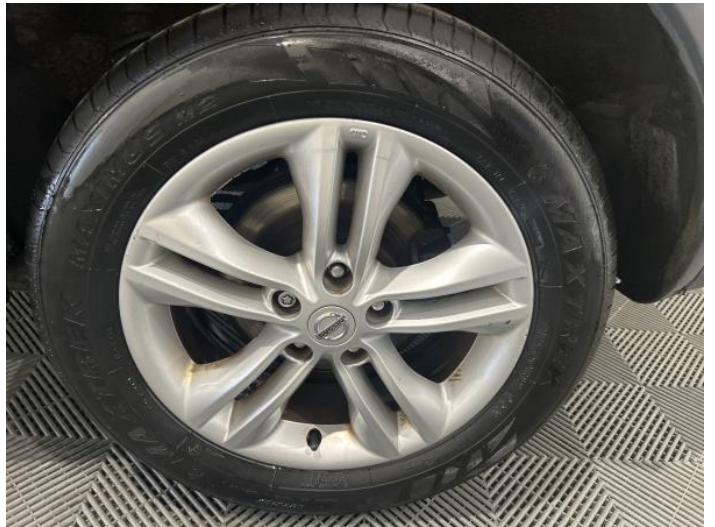
12: Wheel nsr
Scratched
Up To 50mm

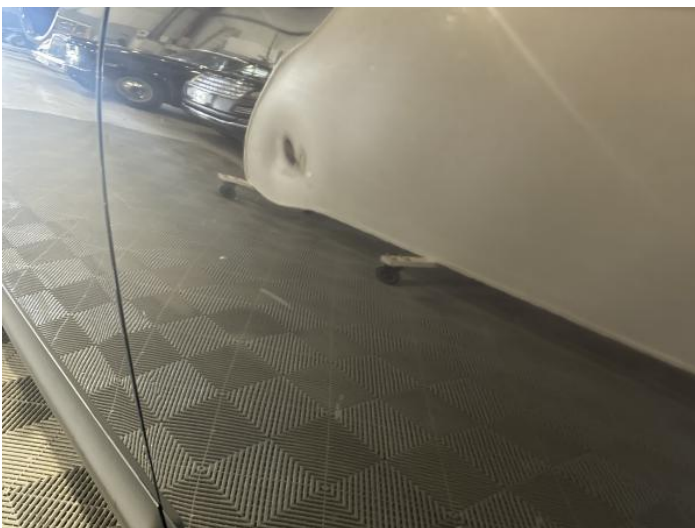
13: Door nsr
Dented
Over 30mm

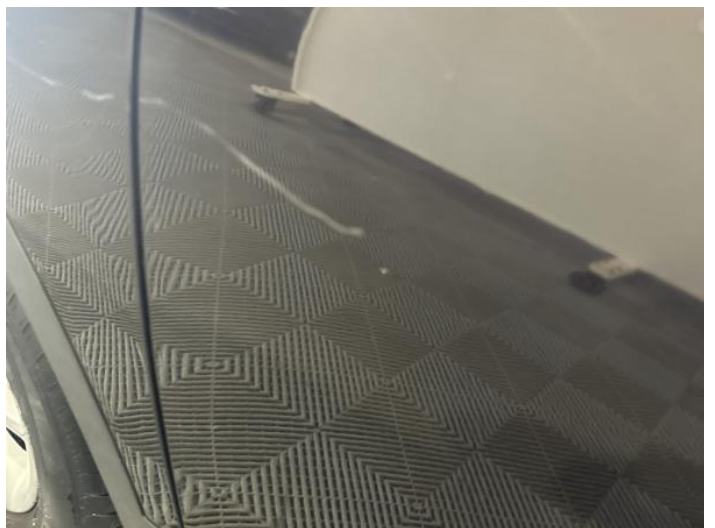
14: Door nsf
Scratched
Over 25mm Thru Paint

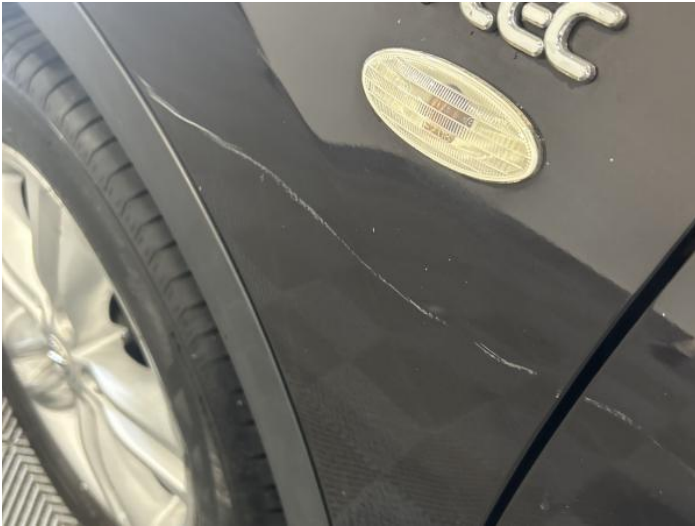
15: Wing nsf
Scratched
Over 25mm Thru Paint

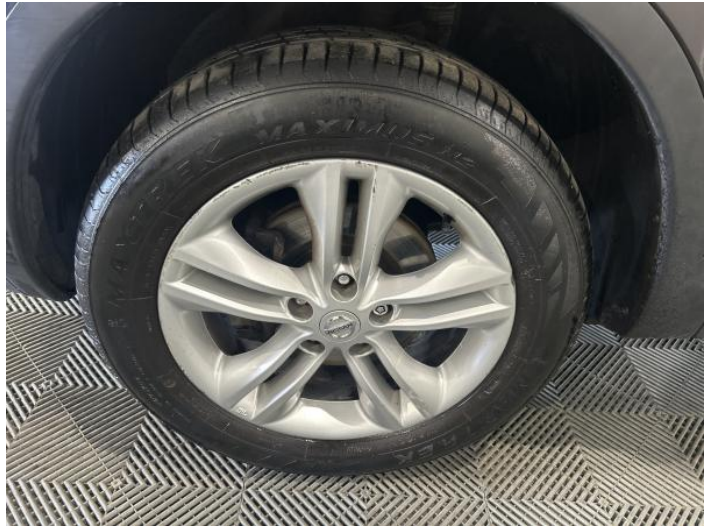
16: Wheel nsf
Scratched
Over 50mm

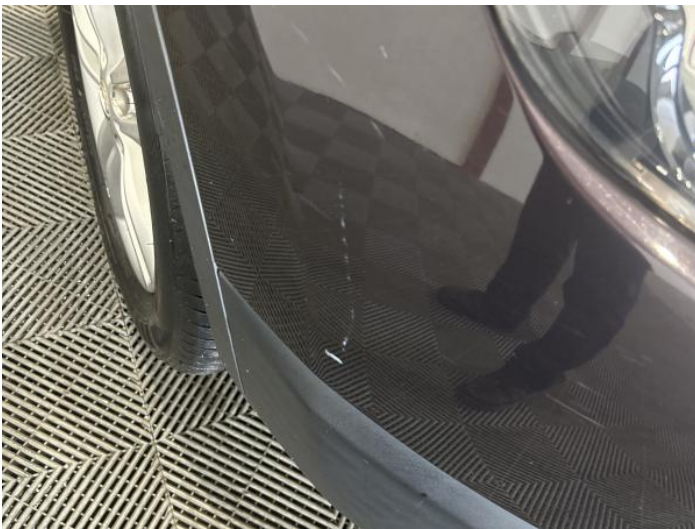
17: Bumper Front
Scratched
25 to 100mm Thru Paint

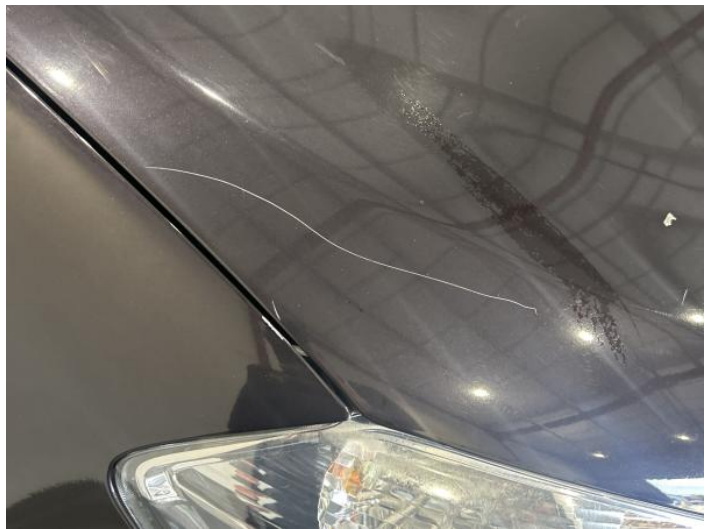
18: Bonnet
Scratched
Over 25mm Thru Paint

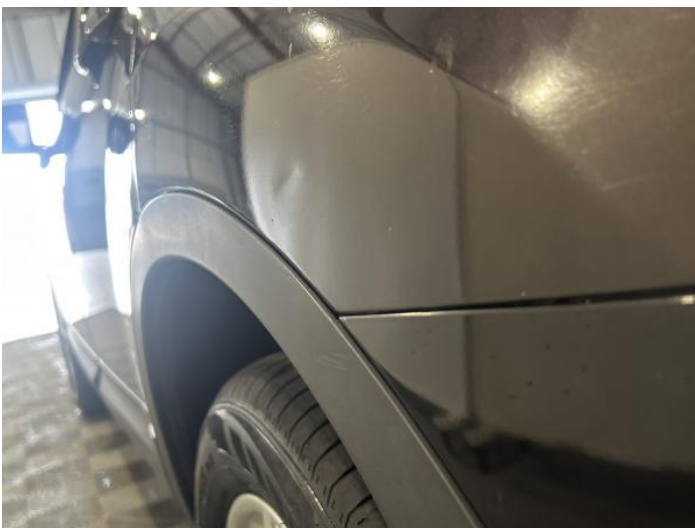
19: Qtr Panel nsr
Dented
Between 10mm + 30mm
