VEHICLE INSPECTION REPORT

SG16NVK

Jeep Renegade 1.6 Multijet Limited 5dr

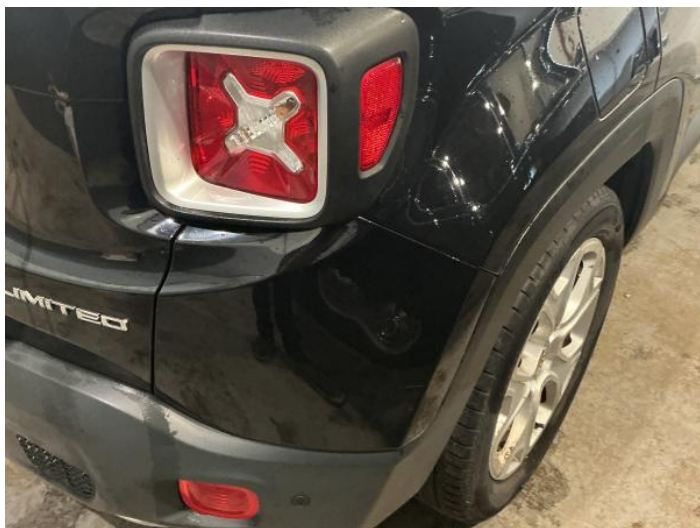
1: Bumper Rear
Scratched
25 to 100mm Thru Paint

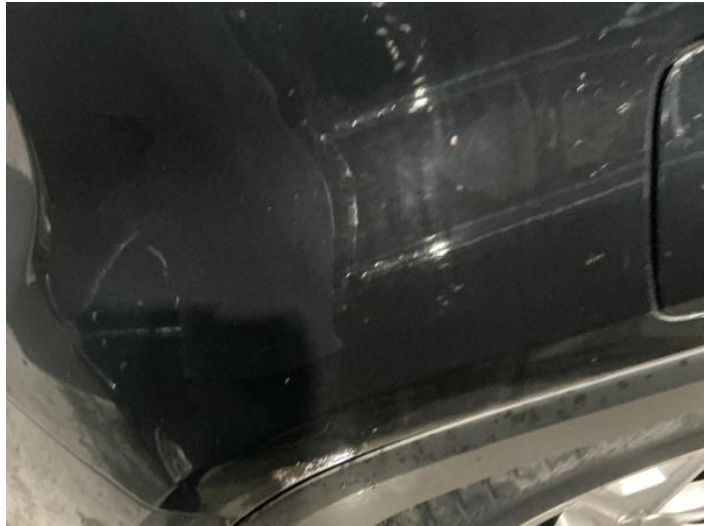
4: Qtr Panel osr
Chipped
1 To 5

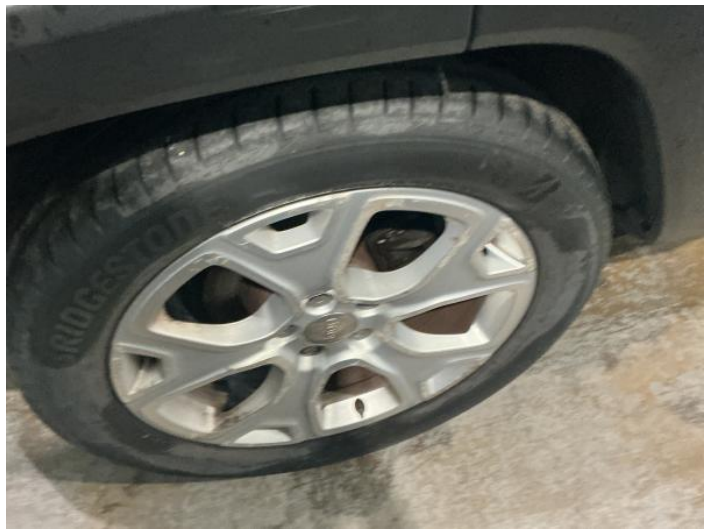
6: Wheel osr
Scratched
Over 50mm

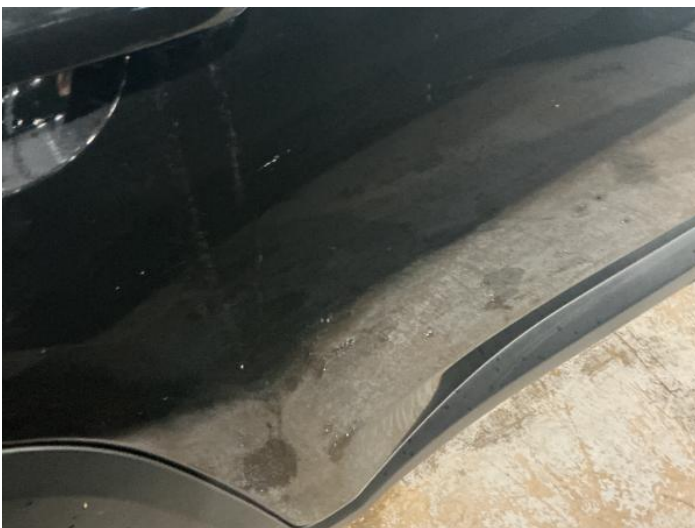
7: Door osr
Chipped
1 To 5

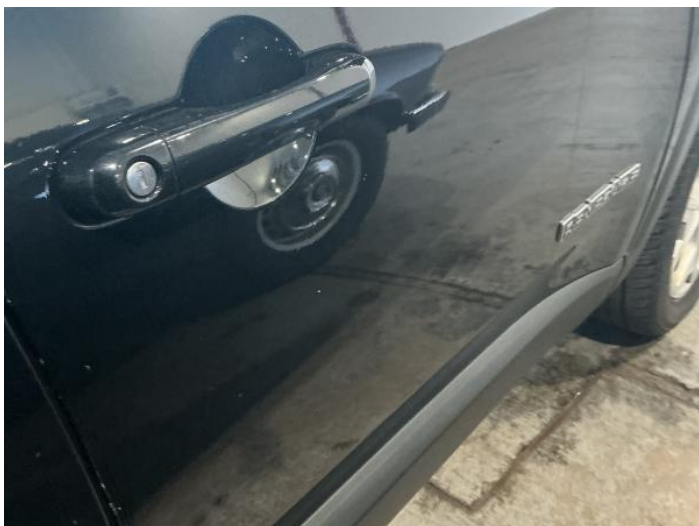
9: Door osf
Chipped
1 To 5

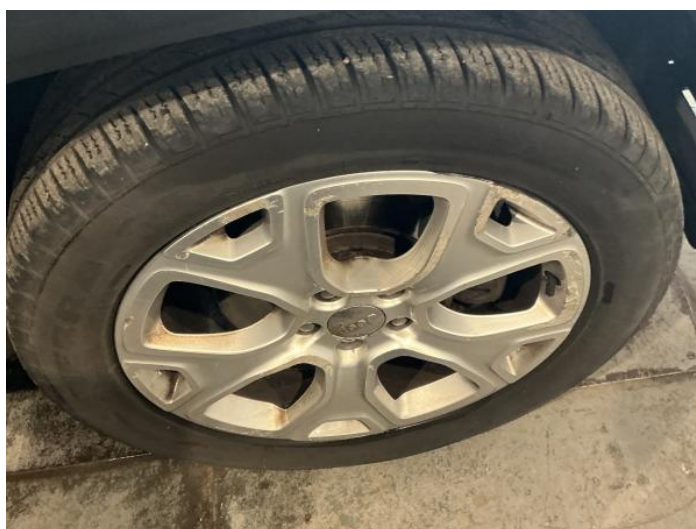
12: Wheel osf
Scratched
Over 50mm

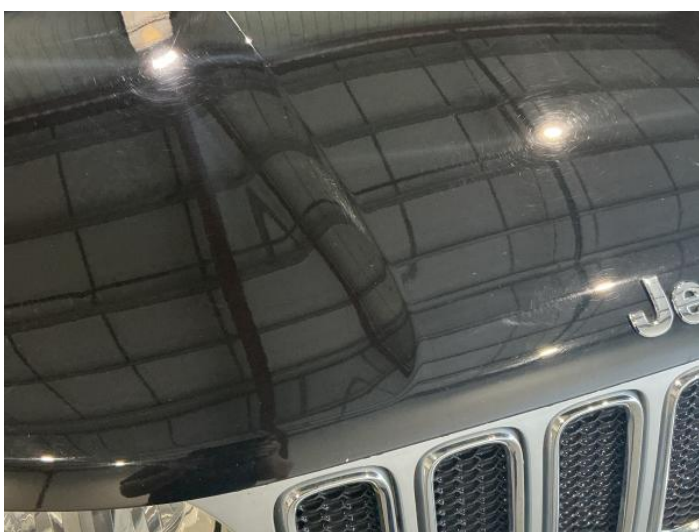
13: Bonnet
Chipped
Multiple Chips

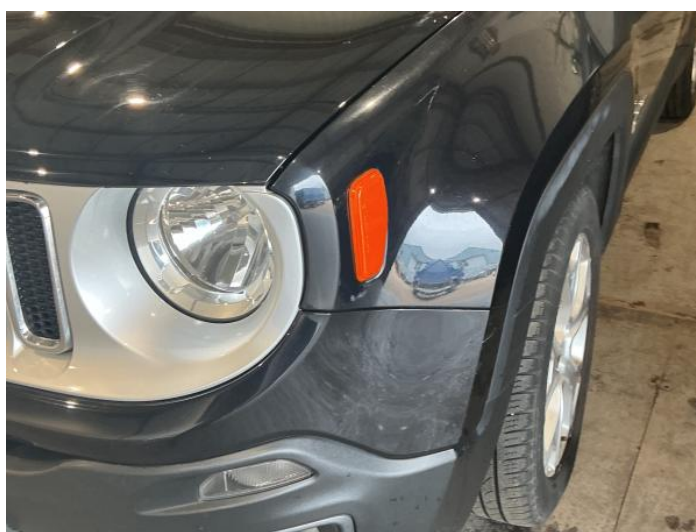
14: Bumper Front
Scratched
Over 100mm Thru Paint

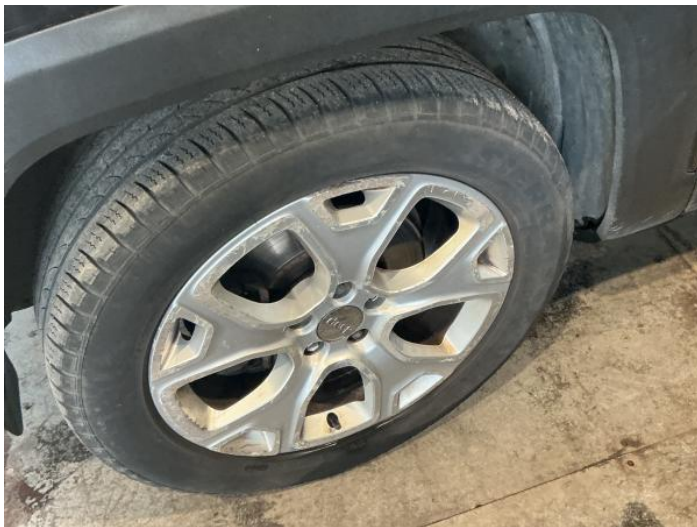
15: Wheel nsf
Scratched
Over 50mm

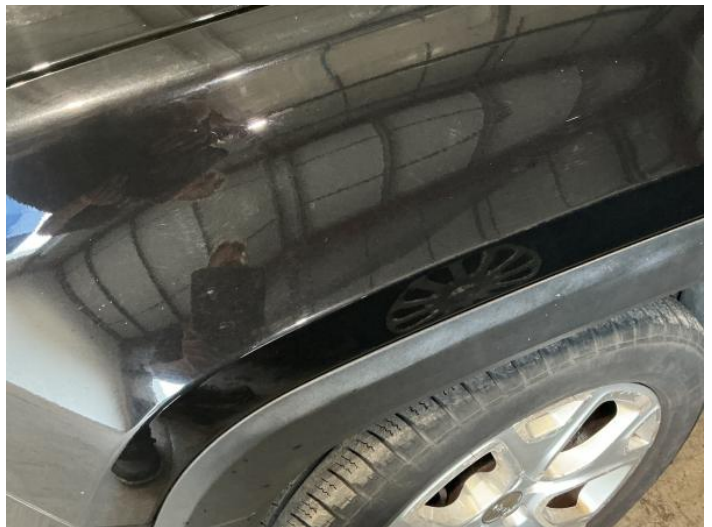
16: Wing nsf
Chipped
1 To 5

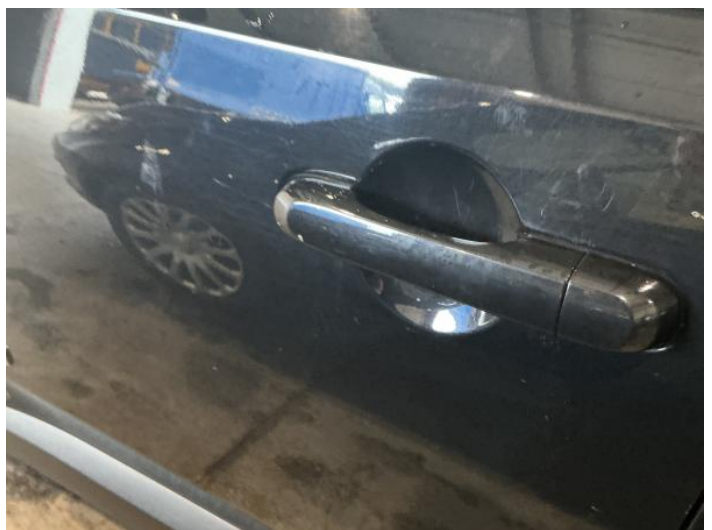
18: Door nsf
Dented
With Paint Damage

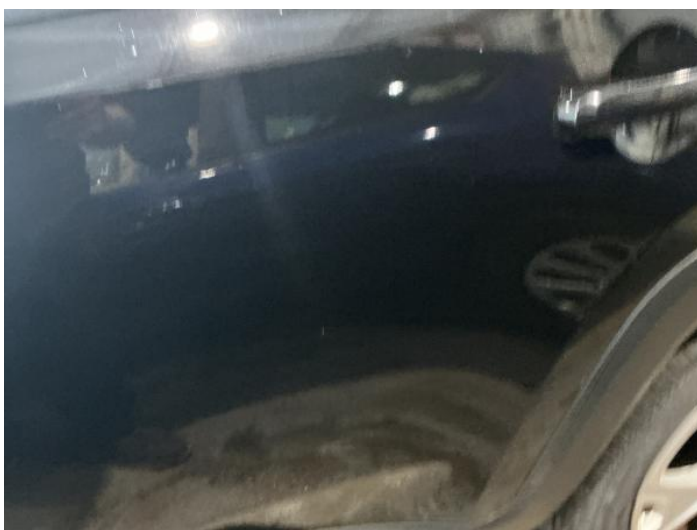
19: Door nsr
Chipped
1 To 5

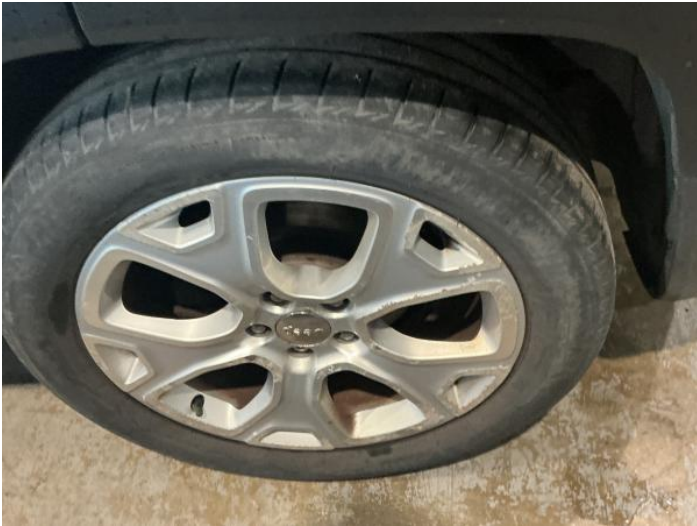
21: Wheel nsr
Scratched
Over 50mm

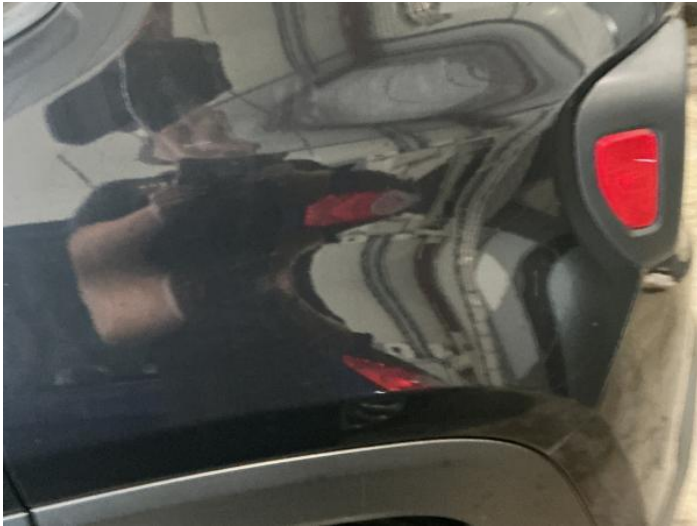
22: Qtr Panel nsr
Chipped
1 To 5

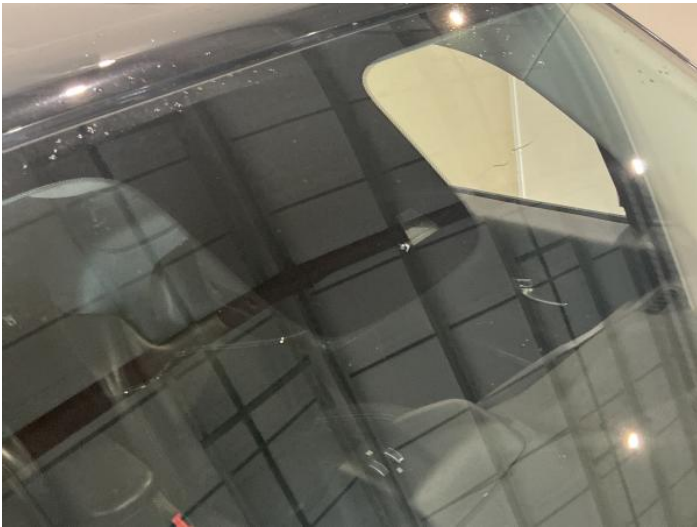
23: Screen Front
Cracked
Replace
