# VEHICLE INSPECTION REPORT

**LP65KWB**

## Smart Forfour 1.0 Proxy Premium Plus 5dr

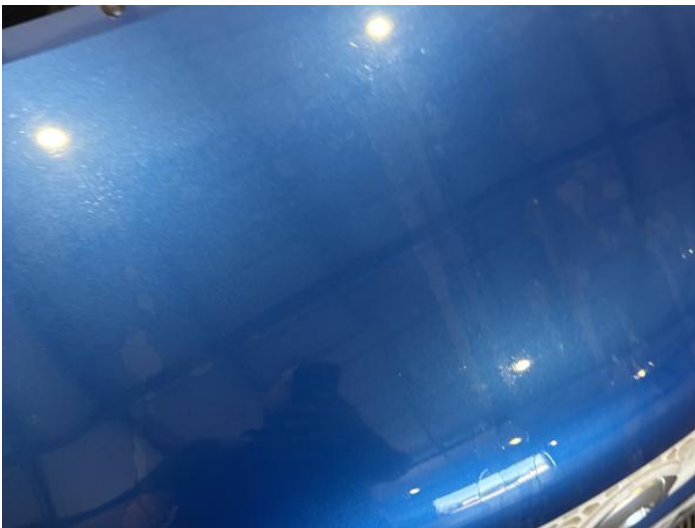
1: Bonnet  
Chipped  
1 To 5

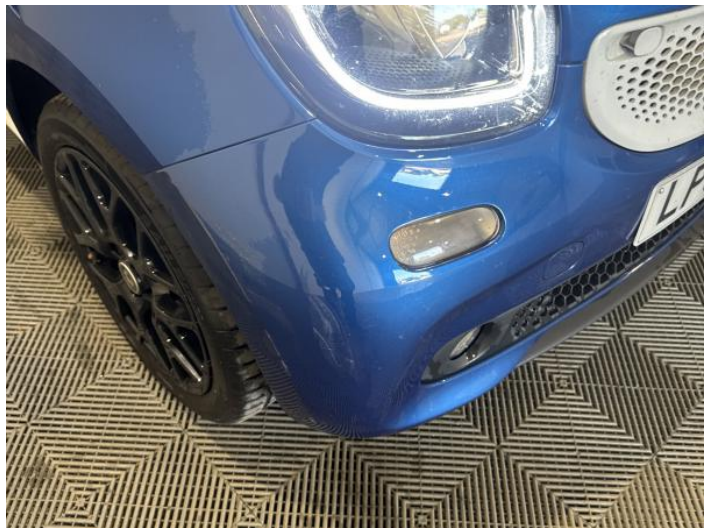
2: Bumper Front  
Scratched  
25 to 100mm Thru Paint

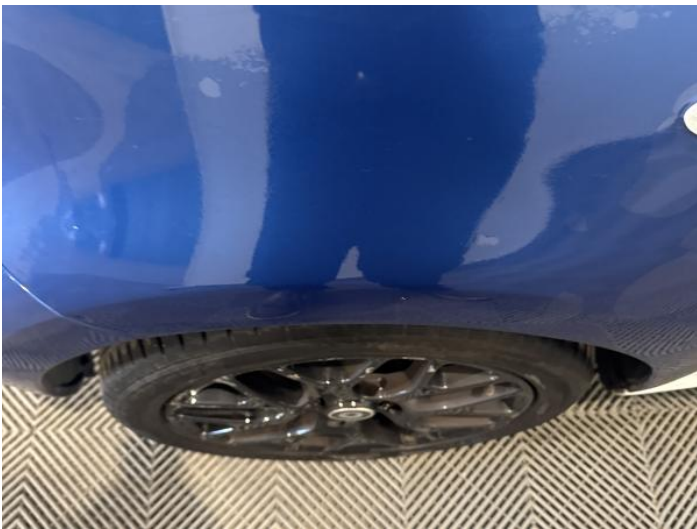
5: Wing nsf  
Chipped  
1 To 5

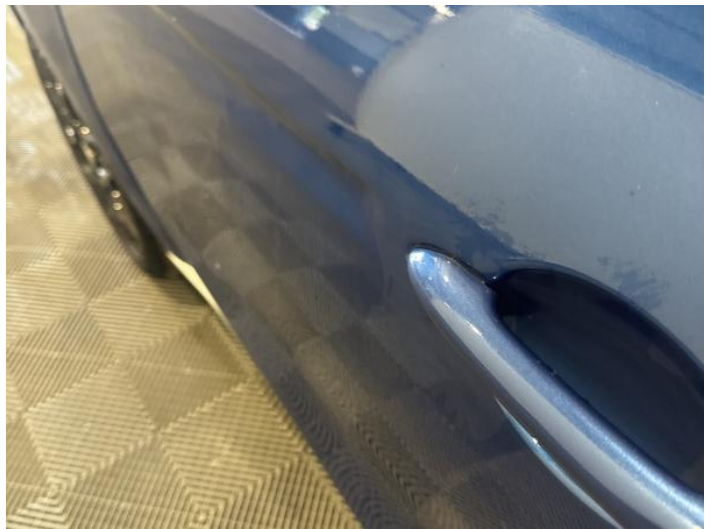
6: Door nsf  
Dented  
Over 2 UpTo 10mm

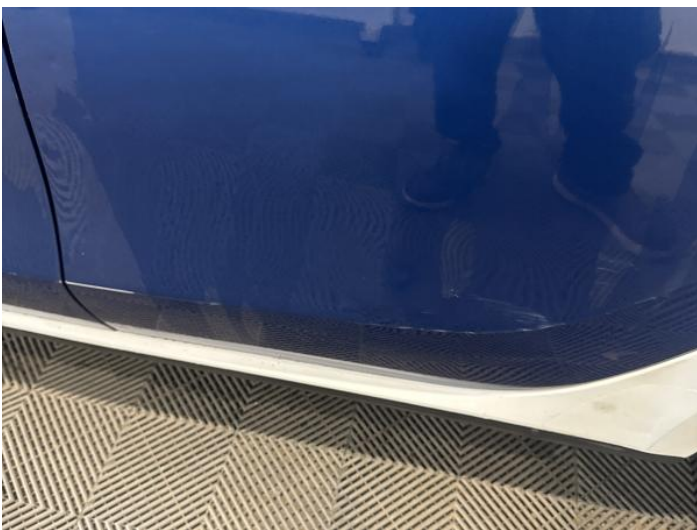
7: Door nsr  
Dented  
With Paint Damage

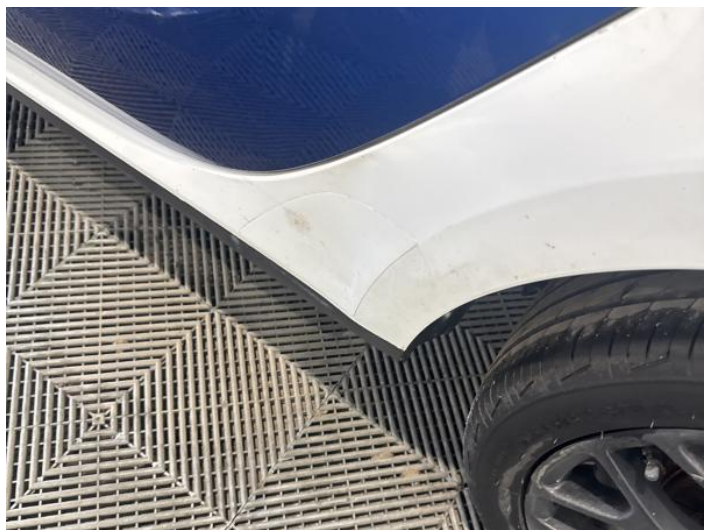
8: Qtr Panel nsr  
Dented  
With Paint Damage

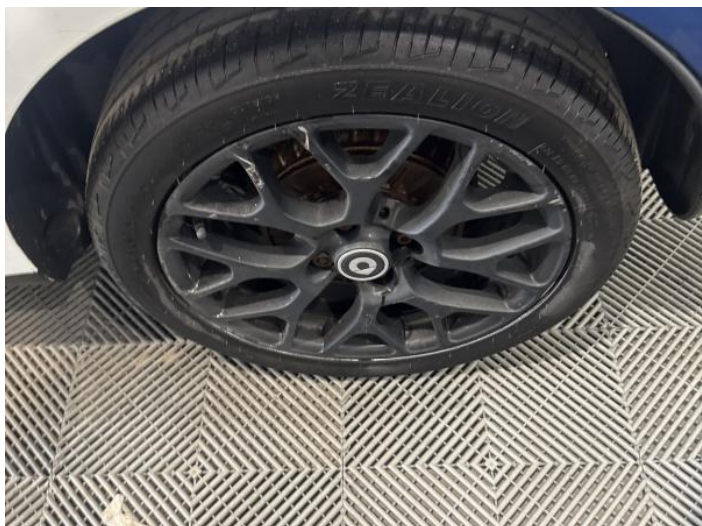
9: Wheel nsr  
Scratched  
Over 50mm

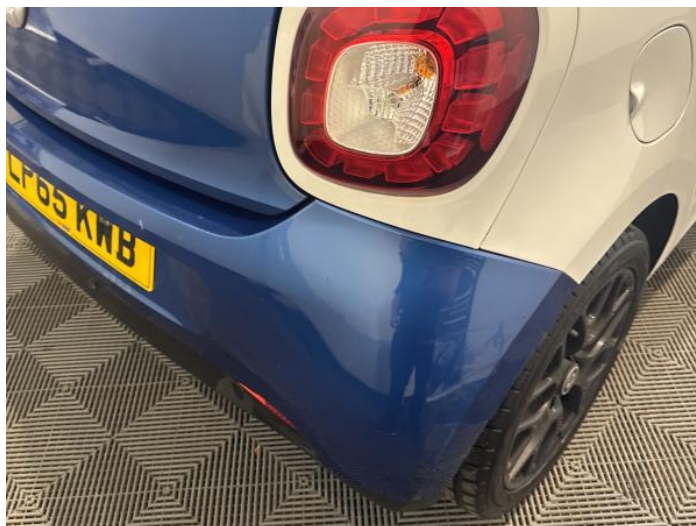
10: Bumper Rear  
Scratched  
25 to 100mm Thru Paint

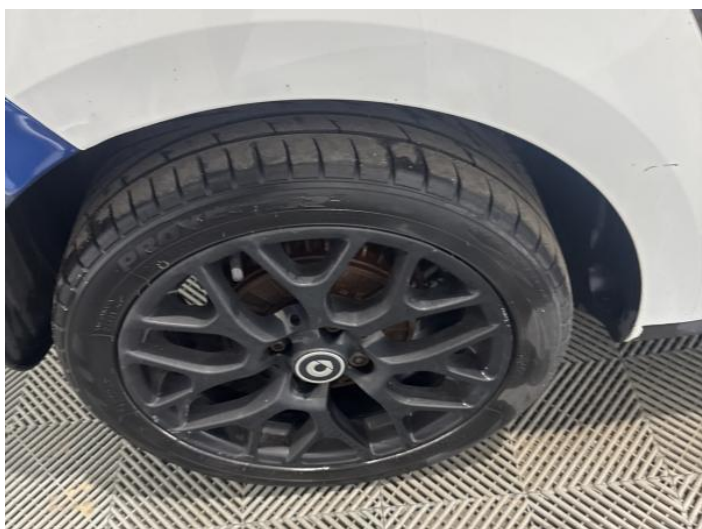
13: Wheel osr  
Scratched  
Over 50mm

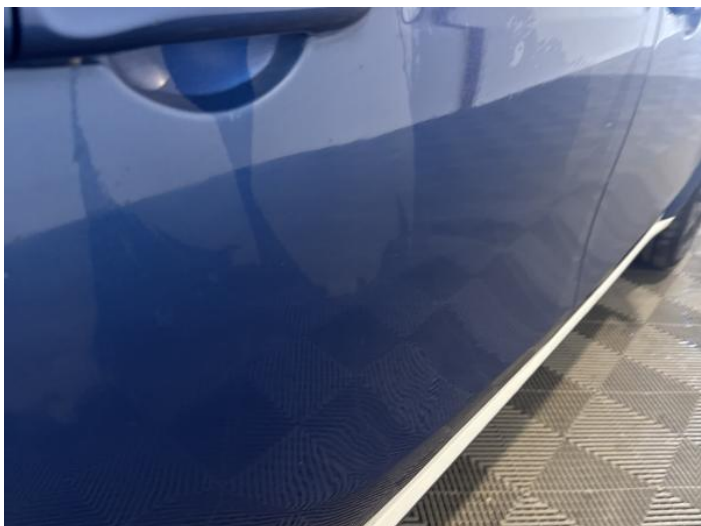
15: Door osr  
Chipped  
1 To 5

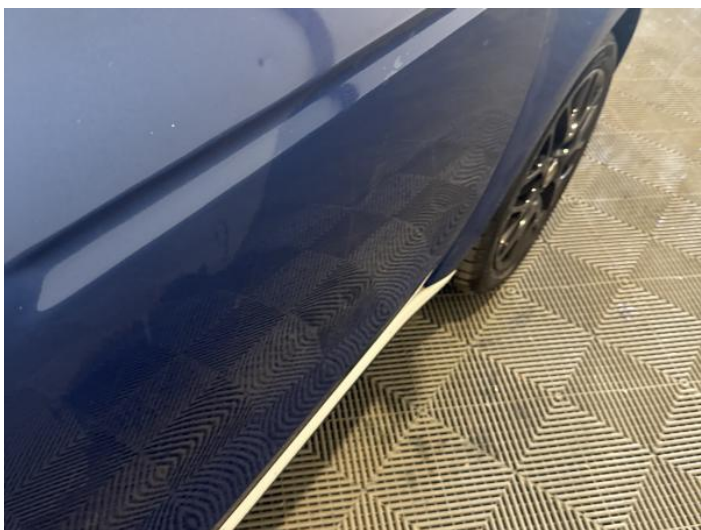
17: Door osf  
Dented  
Between 10mm + 30mm

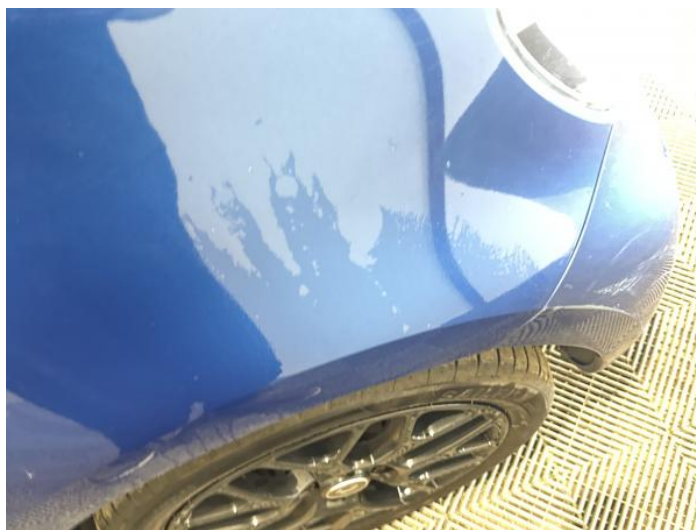
18: Wing nsf  
Chipped  
1 To 5

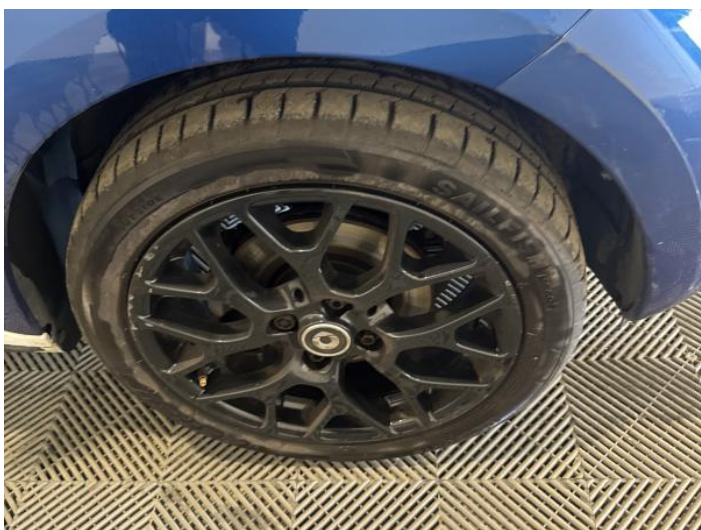
19: Wheel osf  
Scratched  
Over 50mm
