VEHICLE INSPECTION REPORT

LV57ZFF

Vauxhall Astra 1.7 CDTi 16V Design [100] 5dr

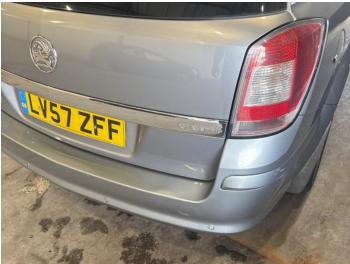
1: Boot Lid Scratched Over 25mm Not Thru Paint

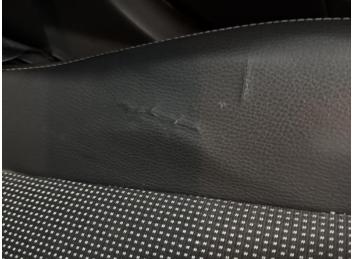
18: Seat Base Cover osf Torn Over 3mm
