# VEHICLE INSPECTION REPORT

**GY10FRR**

## Vauxhall Astra 1.4i 16V Exclusiv 5dr

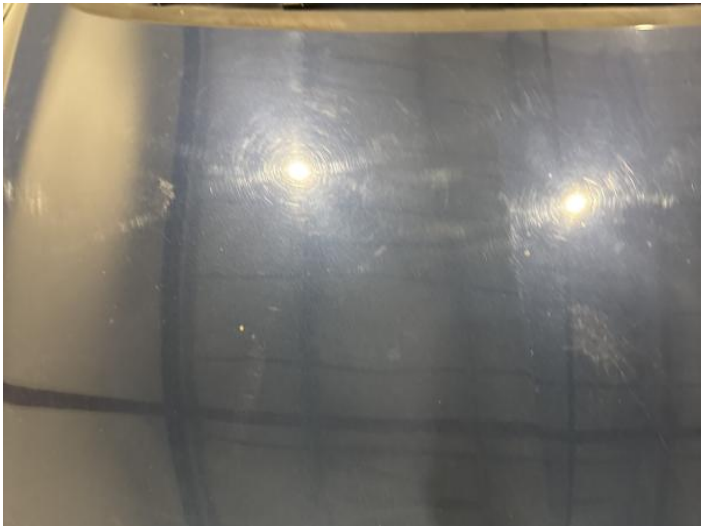
2: Bonnet  
Chipped  
1 To 5

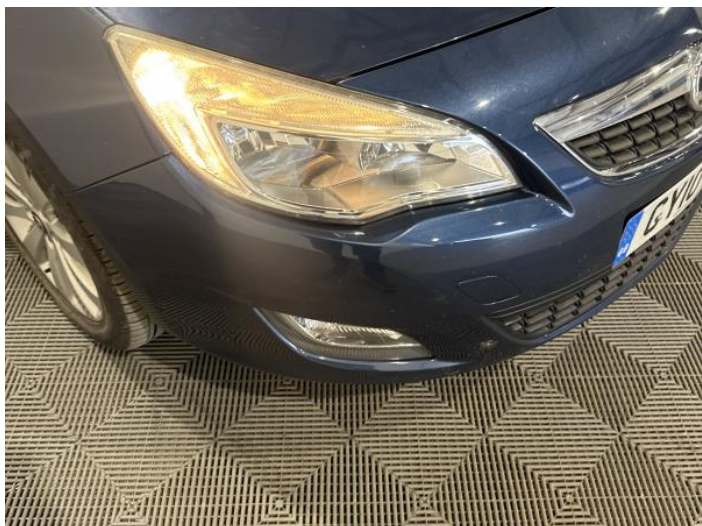
3: Bumper Front  
Scratched  
Over 100mm Thru Paint

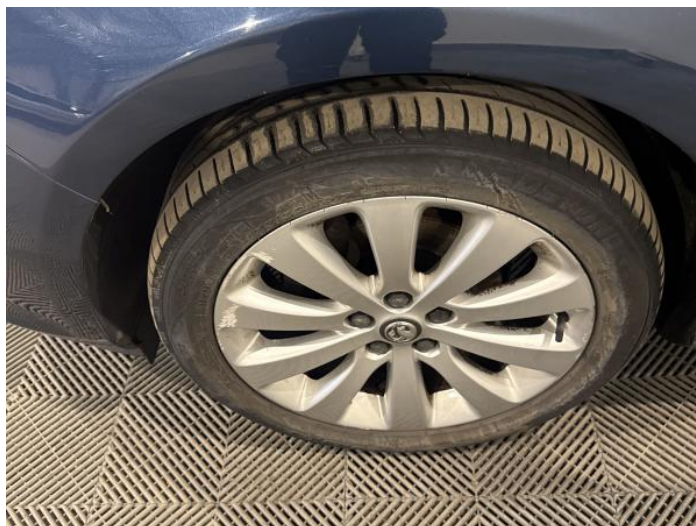
4: Wheel nsf  
Scratched  
Over 50mm

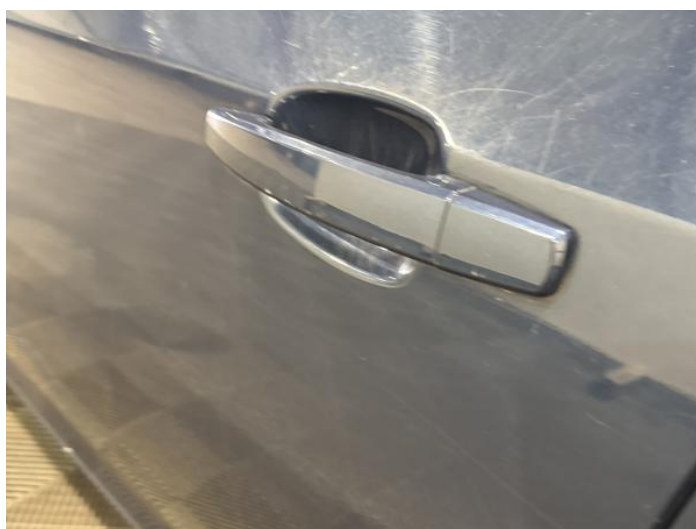
6: Door nsf  
Chipped  
1 To 5

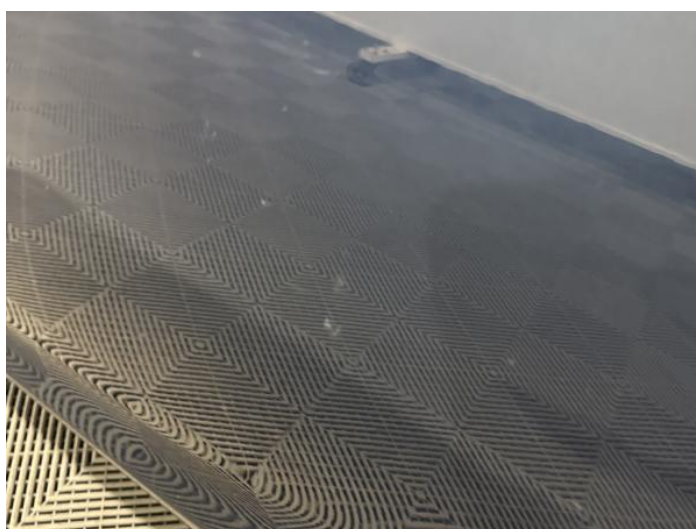
8: Door nsr  
Chipped  
1 To 5

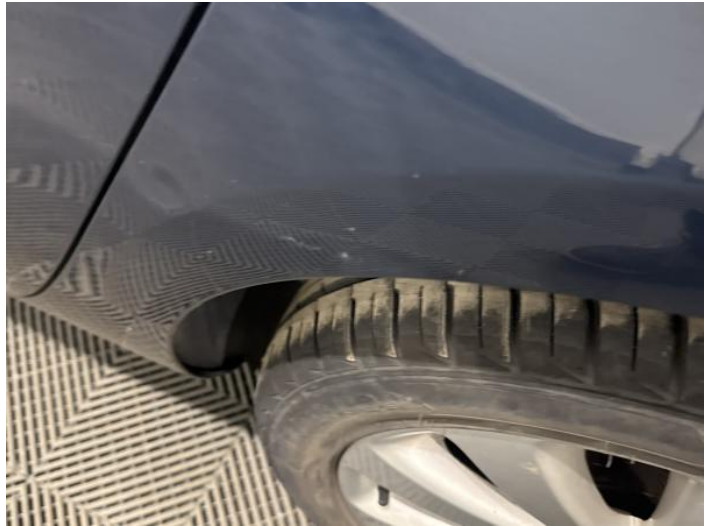
10: Qtr Panel nsr  
Dented  
Over 2 UpTo 10mm

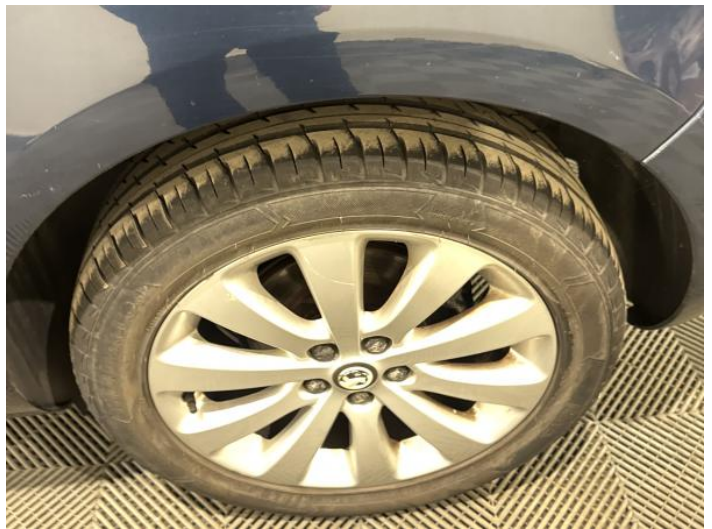
12: Wheel nsr  
Scratched  
Up To 50mm

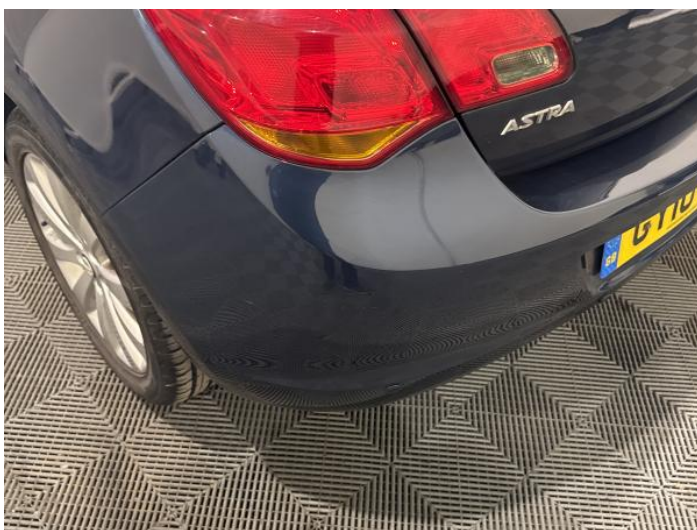
13: Bumper Rear  
Dented  
With Paint Damage

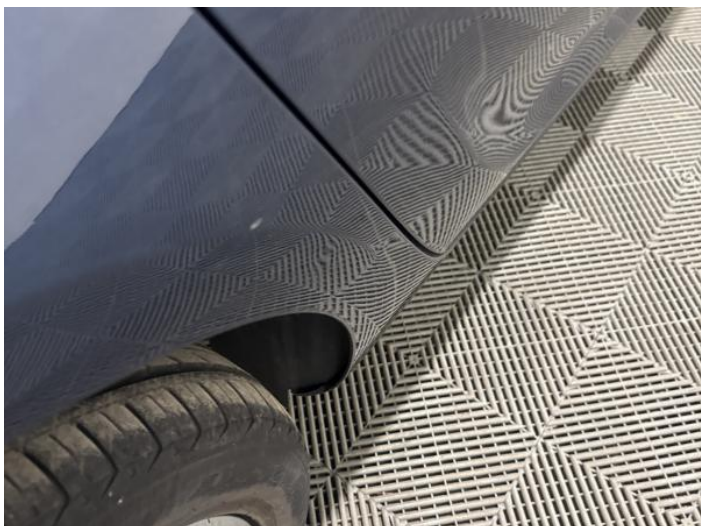
15: Qtr Panel osr  
Dented  
2 Or Less UpTo 10mm

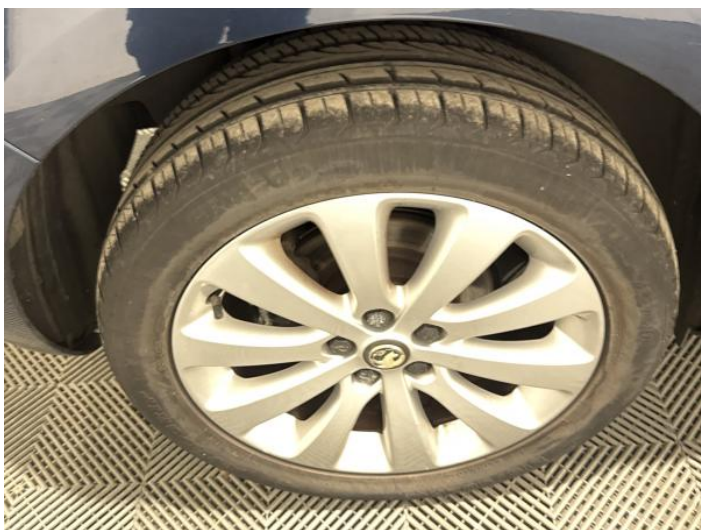
17: Wheel osr  
Scratched  
Over 50mm

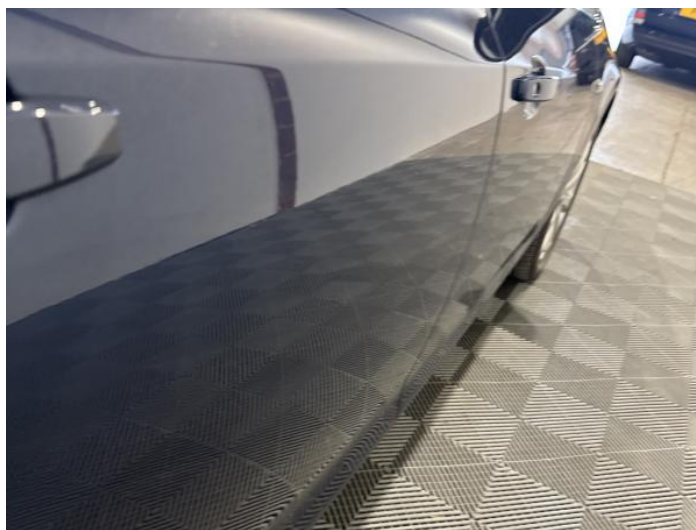
18: Door osr  
Dented  
Over 2 UpTo 10mm

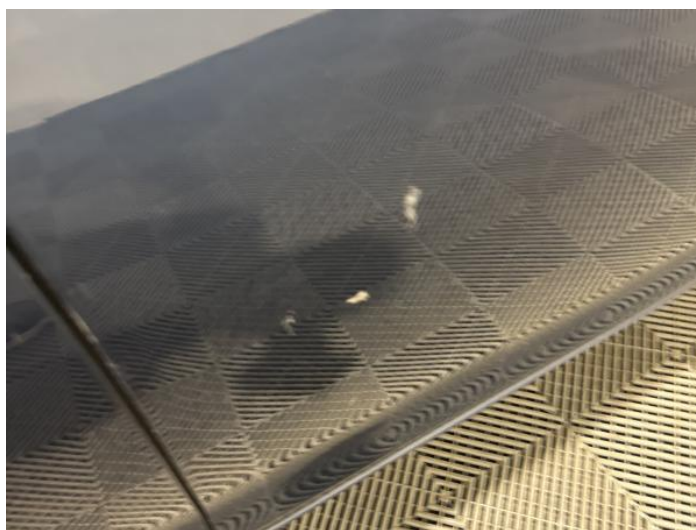
20: Door osf  
Scratched  
Over 25mm Thru Paint

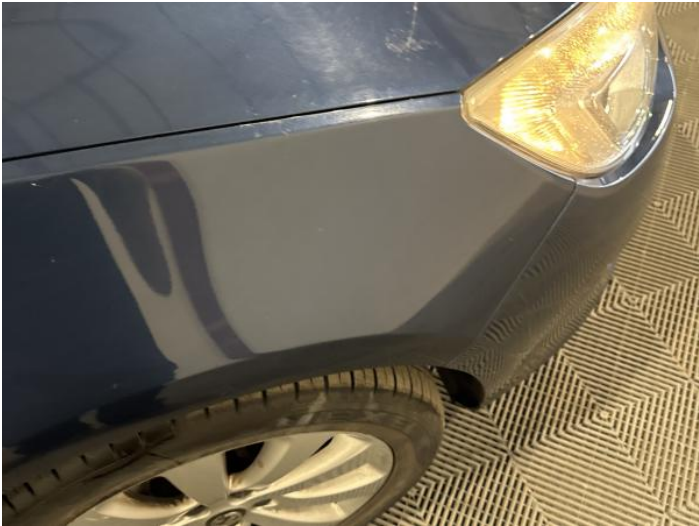
21: Wing osf  
Chipped  
1 To 5

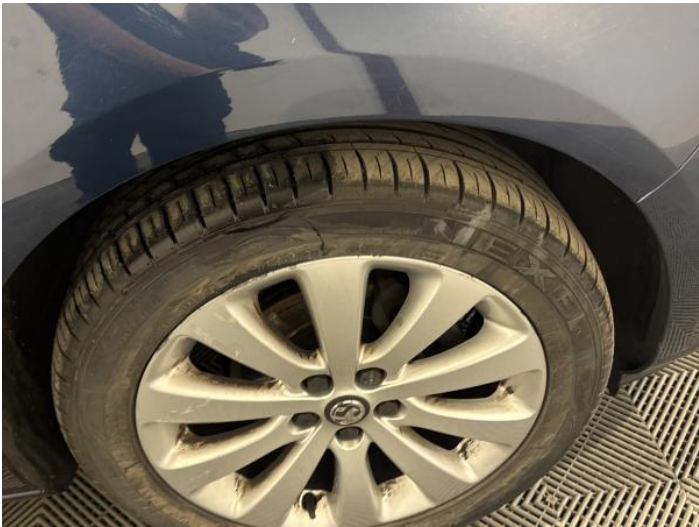
23: Wheel osf  
Scratched  
Over 50mm
