# VEHICLE INSPECTION REPORT

**HV07OKD**

## Toyota Yaris 1.3 VVT-i Zinc 5dr MMT

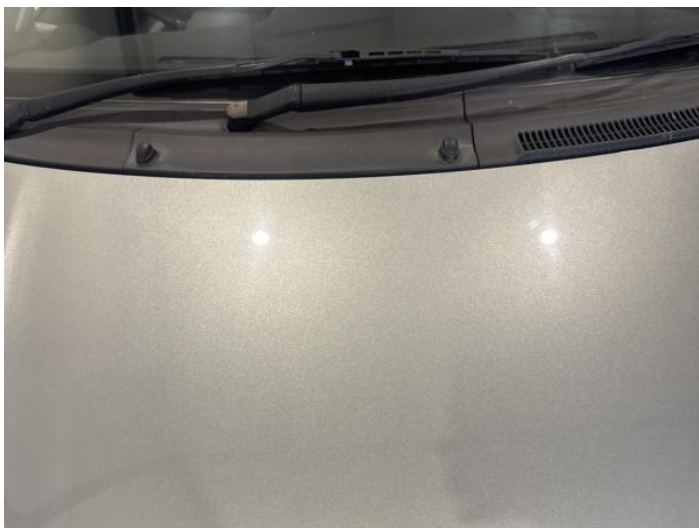
1: Bonnet  
Chipped  
1 To 5

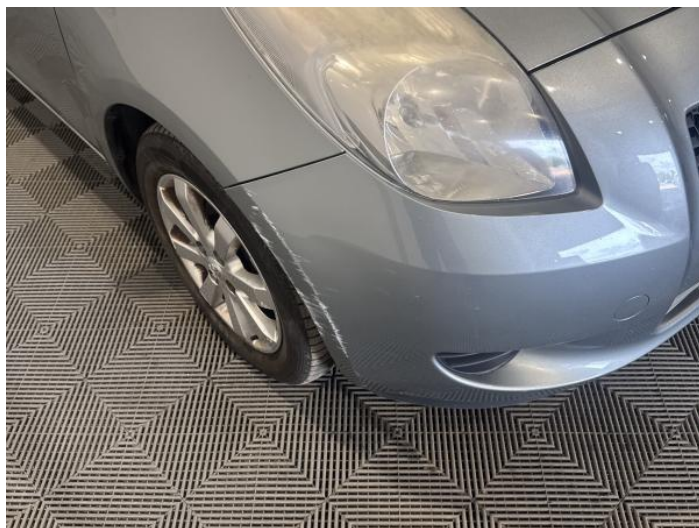
2: Bumper Front  
Scratched  
Over 100mm Thru Paint

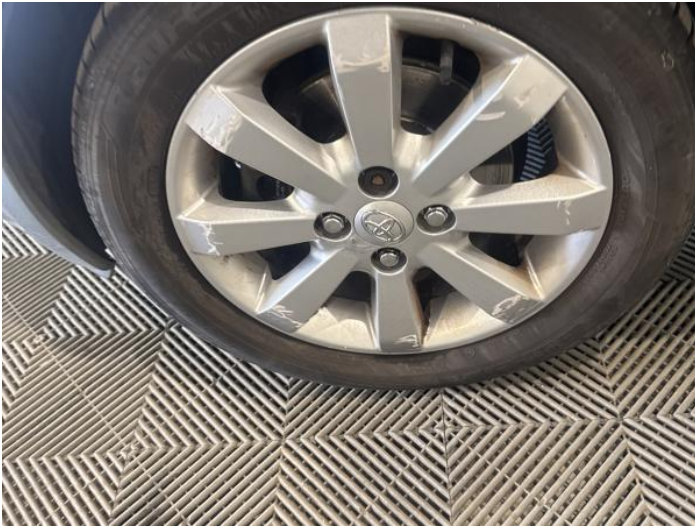
3: Wheel nsf  
Scratched  
Over 50mm

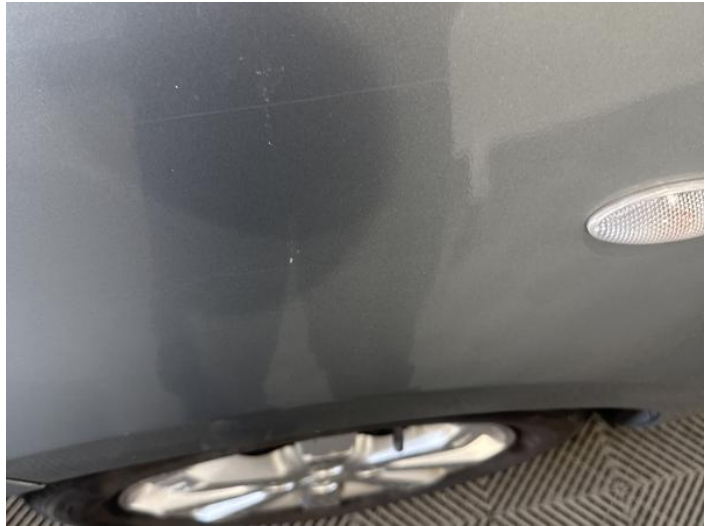
4: Wing nsf  
Chipped  
1 To 5

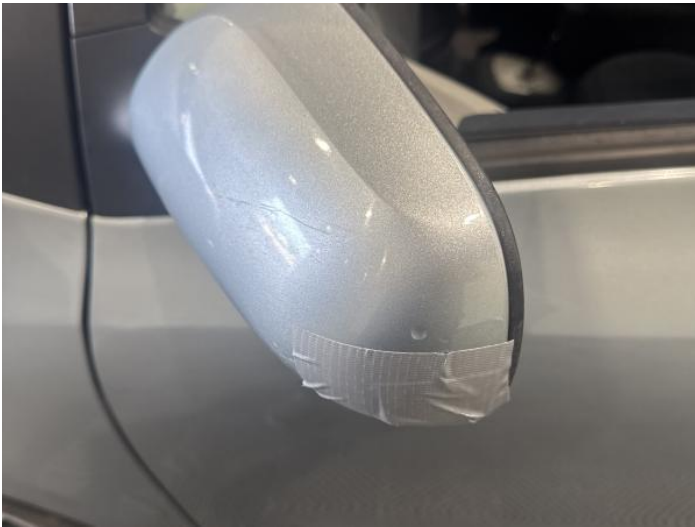
5: Door Mirror Assy nsf  
Broken  
Replace

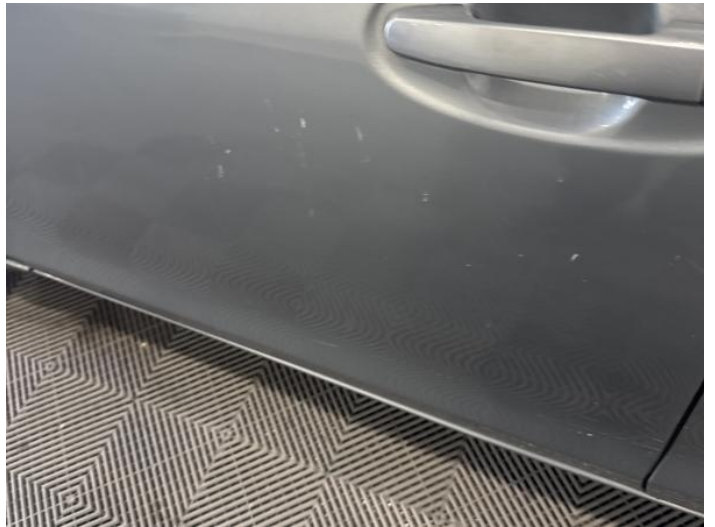
6: Door nsf  
Chipped  
Multiple Chips

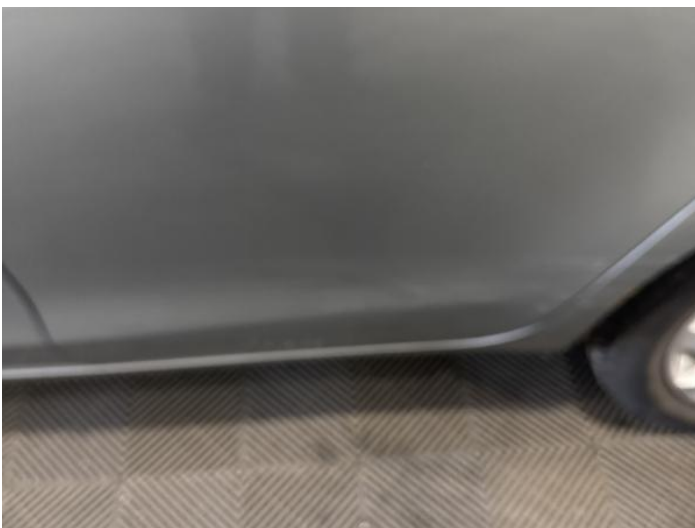
7: Door nsr  
Scratched  
Over 25mm Thru Paint

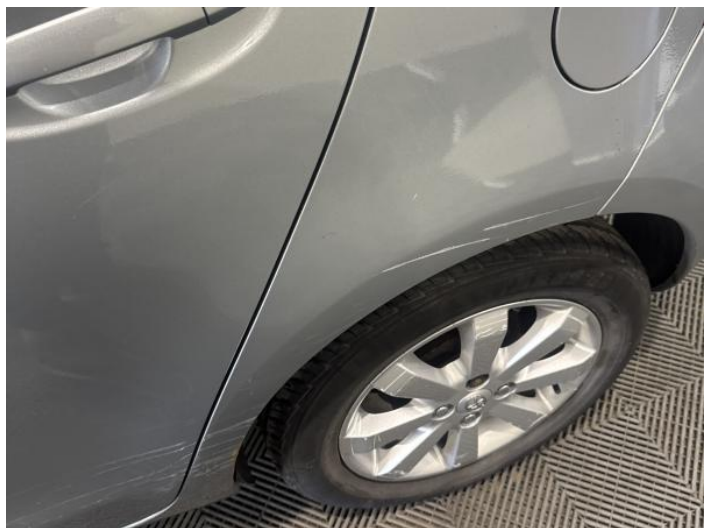
8: Qtr Panel nsr  
Dented  
With Paint Damage

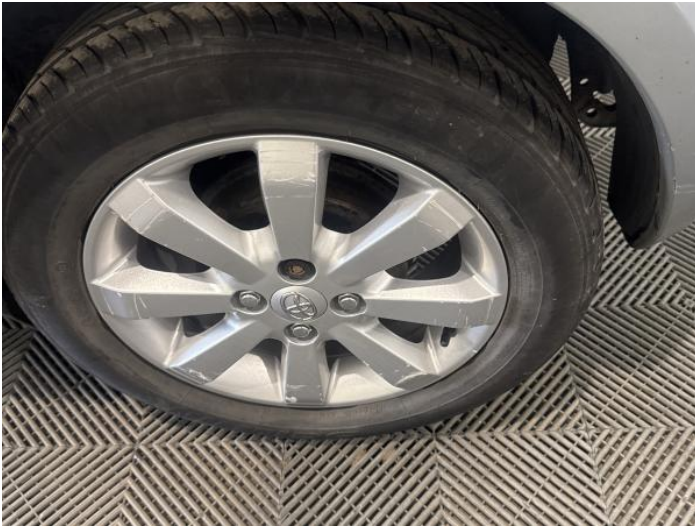
9: Wheel nsr  
Scratched  
Over 50mm

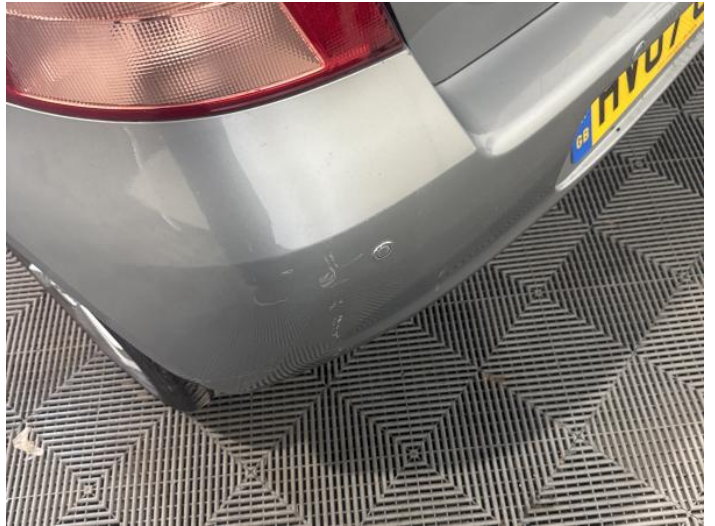
10: Bumper Rear  
Scratched  
Over 100mm Thru Paint

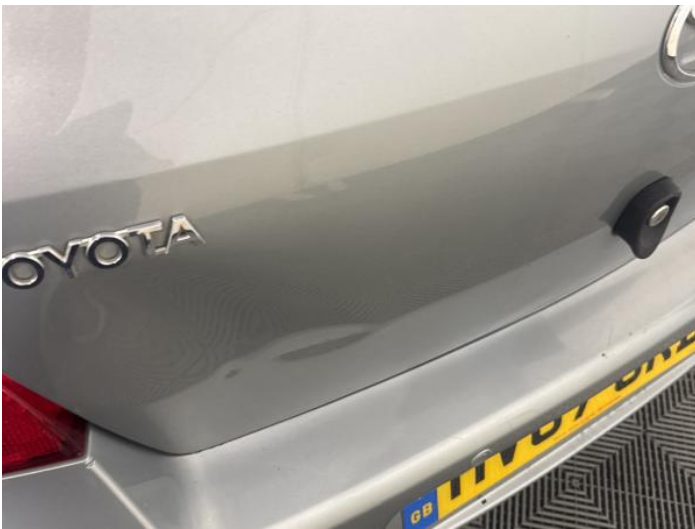
11: Boot Lid  
Dented  
Over 30mm

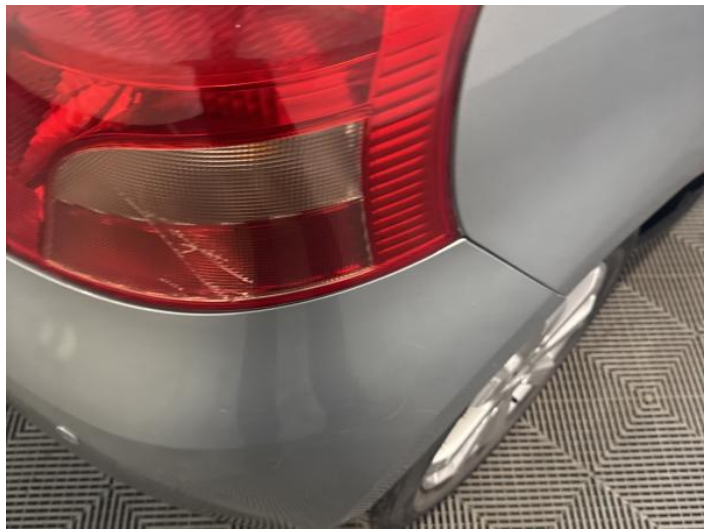
12: Lamp osr  
Broken  
Replace

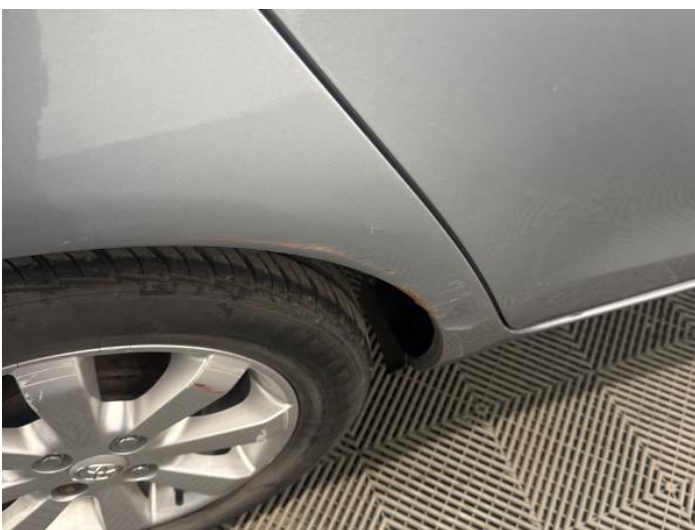
13: Qtr Panel osr  
Dented  
With Paint Damage

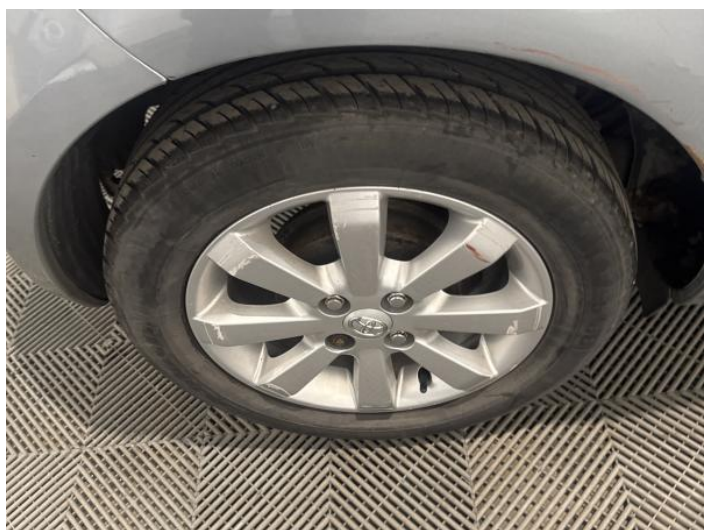
14: Wheel osr  
Scratched  
Over 50mm

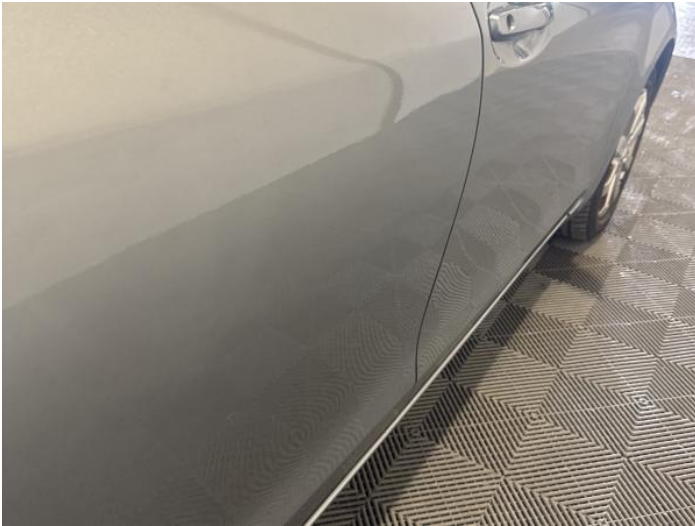
15: Door osr  
Dented  
Over 30mm

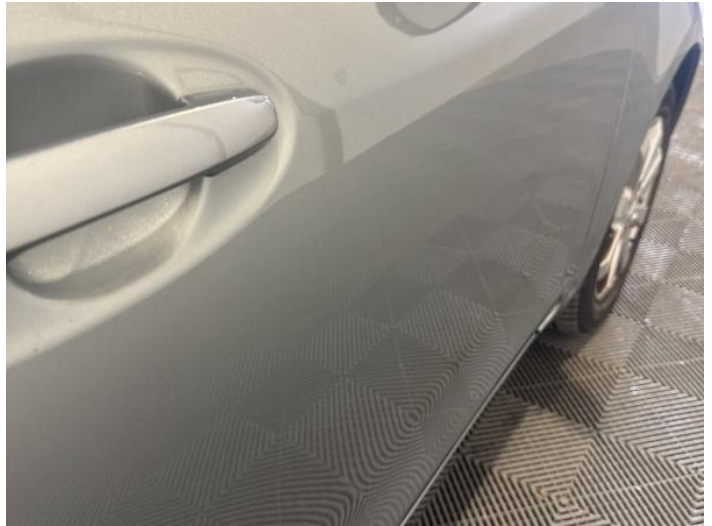
16: Door osf  
Chipped  
1 To 5

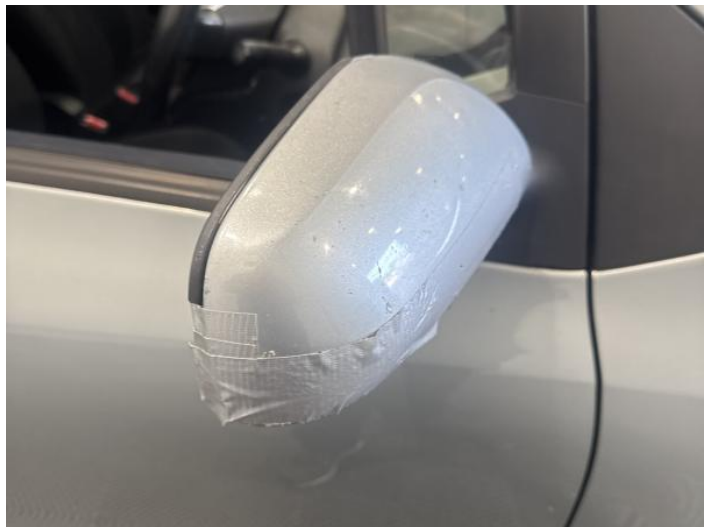
18: Door Mirror Assy osf  
Broken  
Replace

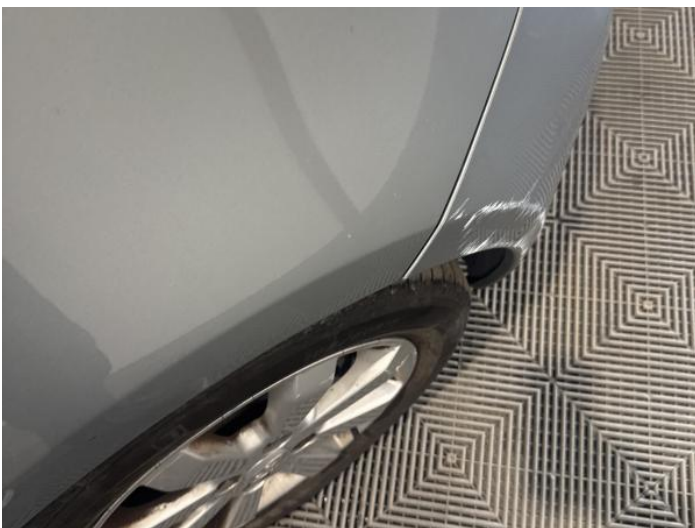
19: Wing osf  
Chipped  
1 To 5

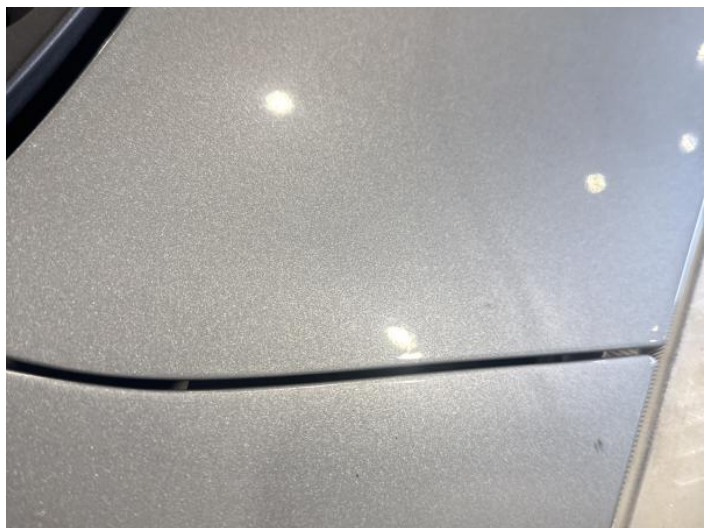
20: Bonnet  
Dented  
2 Or Less UpTo 10mm
