# VEHICLE INSPECTION REPORT

**EO64XFA**

## Kia Rio 1.4 2 5dr Auto

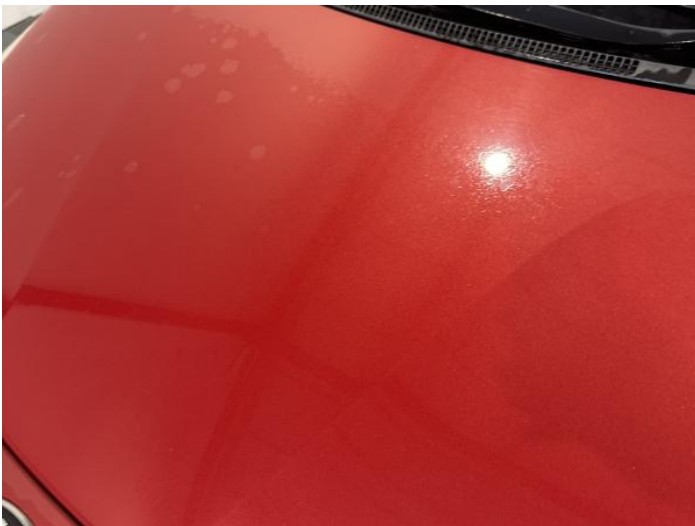
1: Bonnet  
Chipped  
1 To 5

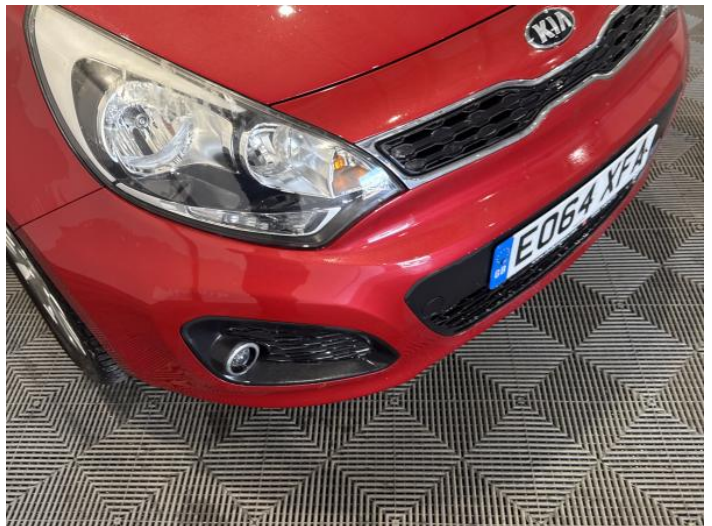
2: Bumper Front  
Chipped  
Multiple Chips

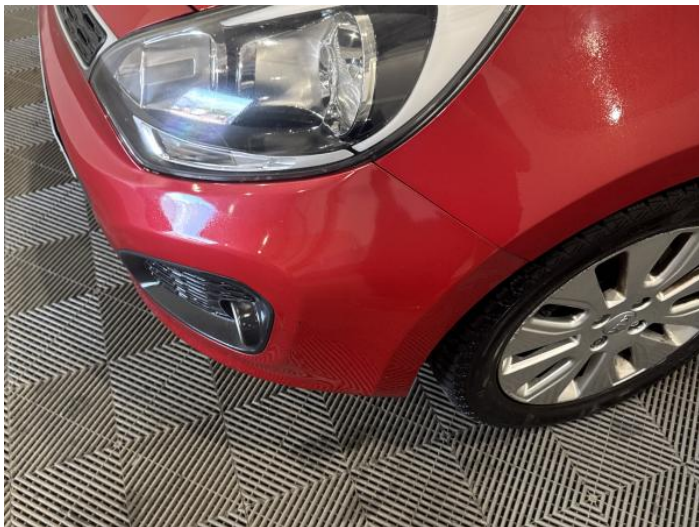
3: Bumper Front  
Scratched  
25 to 100mm Thru Paint

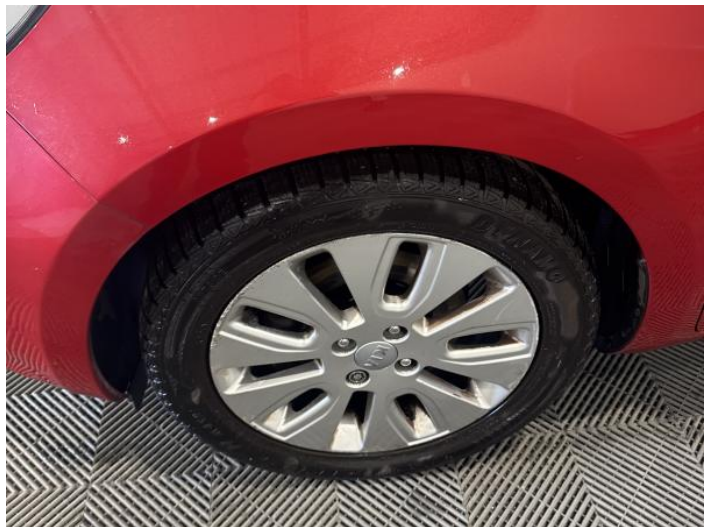
4: Wheel nsf  
Scratched  
Over 50mm

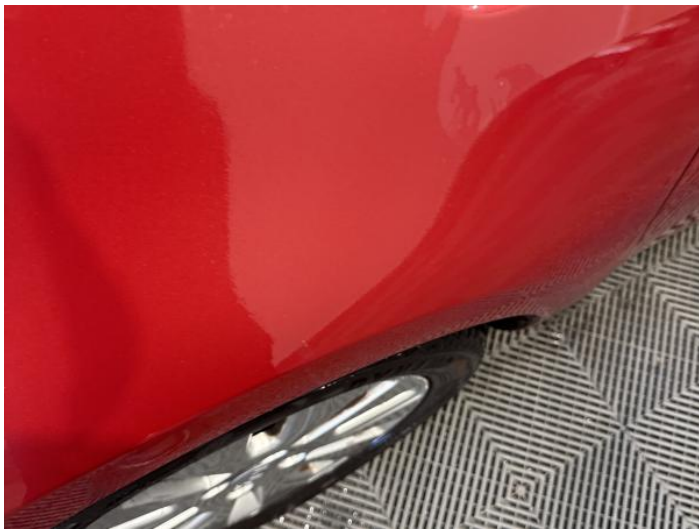
5: Wing nsf  
Chipped  
1 To 5

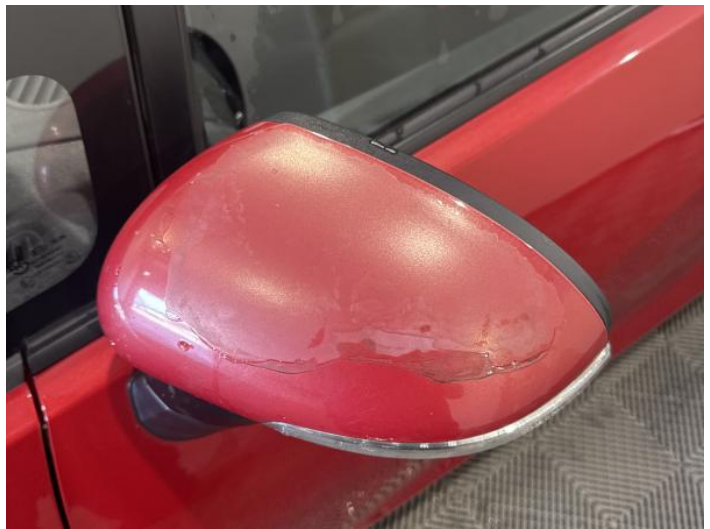
6: Door Mirror Assy nsf  
Scratched (Painted)  
Over 25mm Thru Paint

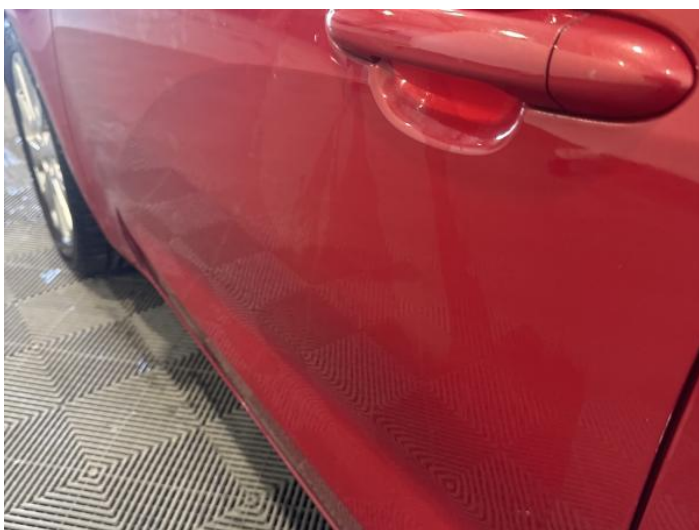
7: Door nsf  
Dented  
Over 30mm

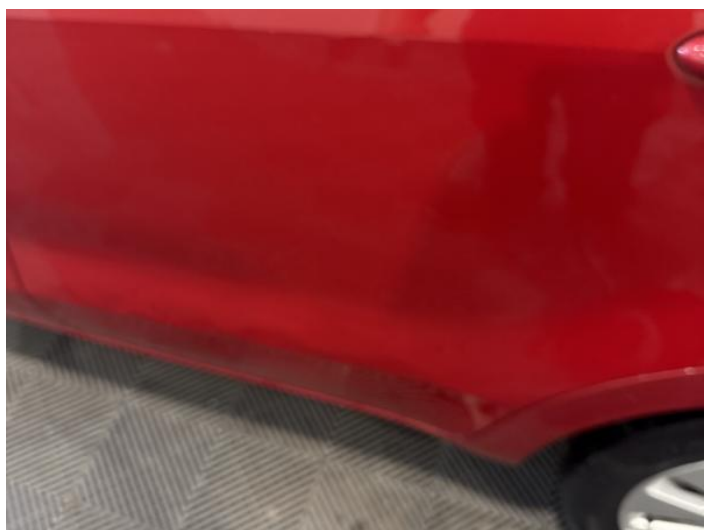
8: Door nsr  
Dented  
Over 30mm

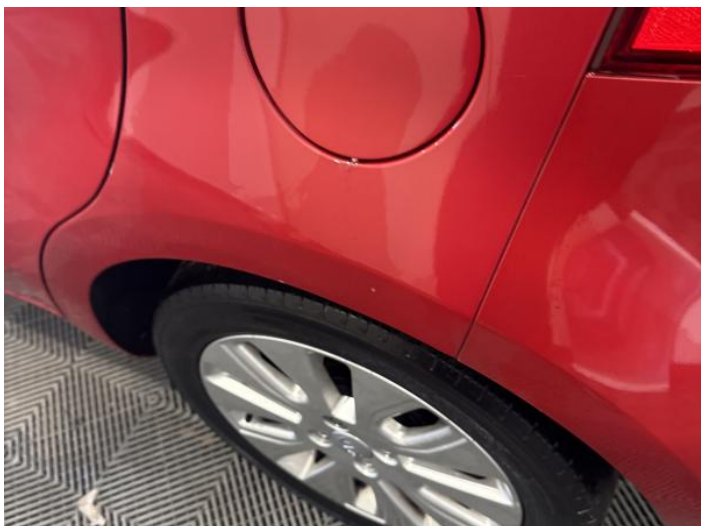
9: Qtr Panel nsr  
Chipped  
1 To 5

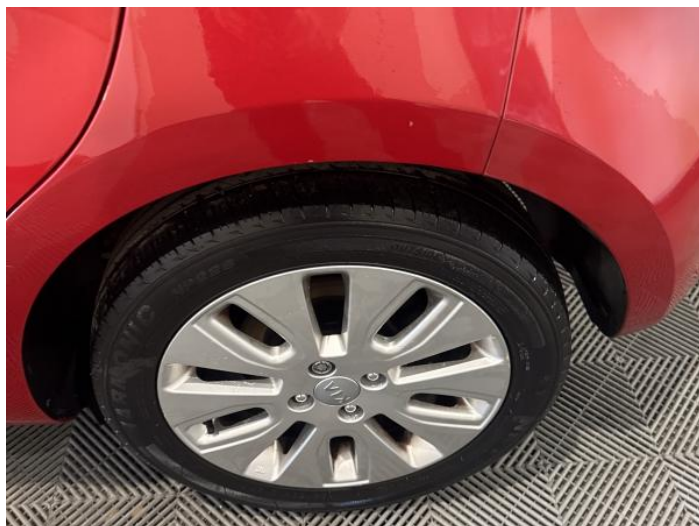
10: Wheel nsr  
Scratched  
Over 50mm

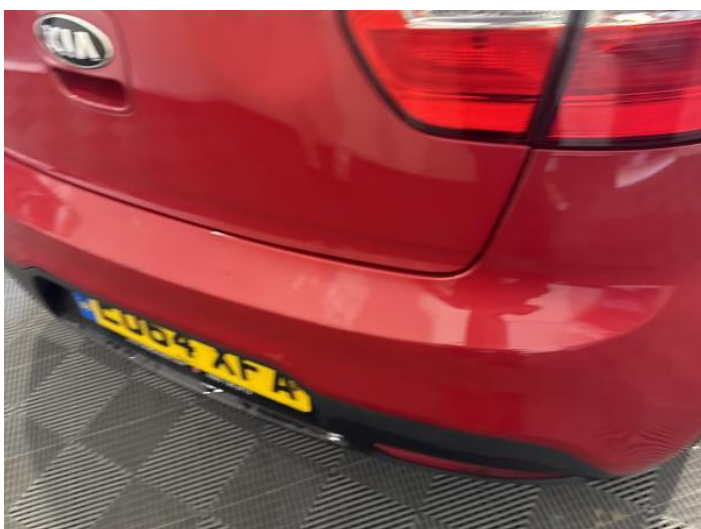
11: Bumper Rear  
Scratched  
25 to 100mm Thru Paint

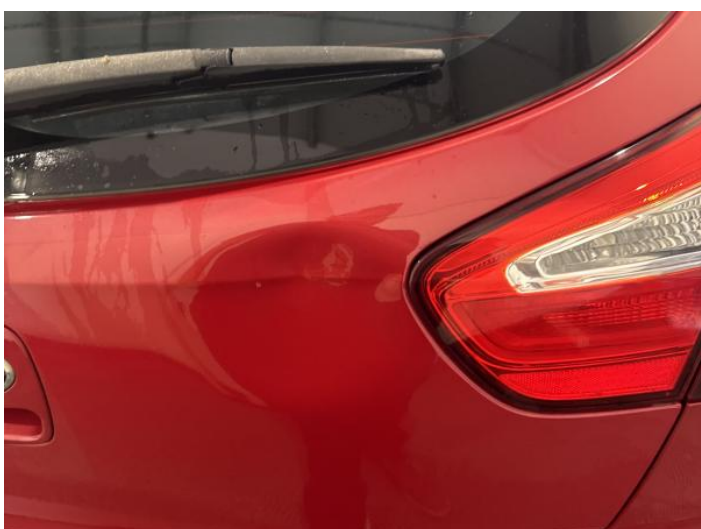
13: Boot Lid  
Dented  
Over 30mm

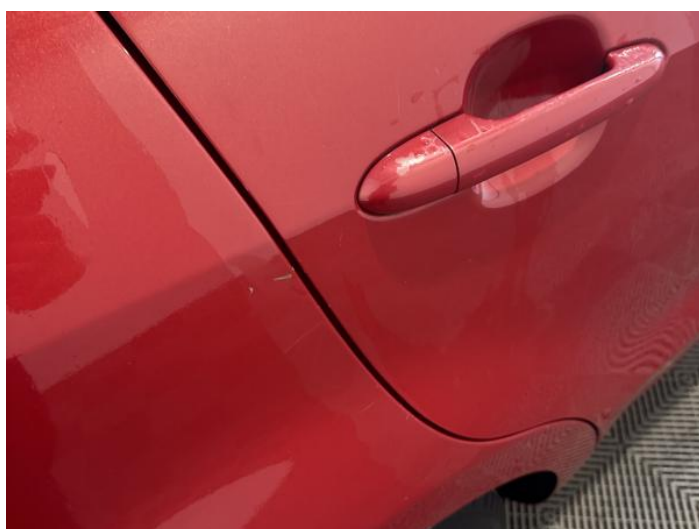
14: Qtr Panel osr  
Scratched  
UpTo 25mm Thru Paint

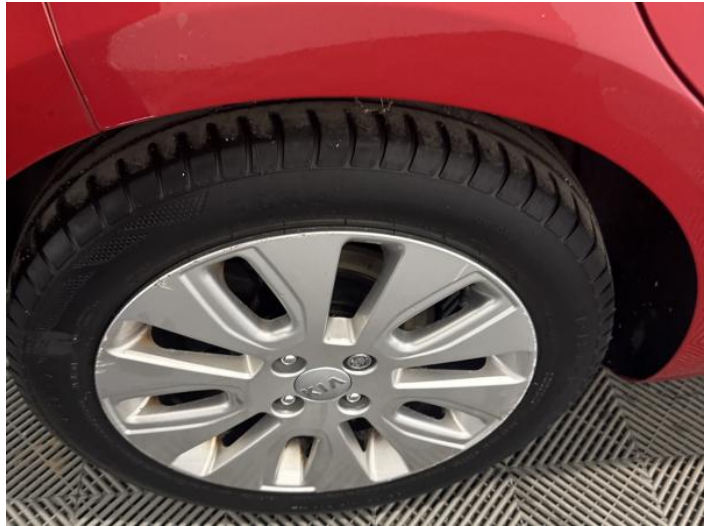
16: Wheel osr  
Scratched  
Over 50mm

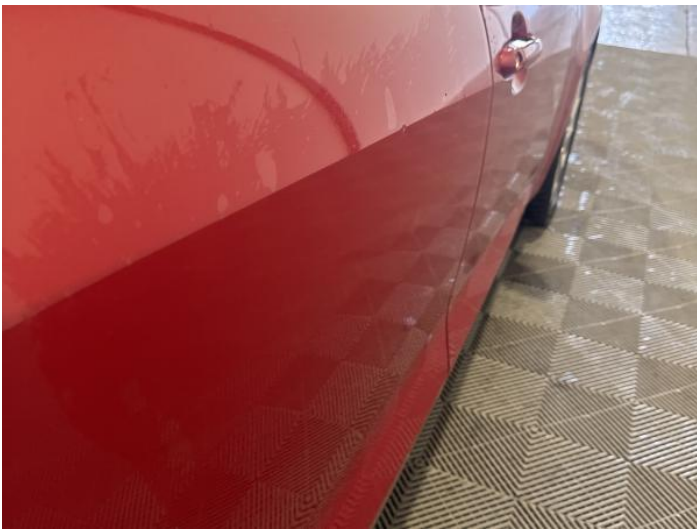
17: Door osr  
Dented  
Over 2 UpTo 10mm

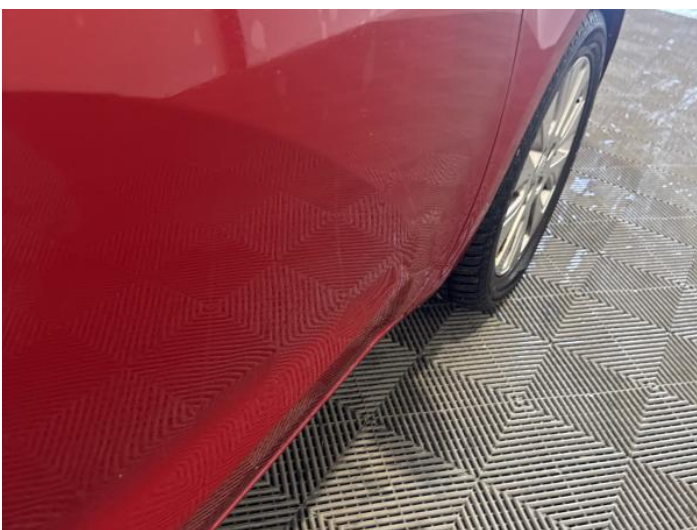
19: Door osf  
Dented  
Over 2 UpTo 10mm

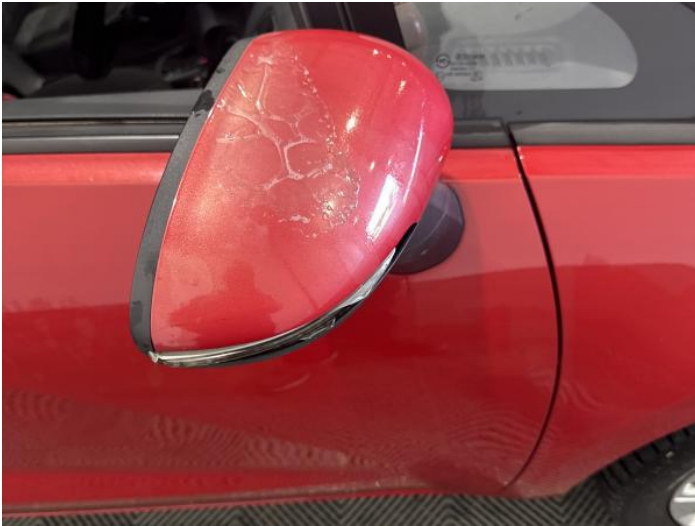
21: Door Mirror Assy osf  
Broken  
Replace

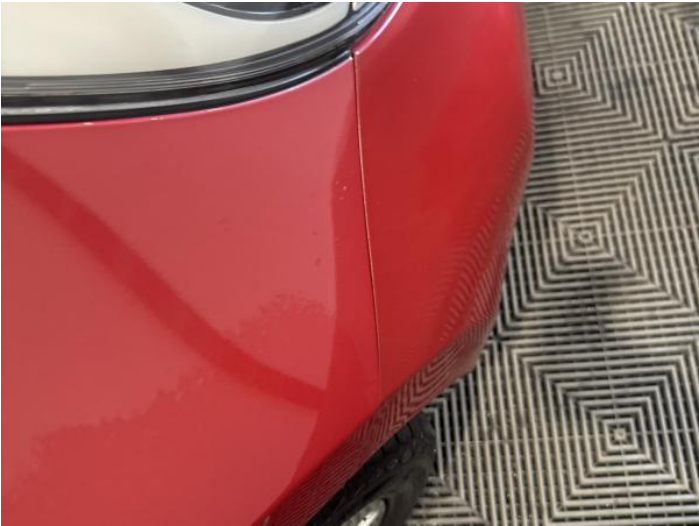
22: Wing osf  
Chipped  
1 To 5

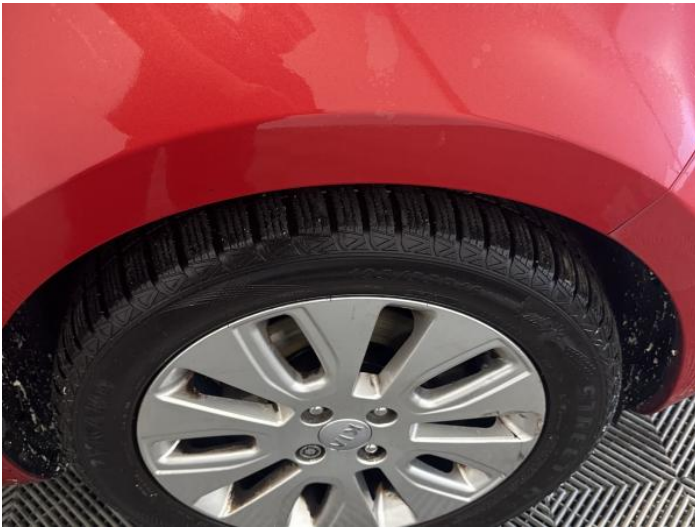
23: Wheel osf  
Scratched  
Over 50mm

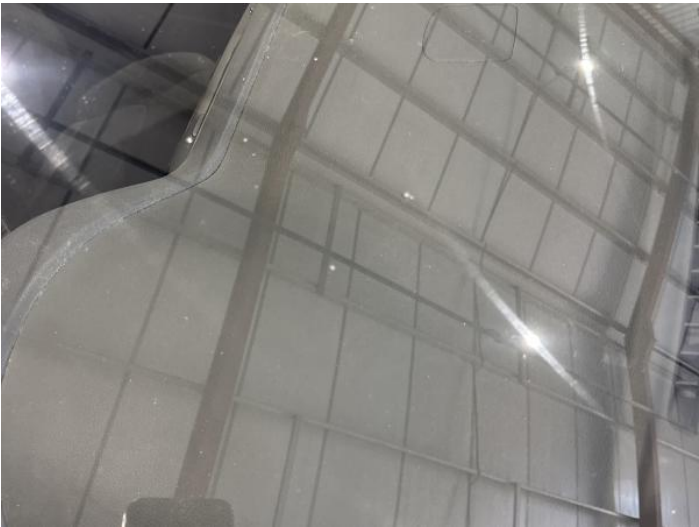
24: Screen Front  
Chipped  
UpTo 10mm
