# VEHICLE INSPECTION REPORT

**KD19FBG**

## Nissan Qashqai 1.3 DiG-T N-Motion 5dr

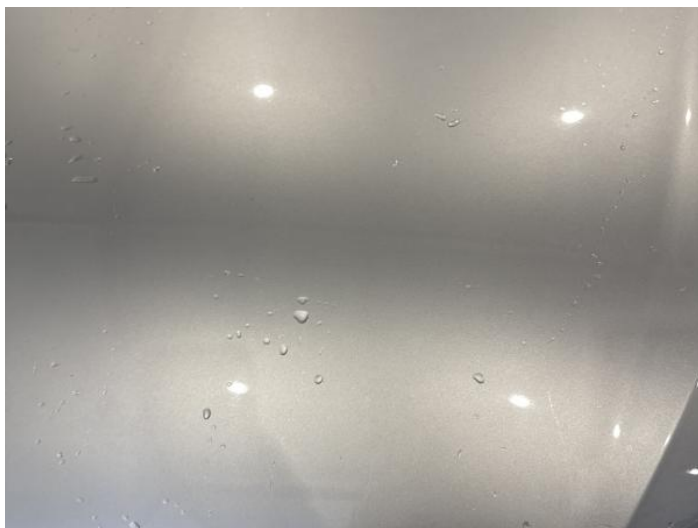
1: Bonnet  
Chipped  
1 To 5

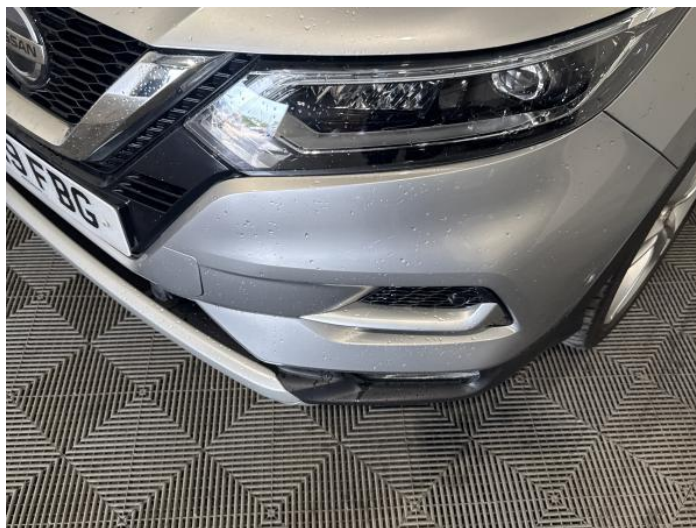
2: Bumper Front  
Chipped  
Multiple Chips

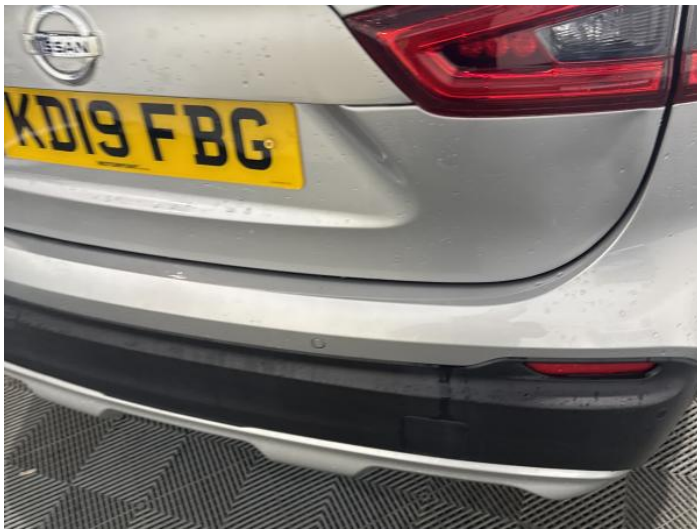
9: Bumper Rear  
Scratched  
25 to 100mm Thru Paint

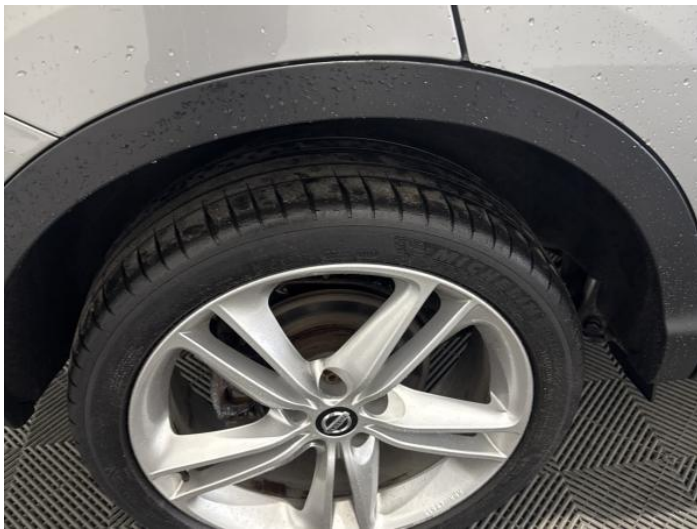
11: Wheel osr  
Scratched  
Up To 50mm

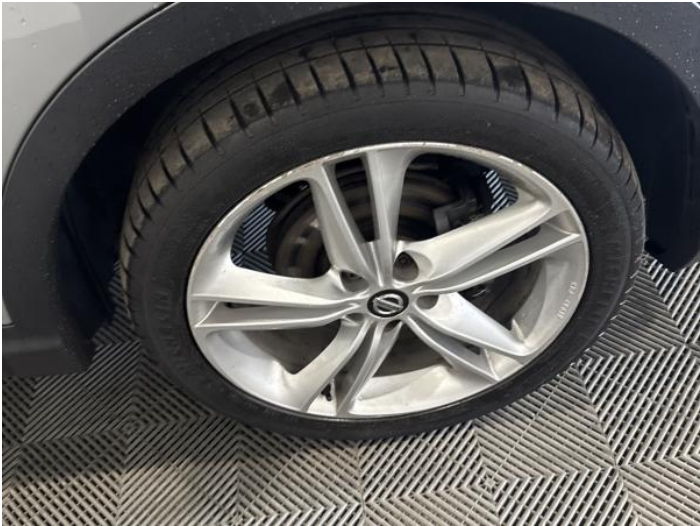
15: Wheel osf  
Scratched  
Over 50mm
