VEHICLE INSPECTION REPORT

GV15FRD

Mazda 6 2.2d Sport Nav 5dr

nama
GRADE
3

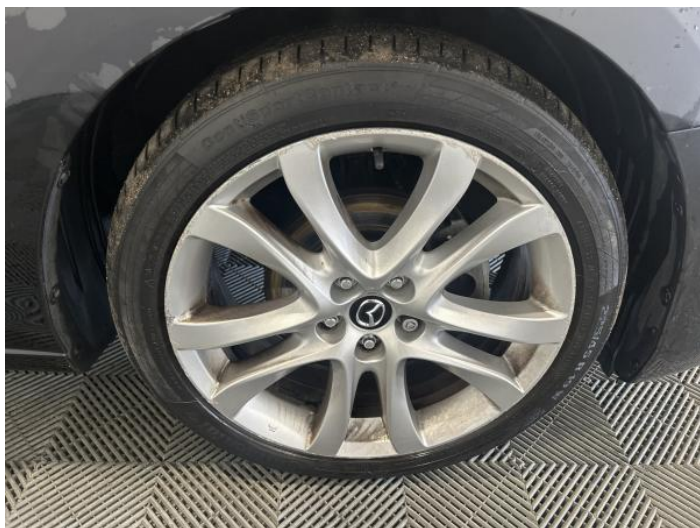
1: Wheel osf
Scratched
Over 50mm

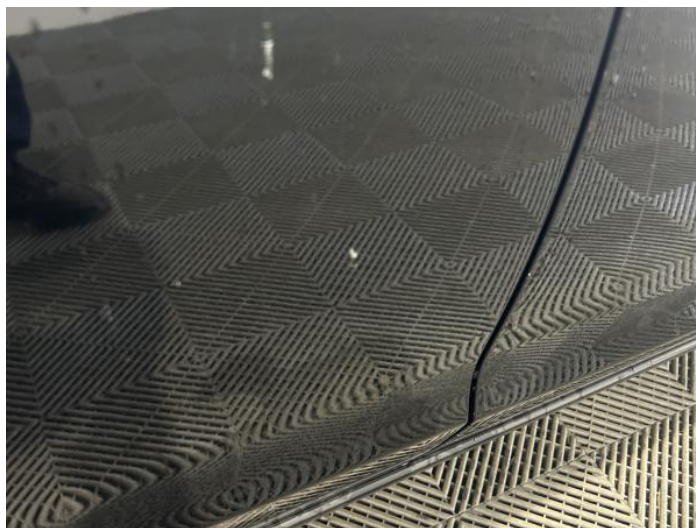
2: Door osr
Chipped
1 To 5

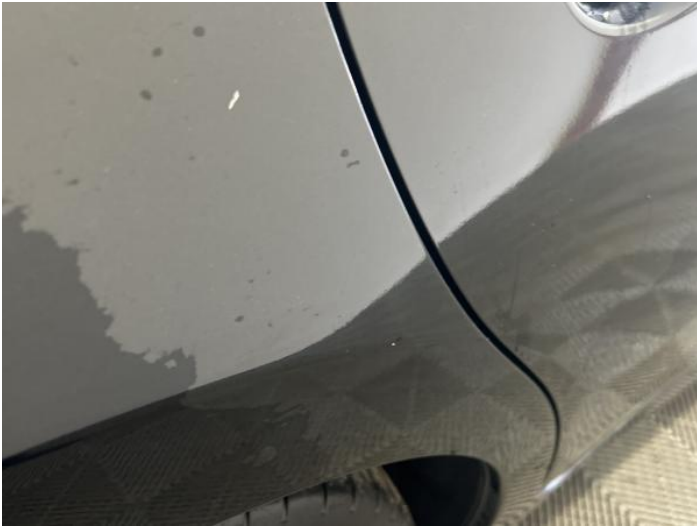
3: Qtr Panel osr
Chipped
1 To 5

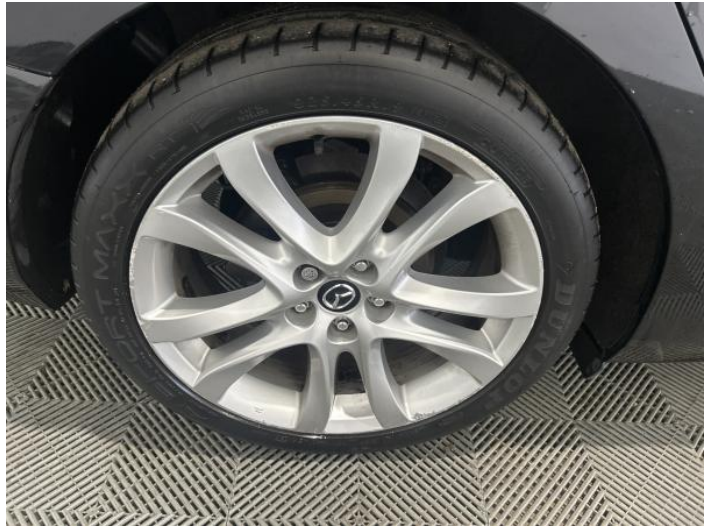
4: Wheel osr
Scratched
Over 50mm

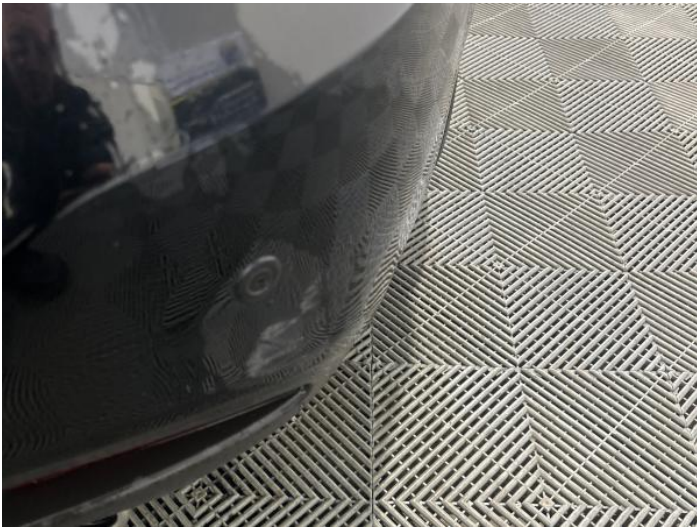
5: Bumper Rear
Scratched
25 to 100mm Thru Paint

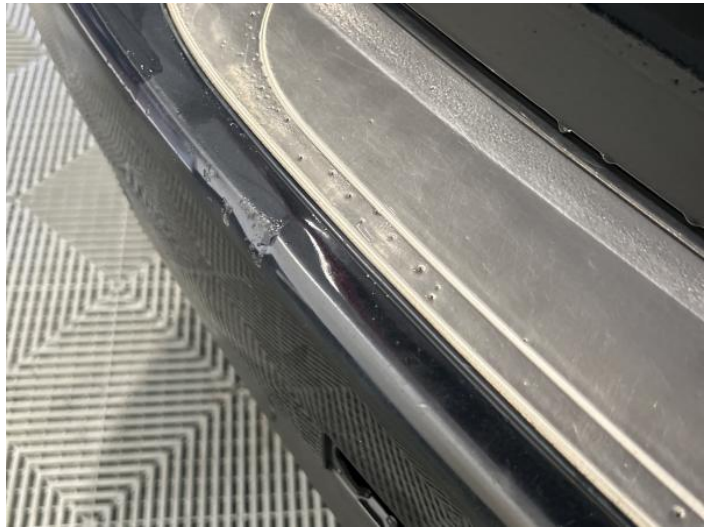
6: Bumper Rear
Chipped
Multiple Chips

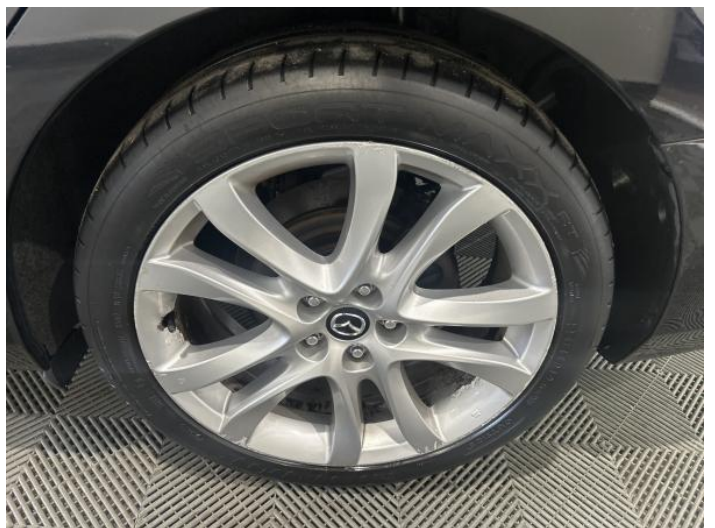
8: Wheel nsr
Scratched
Over 50mm

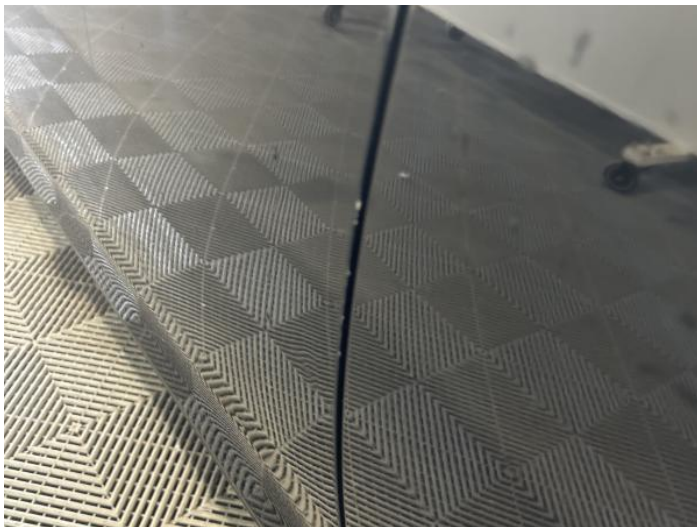
9: Door nsf
Chipped
Edge Chip

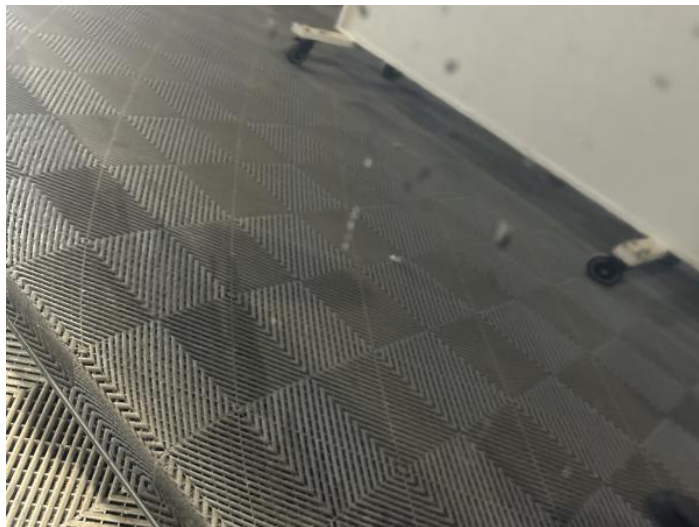
10: Door nsf
Chipped
1 To 5

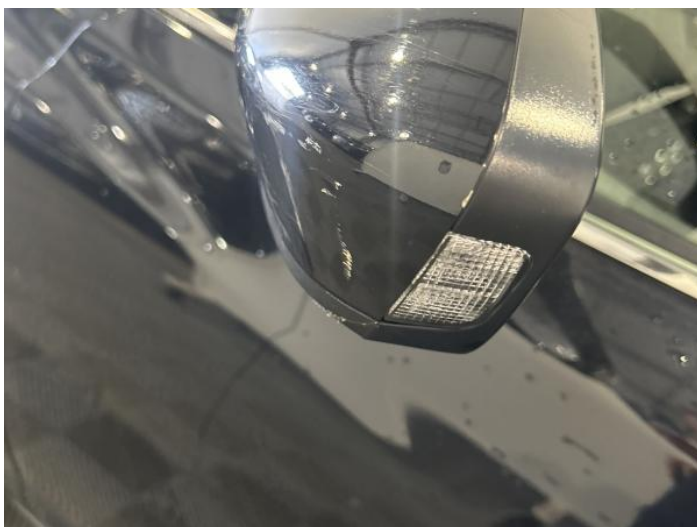
11: Door Mirror Assy nsf
Scratched (Painted)
Over 25mm Thru Paint

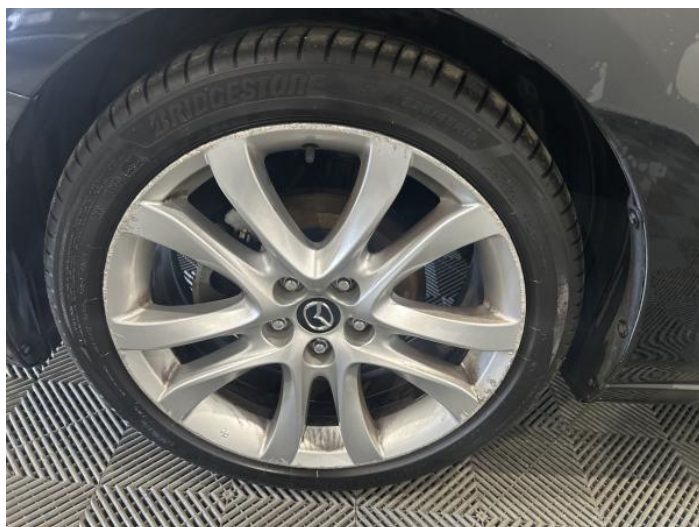
12: Wheel nsf
Scratched
Over 50mm

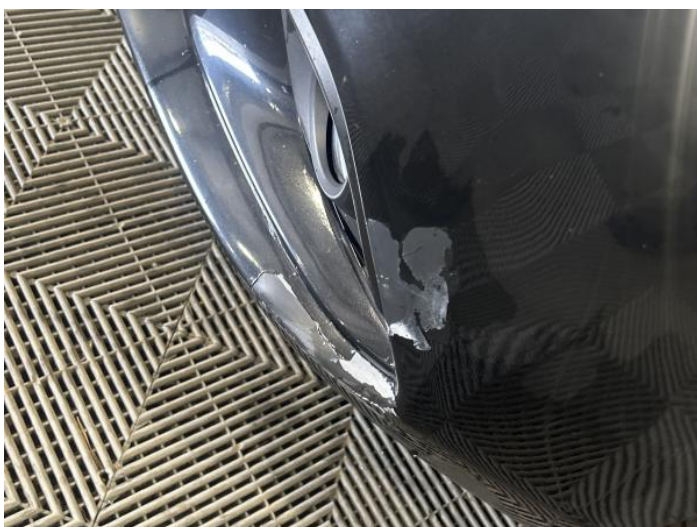
13: Bumper Front
Poor Previous Repair
Paint Flake

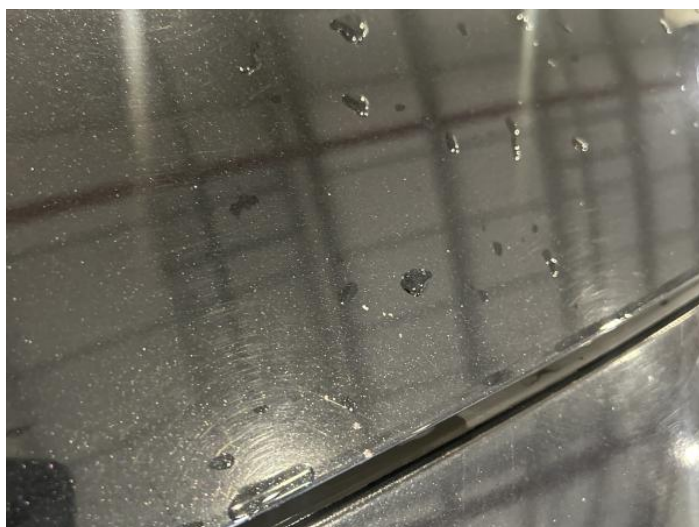
14: Bonnet
Chipped
1 To 5

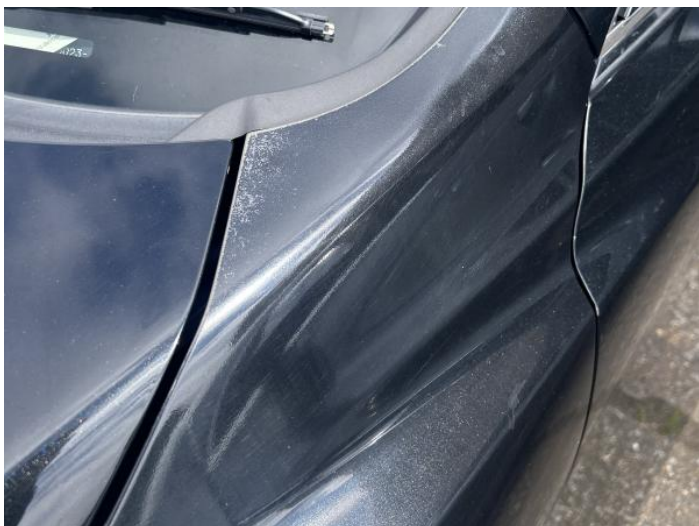
15: Wing nsf
Poor Previous Repair
Poor Paint

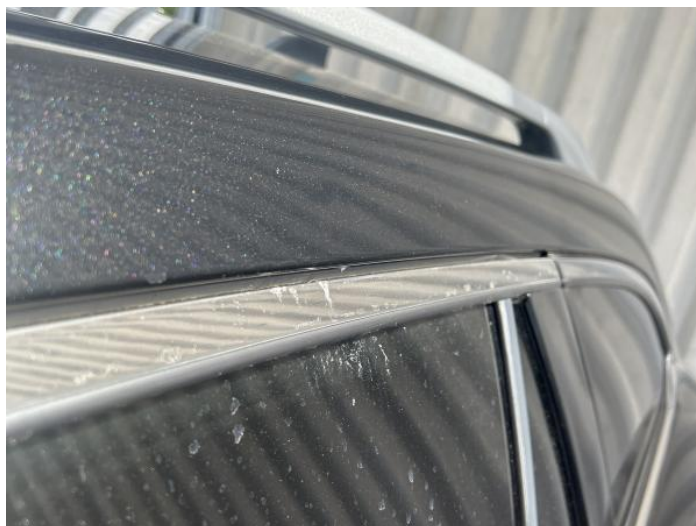
16: D Post ns
Dented
2 Or Less UpTo 10mm
