VEHICLE INSPECTION REPORT

FV58LNY

Vauxhall Zafira 1.6i Exclusiv 5dr

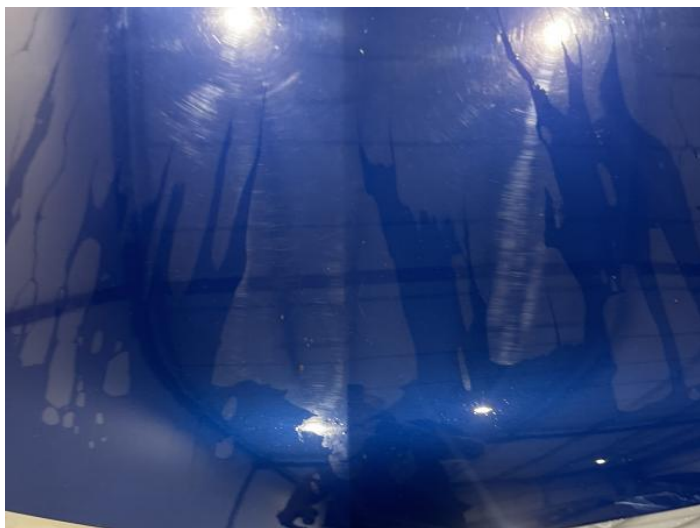
1: Bonnet
Chipped
Multiple Chips

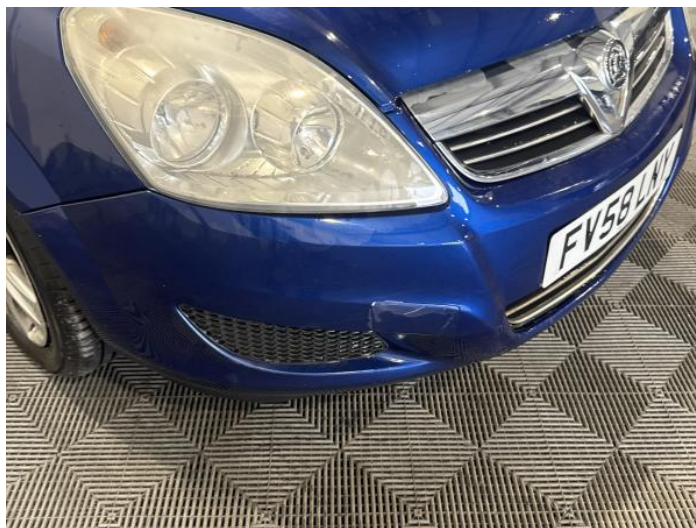
2: Bumper Front
Scratched
Over 100mm Thru Paint

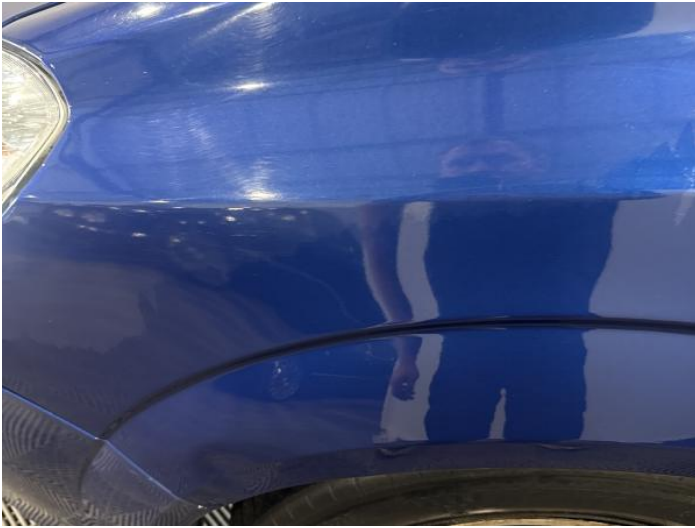
3: Wing nsf
Chipped
1 To 5

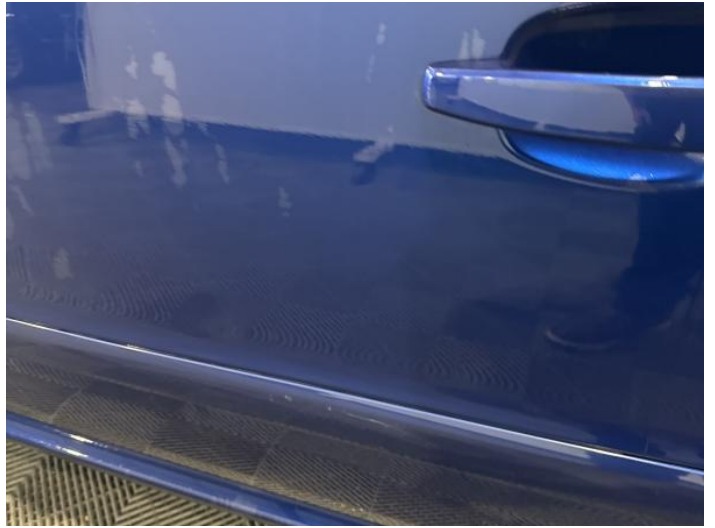
4: Door nsf
Chipped
1 To 5

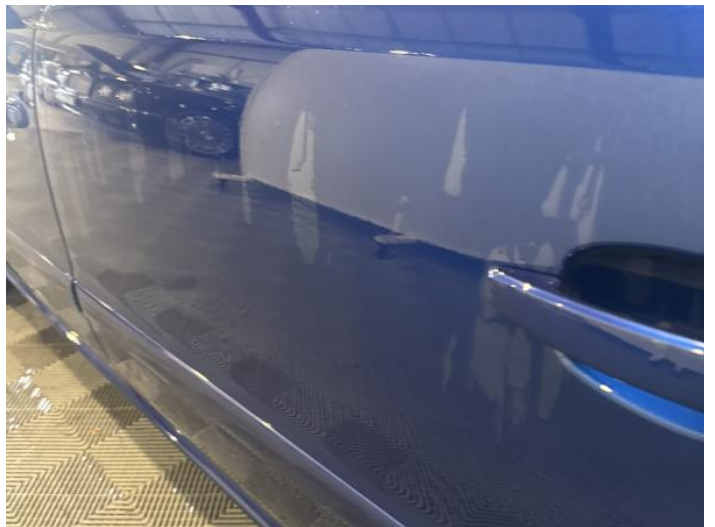
6: Door nsr
Dented
2 Or Less UpTo 10mm

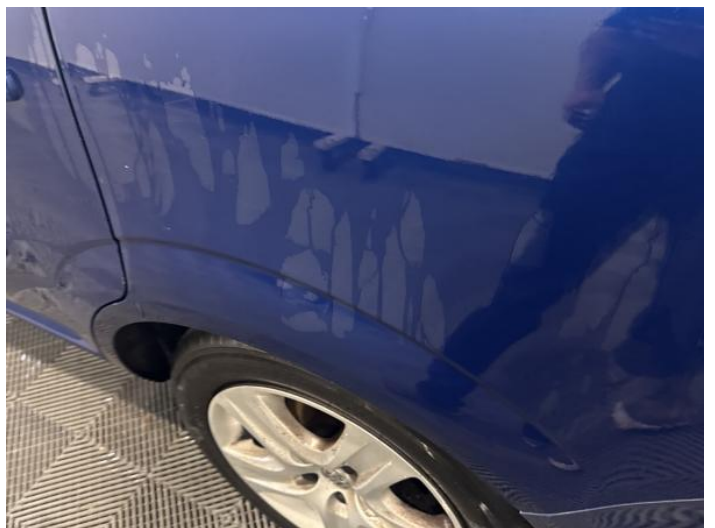
8: Qtr Panel nsr
Chipped
1 To 5

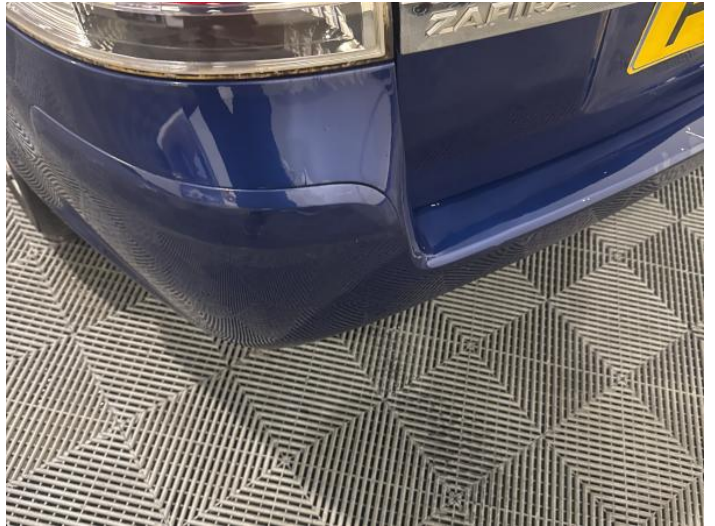
9: Qtr Panel nsr
Scratched
Over 25mm Not Thru Paint

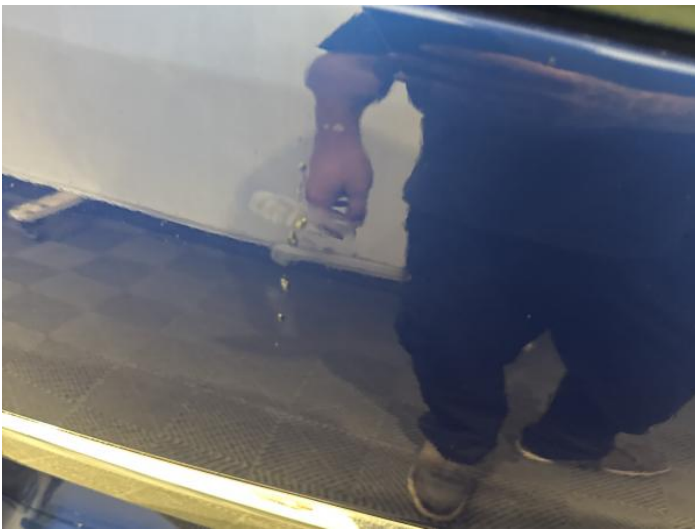
11: Boot Lid
Poor Previous Repair
Poor Paint

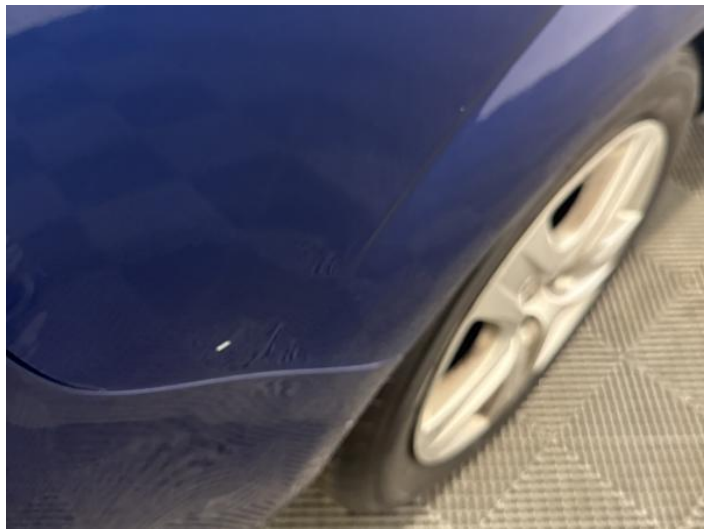
12: Qtr Panel osr
Chipped
1 To 5

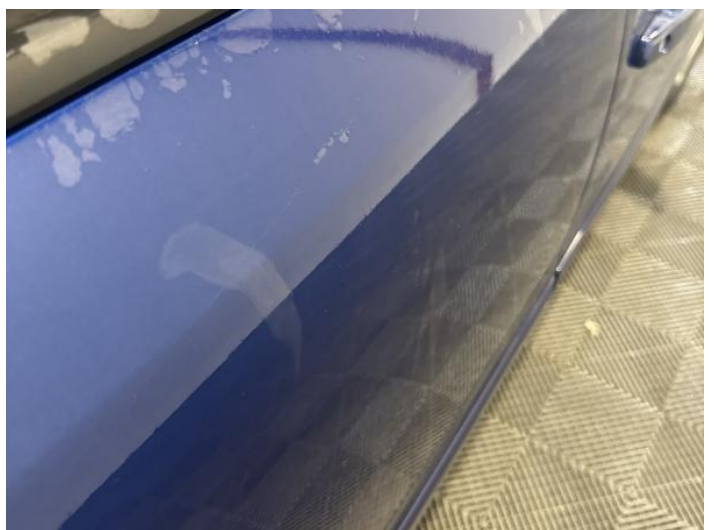
13: Qtr Panel osr
Scratched
Over 25mm Not Thru Paint

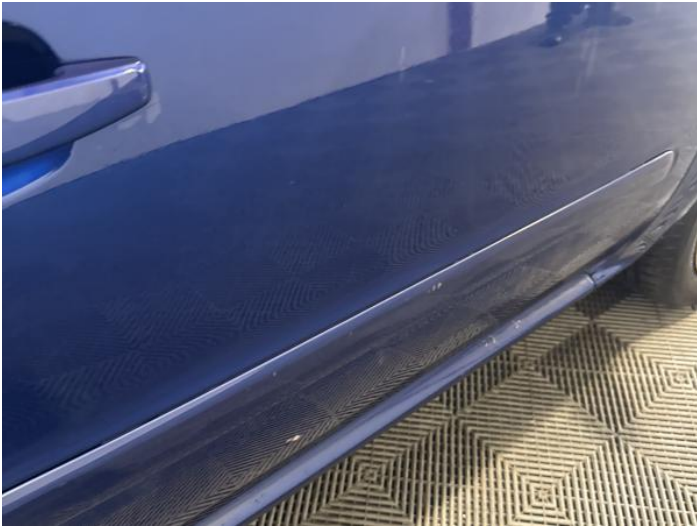
15: Door osf
Chipped
1 To 5

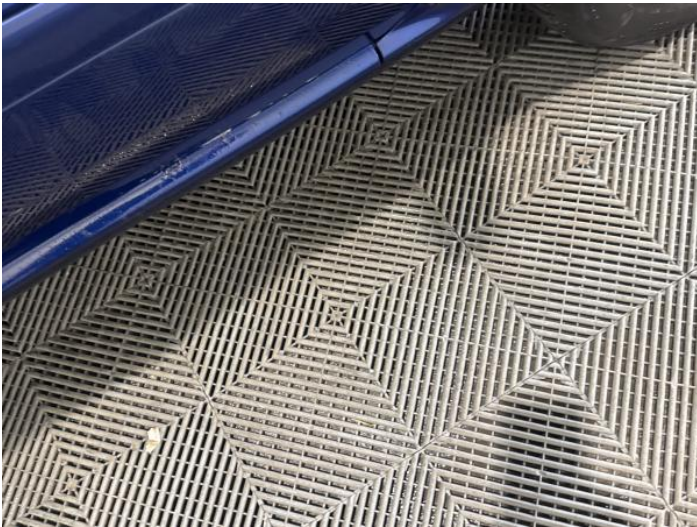
17: Sill os
Rusted
Over 5mm

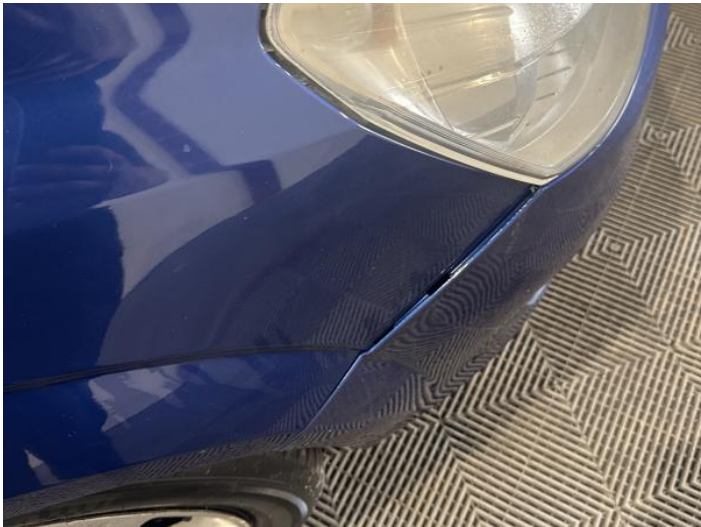
18: Wing osf
Dented
With Paint Damage
