VEHICLE INSPECTION REPORT

Mini Hatchback 1.6 Cooper Pimlico 3dr

Eastbourne Car Auctions

Condition Check

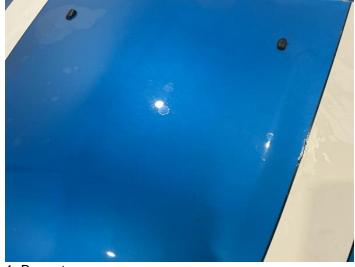
1: Bonnet Chipped 1 To 5

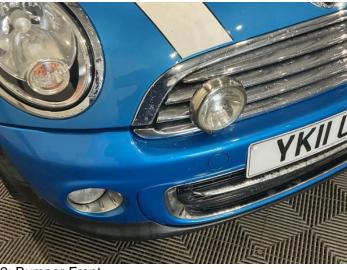
2: Bumper Front Scratched Over 100mm Thru Paint

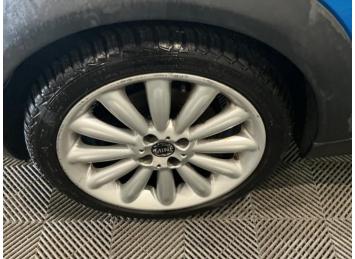
3: Wheel nsf Scratched Over 50mm

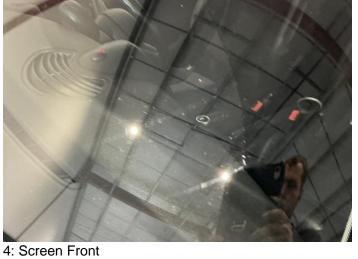
Chipped UpTo 10mm

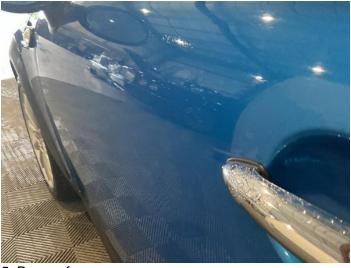
5: Door nsf Dented 2 Or Less UpTo 10mm

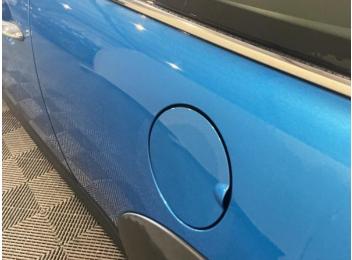
6: Qtr Panel nsr Dented Over 2 UpTo 10mm

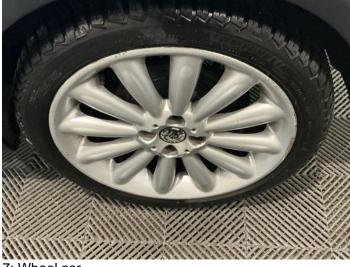
7: Wheel nsr Scratched Over 50mm

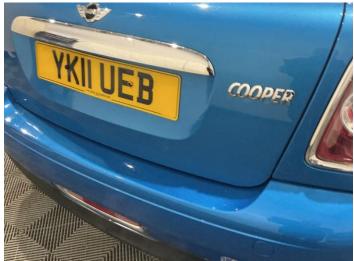
8: Bumper Rear . Chipped **Multiple Chips**

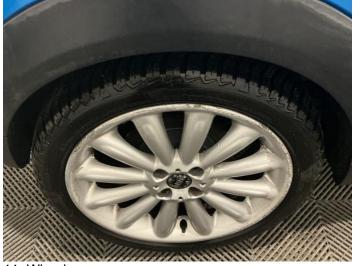
11: Wheel osr Scratched Over 50mm

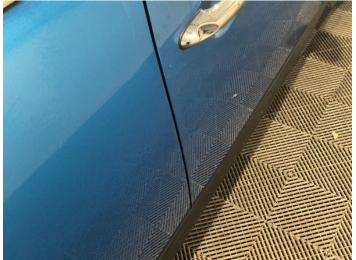
12: Qtr Panel osr Dented Between 10mm + 30mm

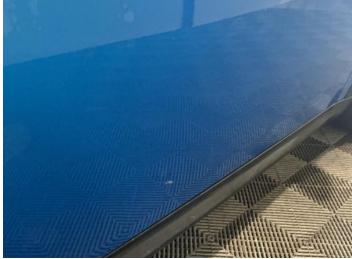
13: Door osf Scratched Over 25mm Thru Paint
