VEHICLE INSPECTION REPORT

NX64NUO

Land Rover Range Rover 4.4 SDV8 Autobiography 4dr Auto

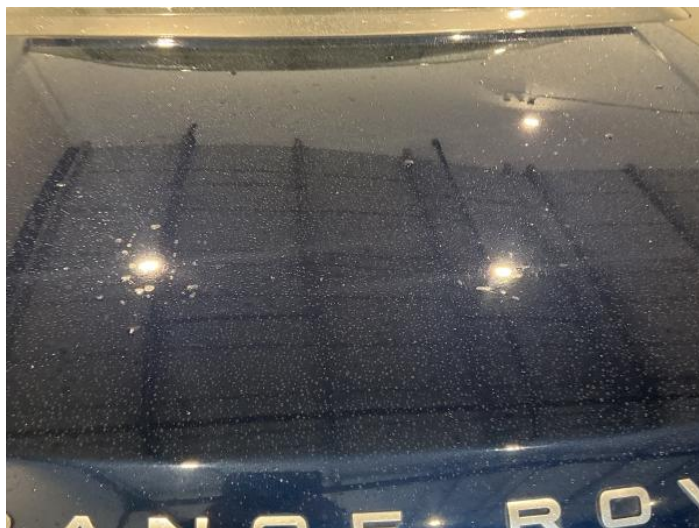
2: Bonnet
Chipped
1 To 5

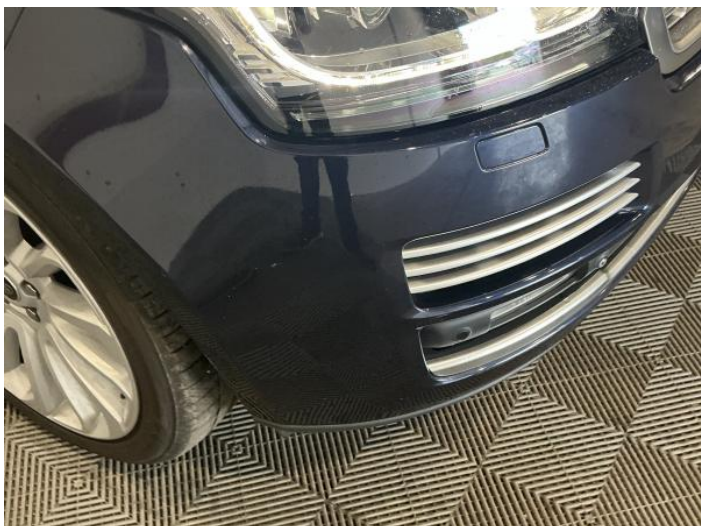
3: Bumper Front
Scratched
25 to 100mm Thru Paint

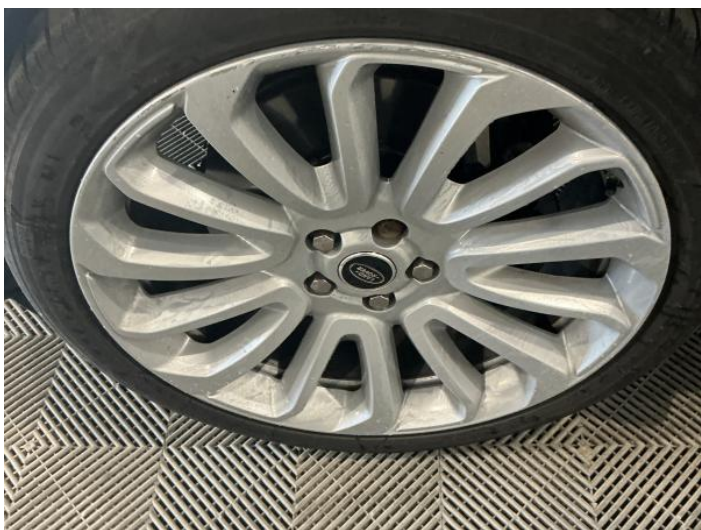
5: Wheel nsf
Scratched
Over 50mm

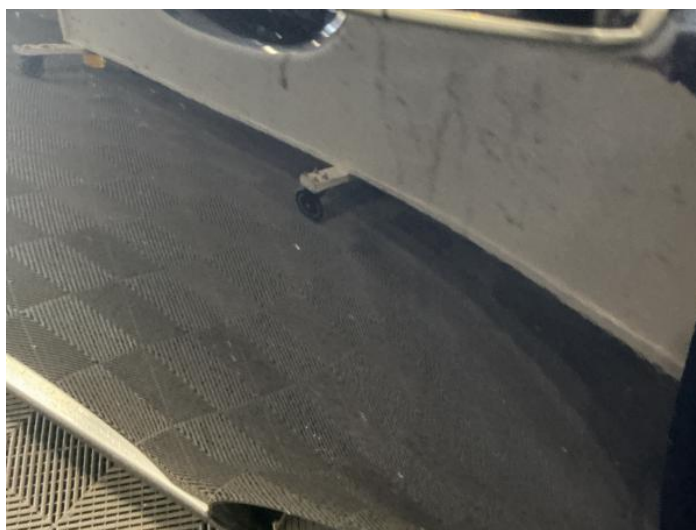
8: Door nsr
Chipped
1 To 5

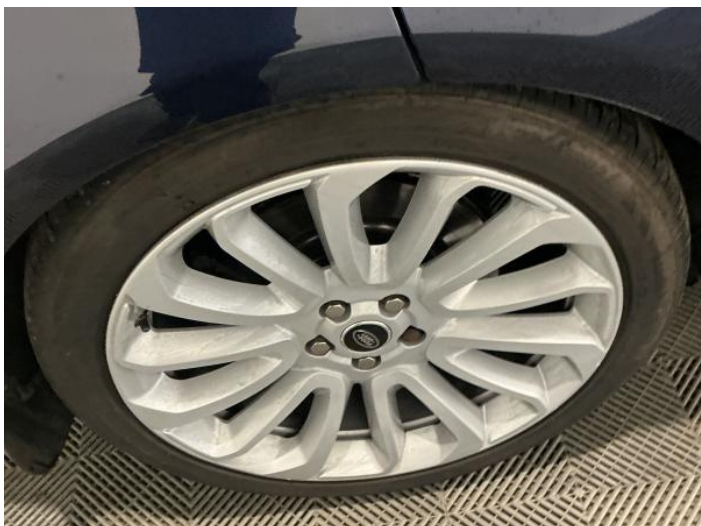
15: Wheel osr
Scratched
Over 50mm

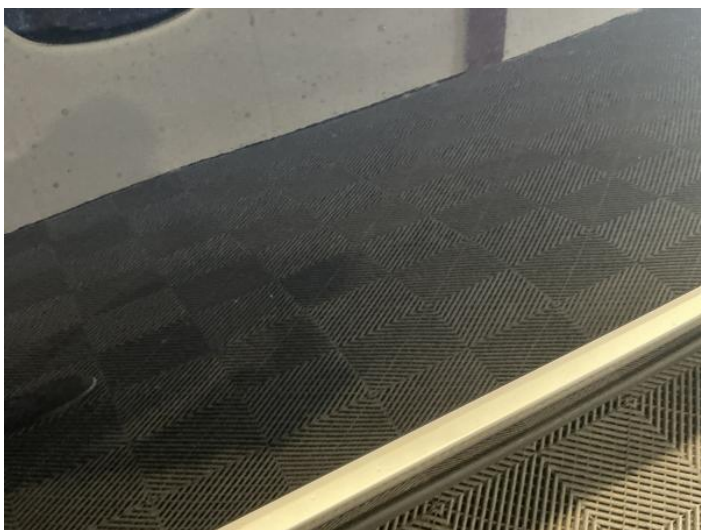
17: Door osf
Chipped
1 To 5

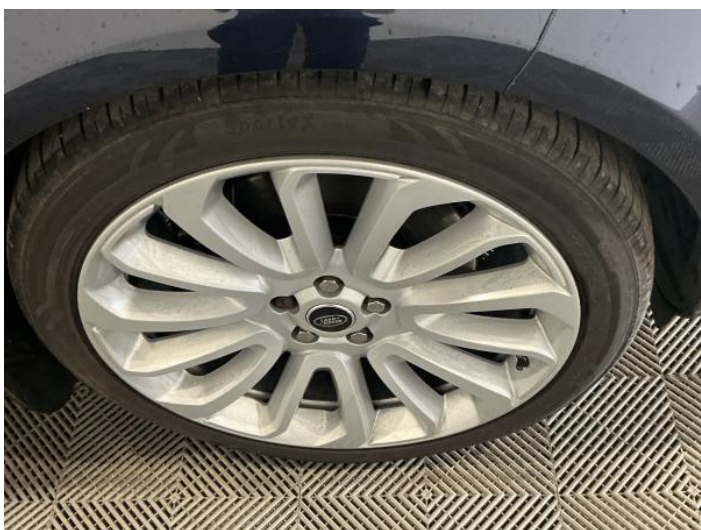
19: Wheel osf
Scratched
Over 50mm
