# VEHICLE INSPECTION REPORT

**GX16MGV**

## Tesla Model S 235kW 70kWh 5dr [Nav]

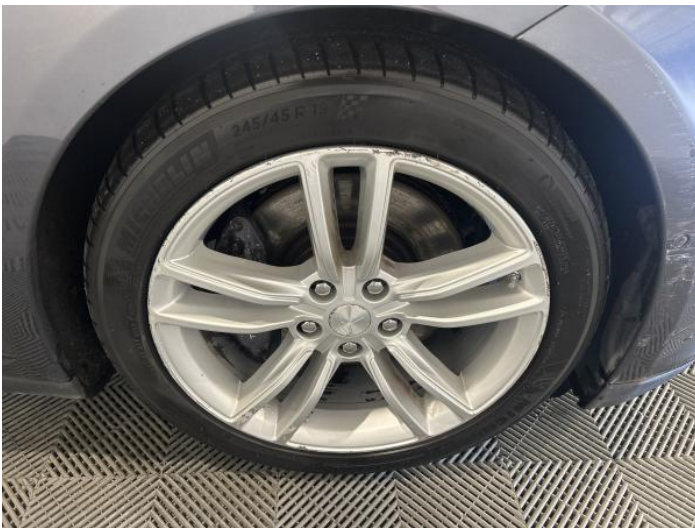
1: Wheel osf  
Scratched  
Over 50mm

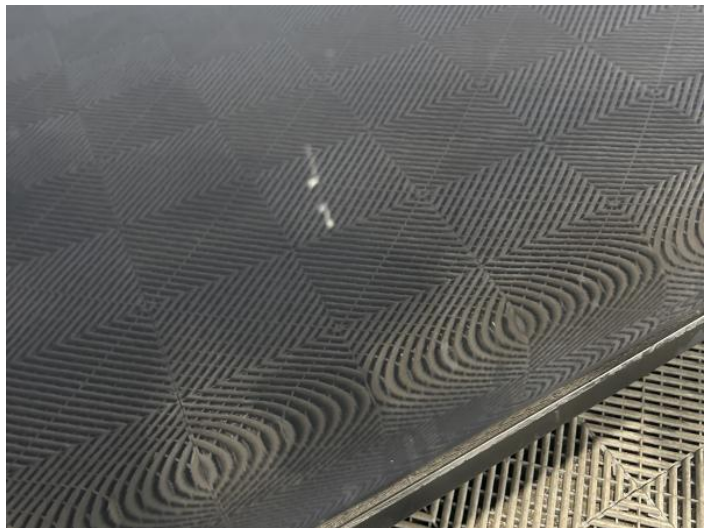
2: Door osf  
Scratched  
UpTo 25mm Thru Paint

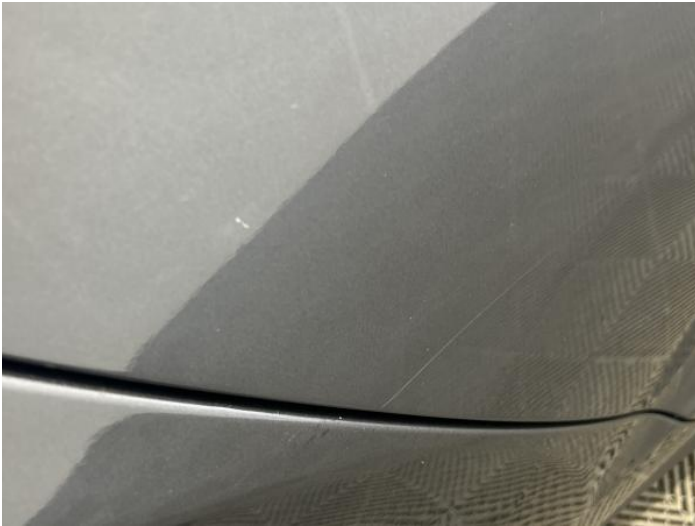
3: Door osr  
Chipped  
1 To 5

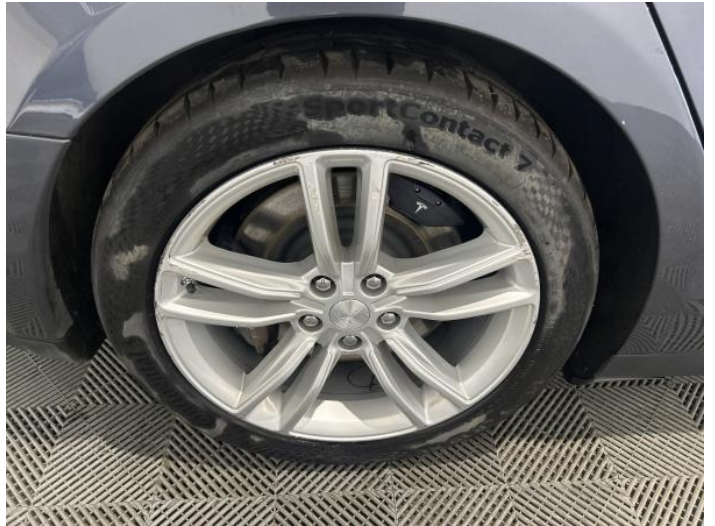
4: Wheel osr  
Scratched  
Over 50mm

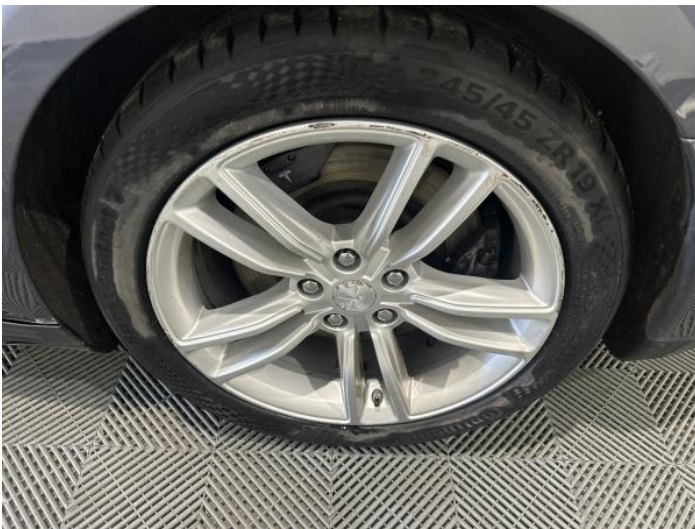
5: Wheel nsr  
Scratched  
Over 50mm

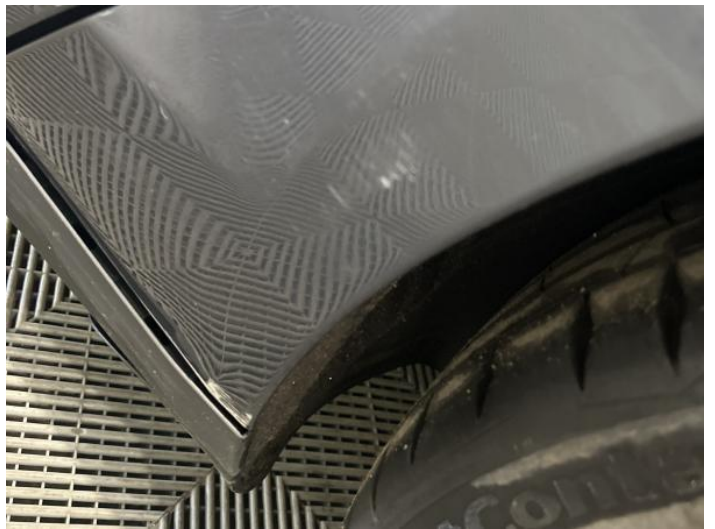
6: Qtr Panel nsr  
Scratched  
Over 25mm Thru Paint

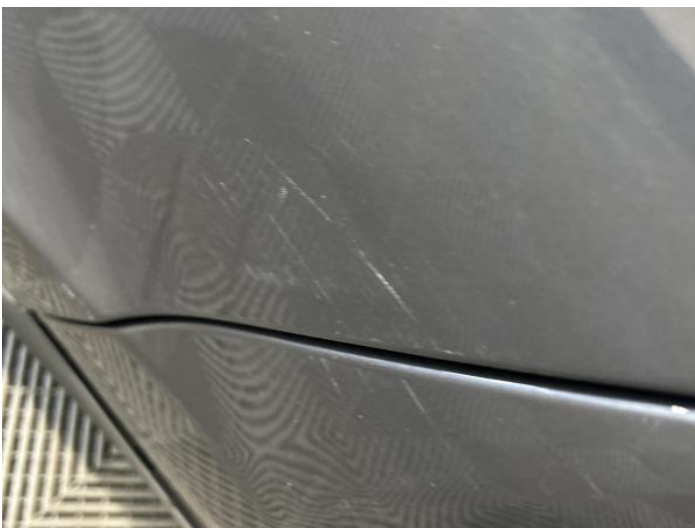
7: Door nsr  
Scratched  
Over 25mm Not Thru Paint

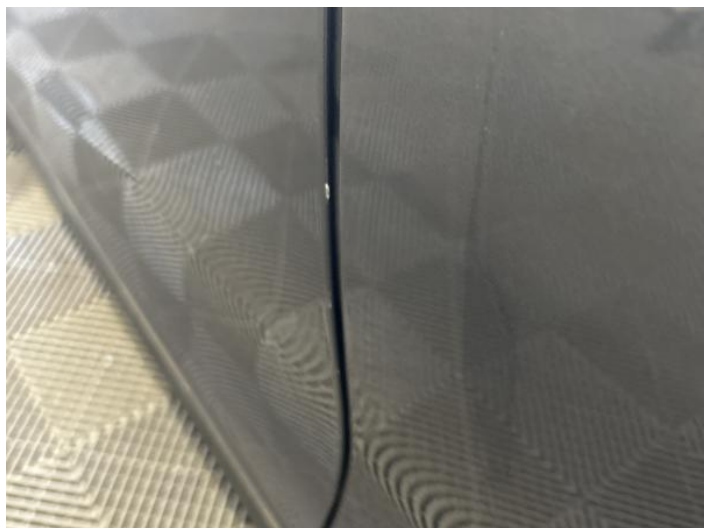
8: Door nsf  
Chipped  
Edge Chip

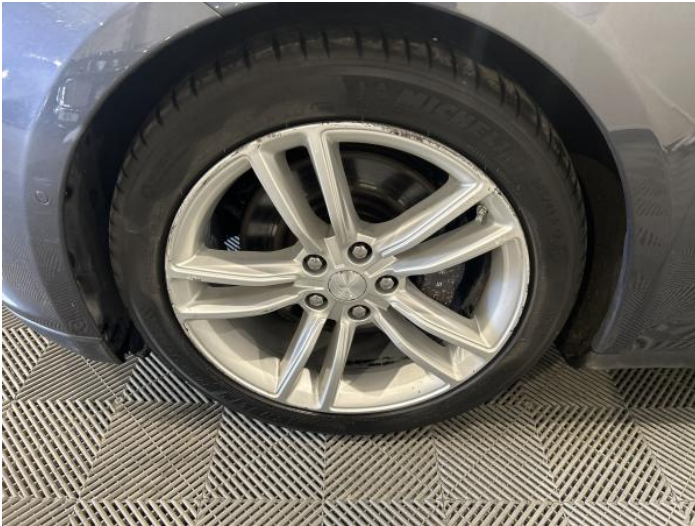
9: Wheel nsf  
 Scratched  
 Over 50mm

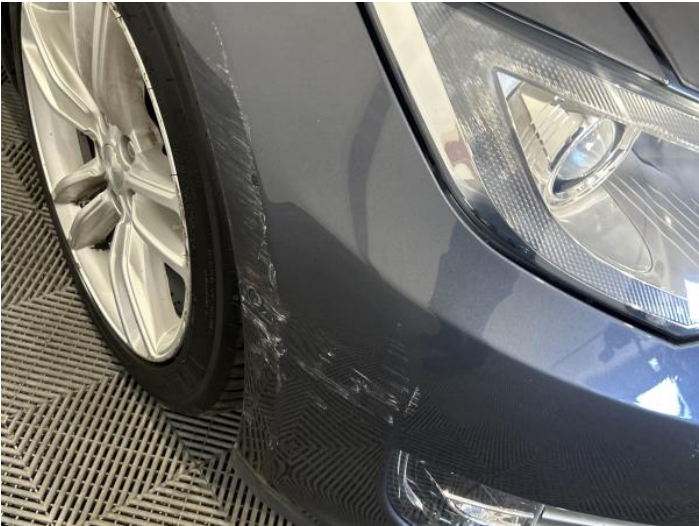
10: Bumper Front  
 Scratched  
 Over 100mm Thru Paint
