VEHICLE INSPECTION REPORT

KO15OKG

Nissan Qashqai 1.6 dCi N-Tec+ 5dr Xtronic

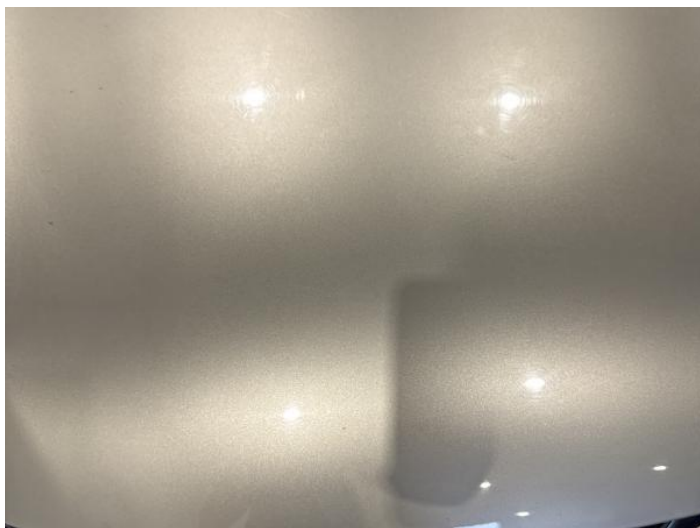
1: Bonnet
Chipped
1 To 5

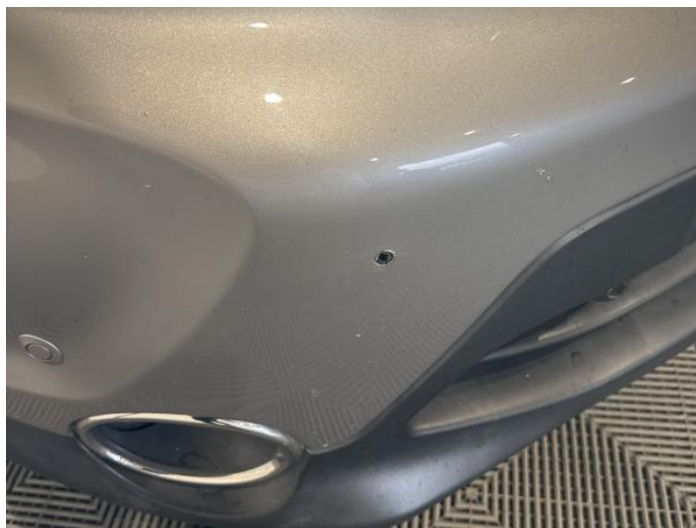
2: Bumper Front
Hole
UpTo 25mm

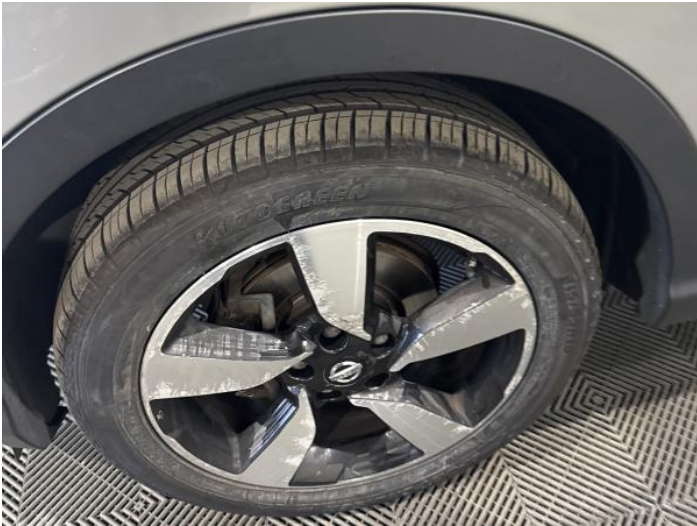
3: Wheel nsf
Scratched
Over 50mm

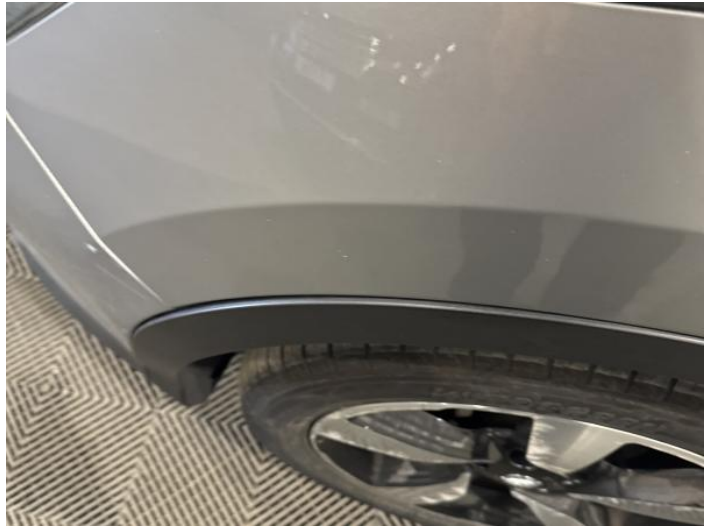
4: Wing nsf
Chipped
1 To 5

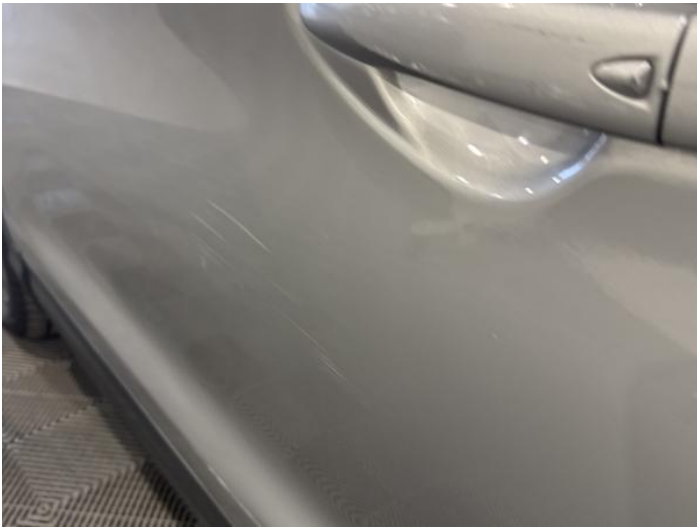
5: Door nsf
Scratched
Over 25mm Thru Paint

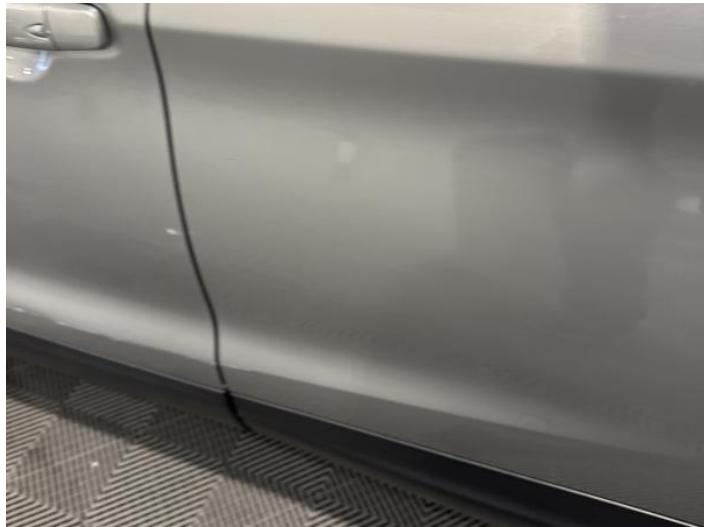
6: Door nsr
Scratched
Over 25mm Thru Paint

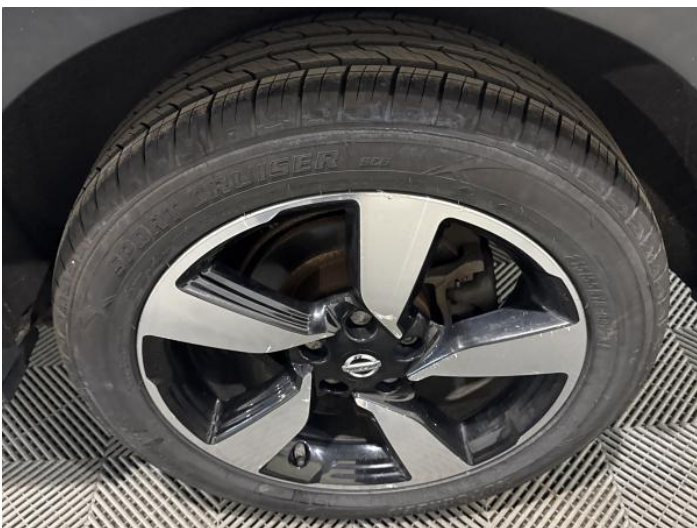
7: Wheel nsr
Scratched
Over 50mm

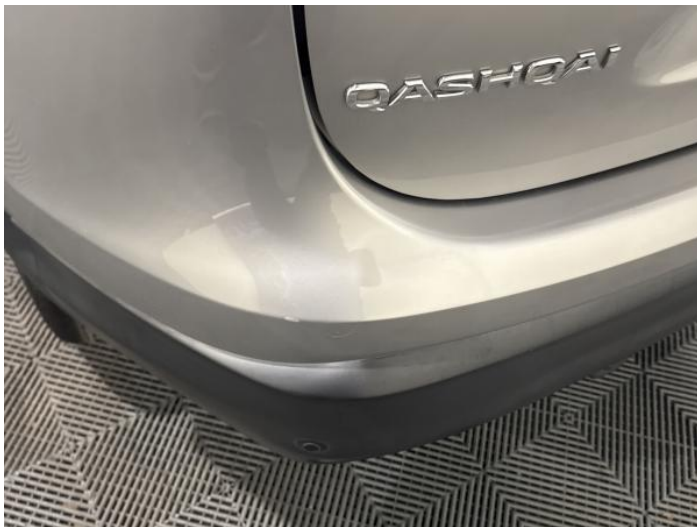
9: Bumper Rear
Scratched
25 to 100mm Thru Paint

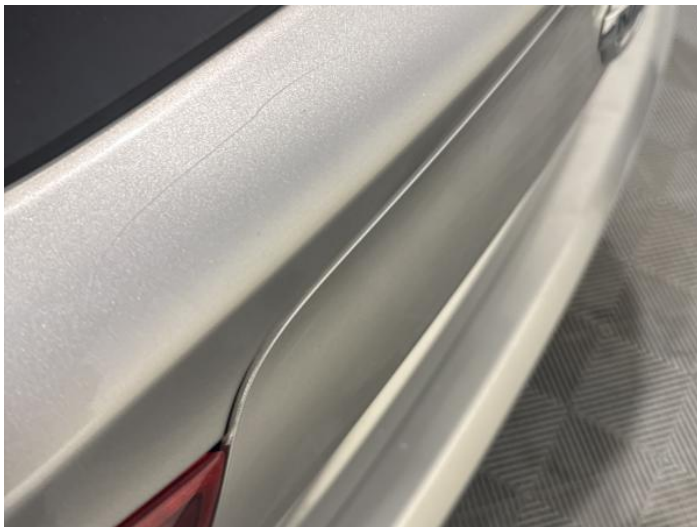
11: Boot Lid
Scratched
Over 25mm Thru Paint

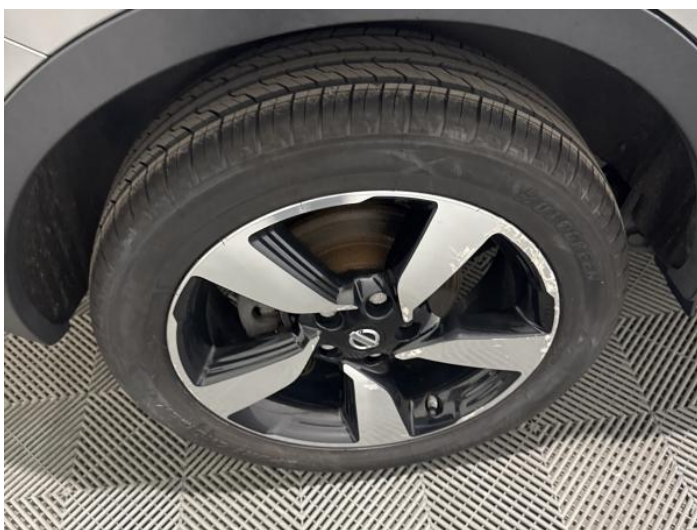
13: Wheel osr
Scratched
Over 50mm

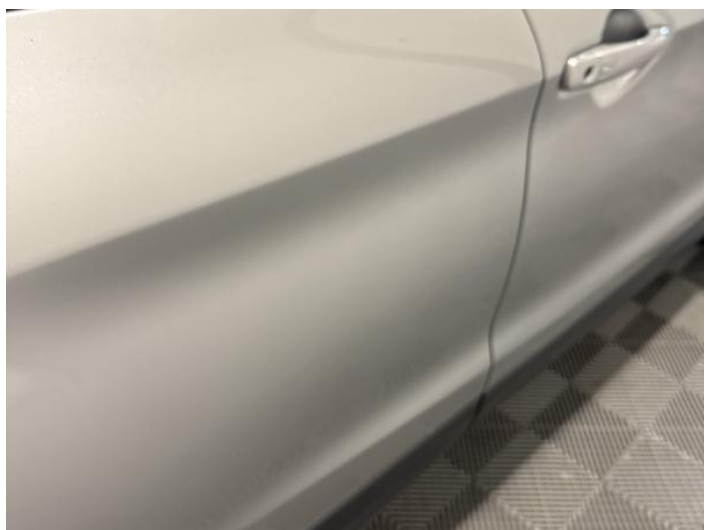
15: Door osr
Scratched
Over 25mm Not Thru Paint

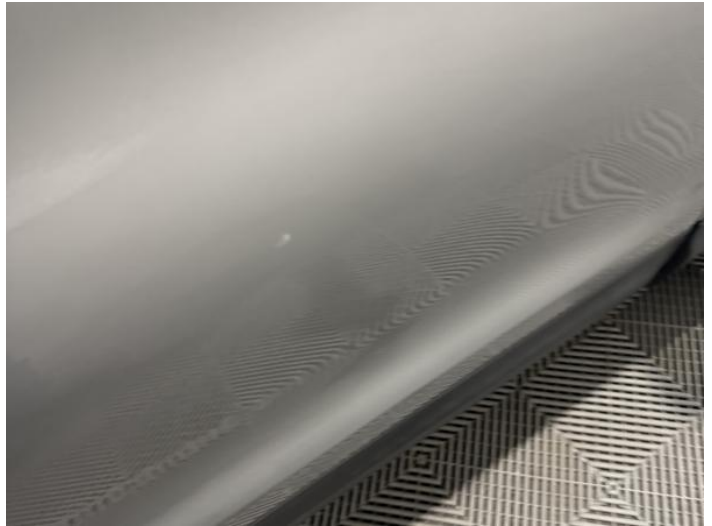
17: Door osf
Scratched
Over 25mm Not Thru Paint

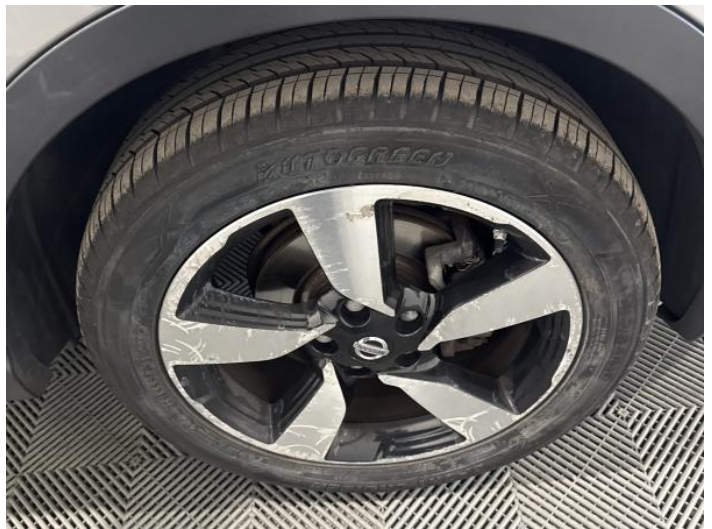
18: Wheel osf
Scratched
Over 50mm
