VEHICLE INSPECTION REPORT

GV19KYU

Toyota Yaris 1.5 Hybrid Y20 5dr CVT [Bi-tone]

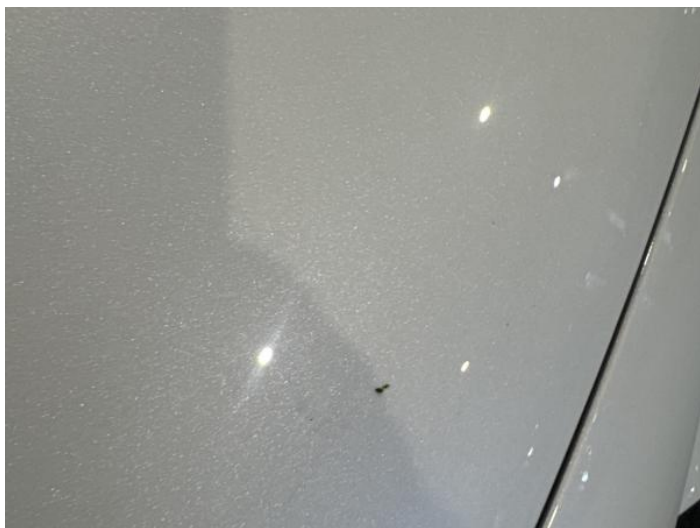
1: Bonnet
Chipped
1 To 5

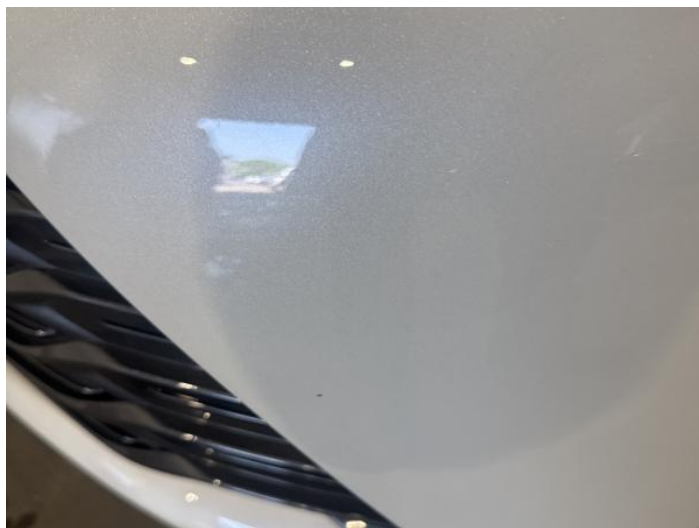
2: Bumper Front
Chipped
Multiple Chips

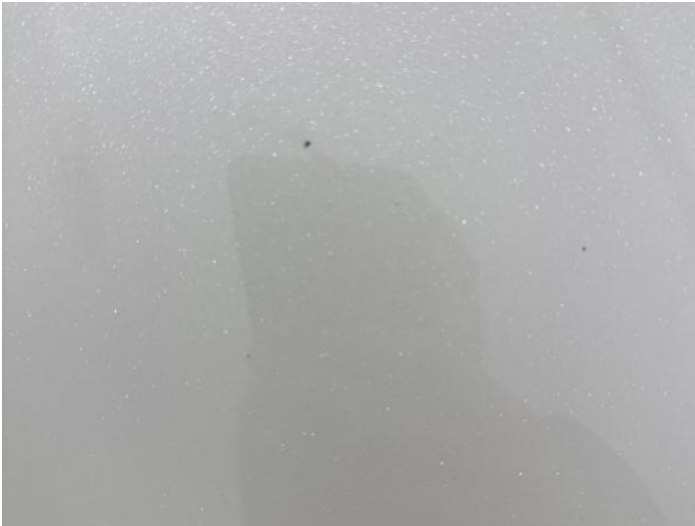
3: Wing osf
Chipped
1 To 5

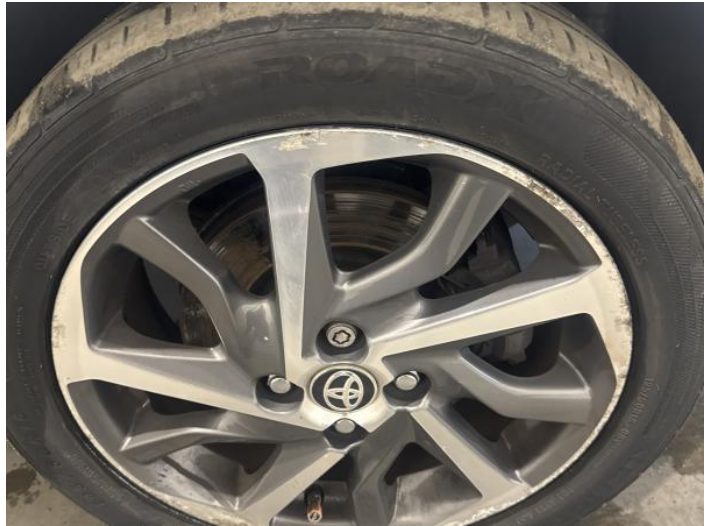
4: Wheel osf
Scratched
Over 50mm

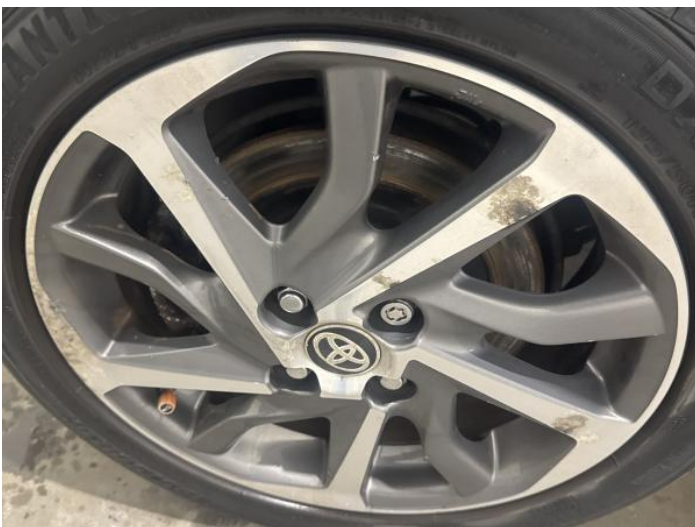
7: Wheel osr
Scratched
Over 50mm

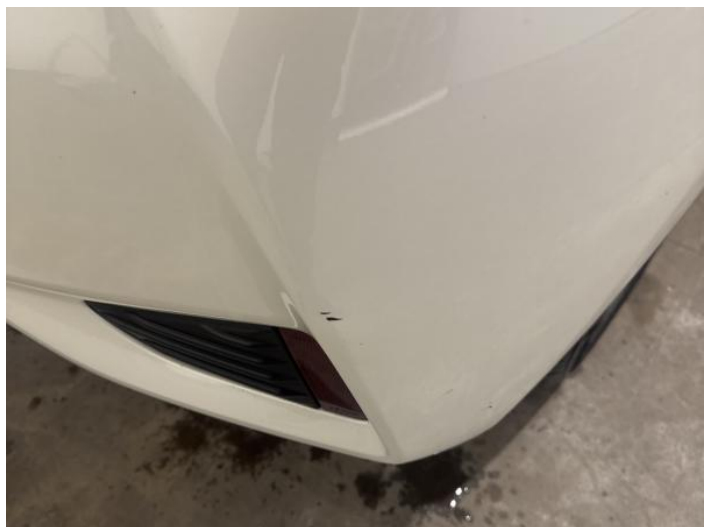
8: Bumper Rear
Scratched
Over 100mm Thru Paint

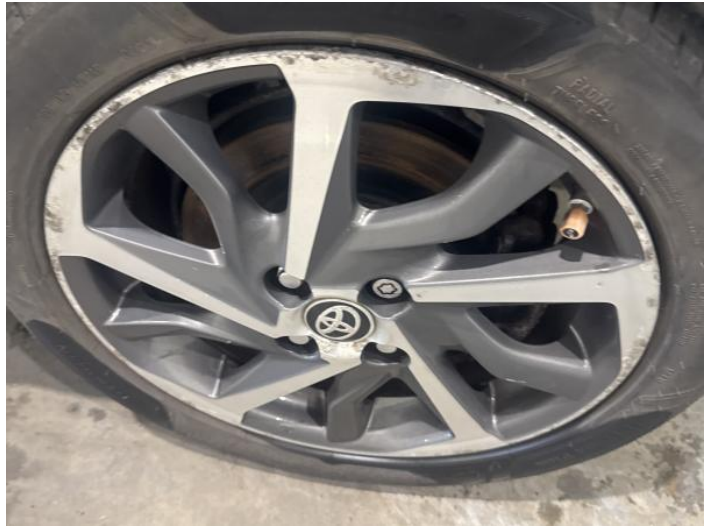
10: Wheel nsr
Scratched
Over 50mm

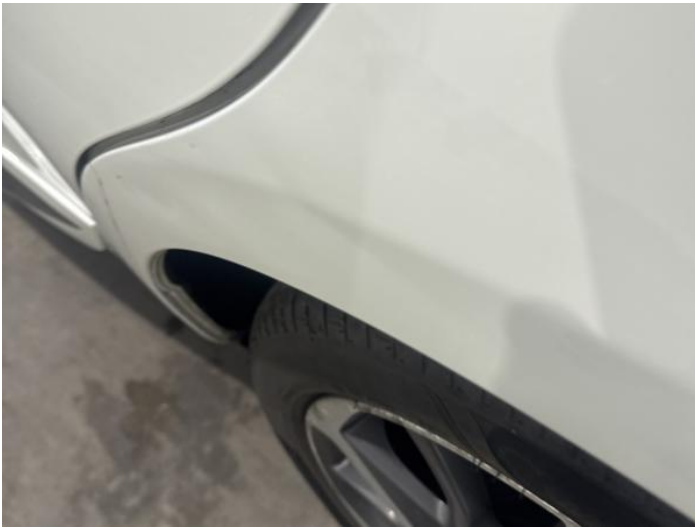
11: Qtr Panel nsr
Dented
Over 30mm

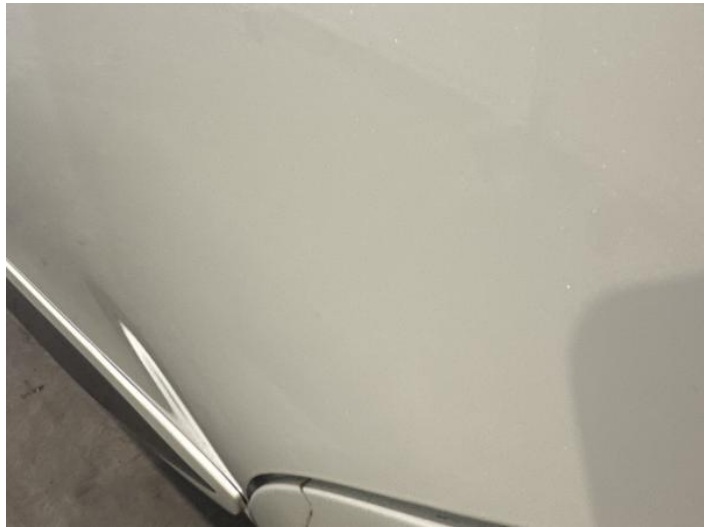
12: Door nsr
Dented
Over 30mm

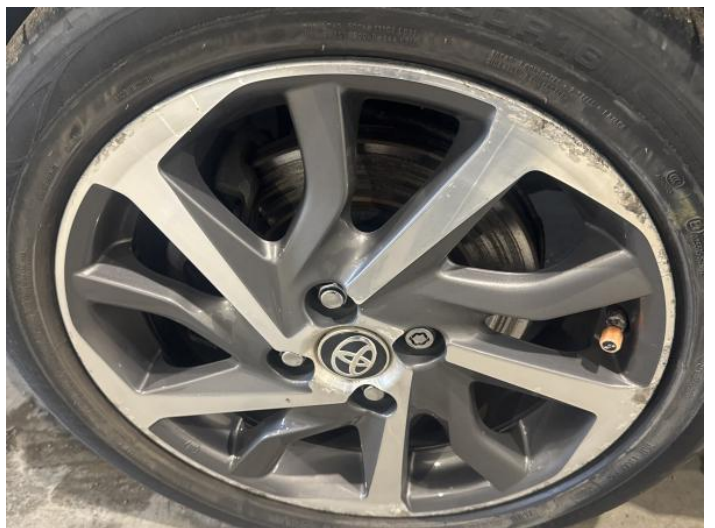
14: Wheel nsf
Scratched
Over 50mm

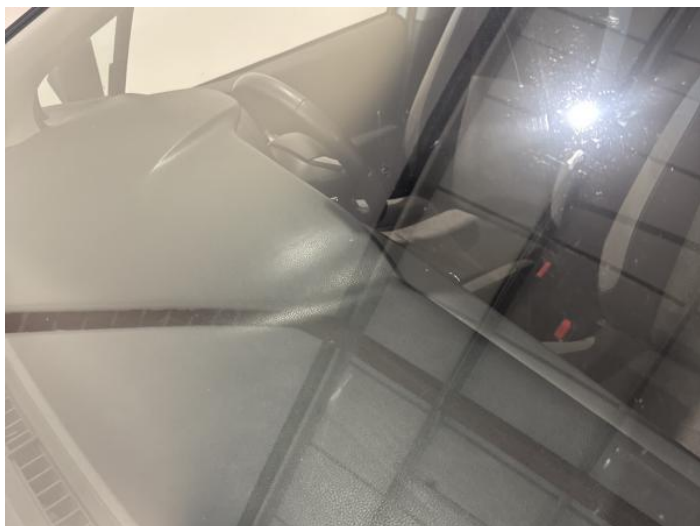
15: Screen Front
Chipped
UpTo 10mm
