# VEHICLE INSPECTION REPORT

**HK08KJX**

## Fiat Grande Punto 1.3 Multijet Dynamic 3dr [75]

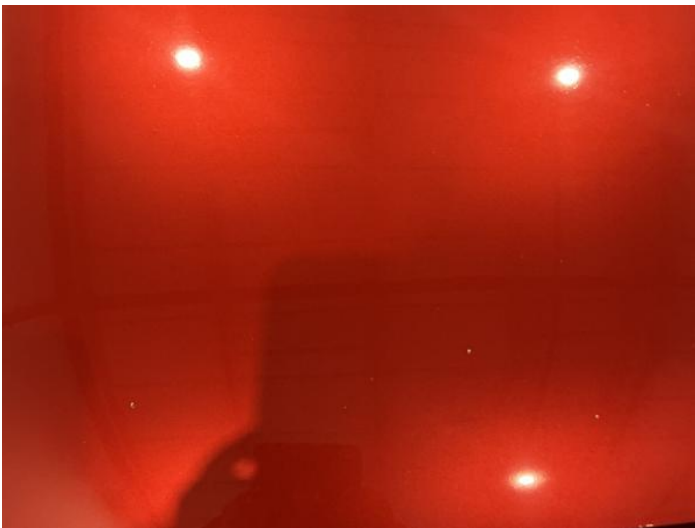
1: Bonnet  
Chipped  
Multiple Chips

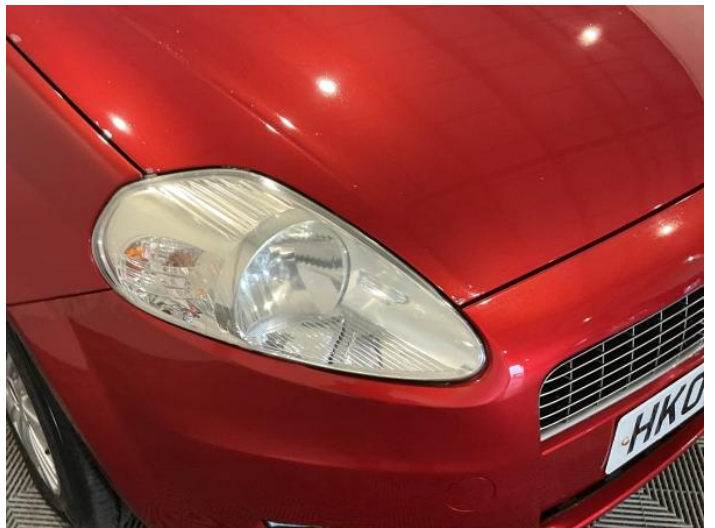
2: Bumper Front  
Scratched  
25 to 100mm Thru Paint

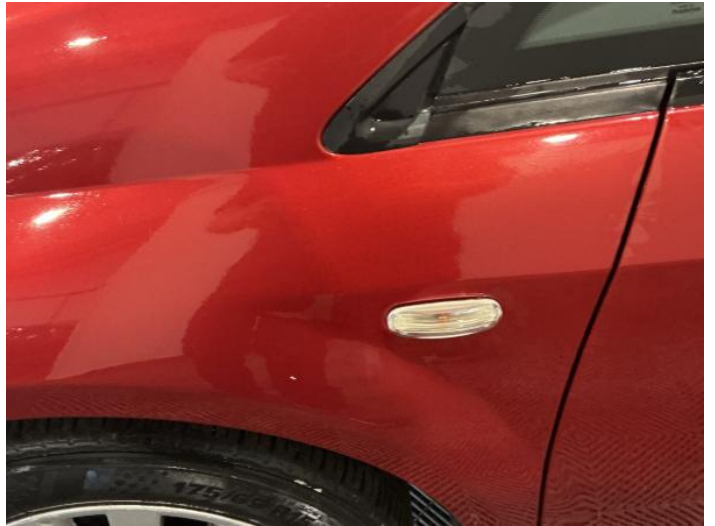
4: Wing nsf  
Chipped  
1 To 5

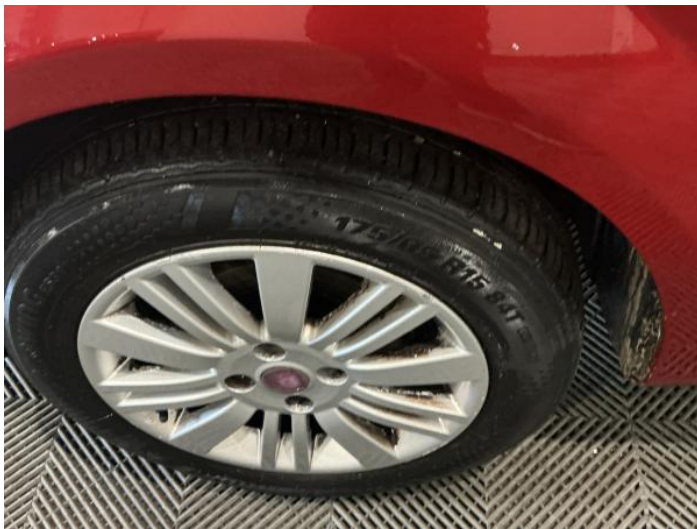
5: Wheel nsf  
Scratched  
Over 50mm

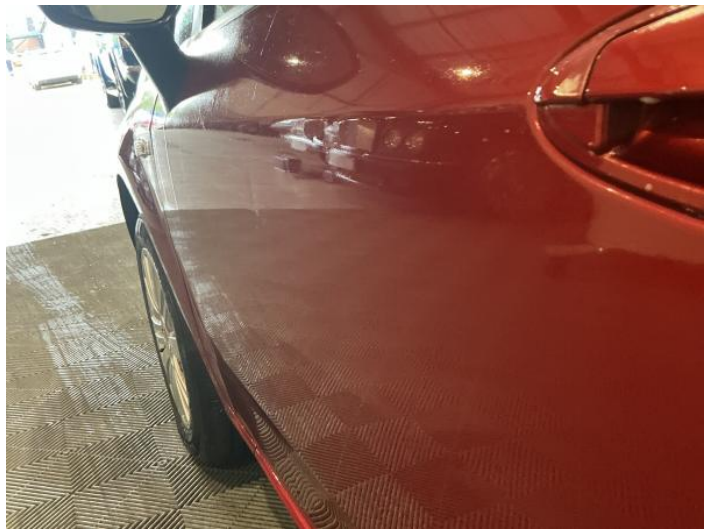
6: Door nsf  
Dented  
Over 30mm

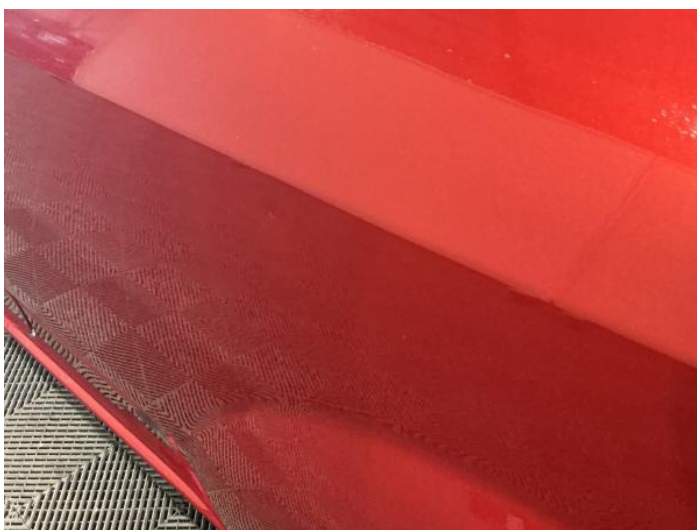
7: Qtr Panel nsr  
Dented  
Over 30mm

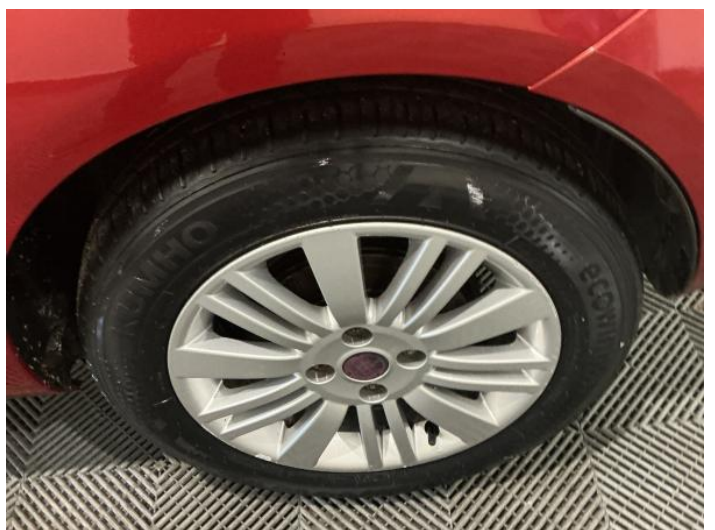
8: Wheel nsr  
Scratched  
Over 50mm

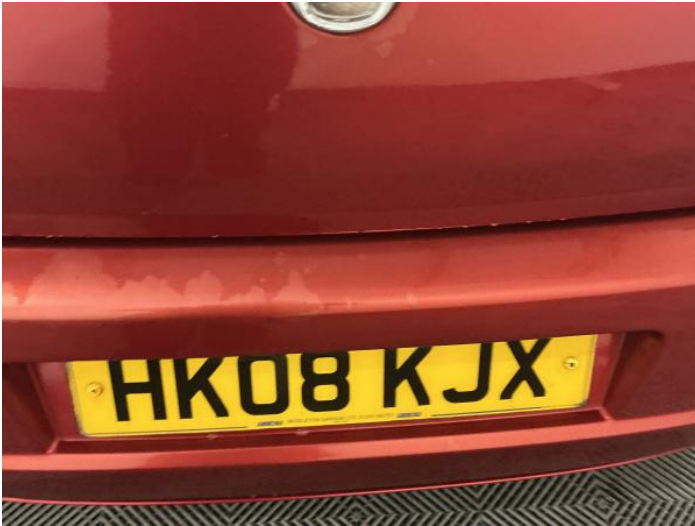
9: Bumper Rear  
Poor Previous Repair  
Paint Flake

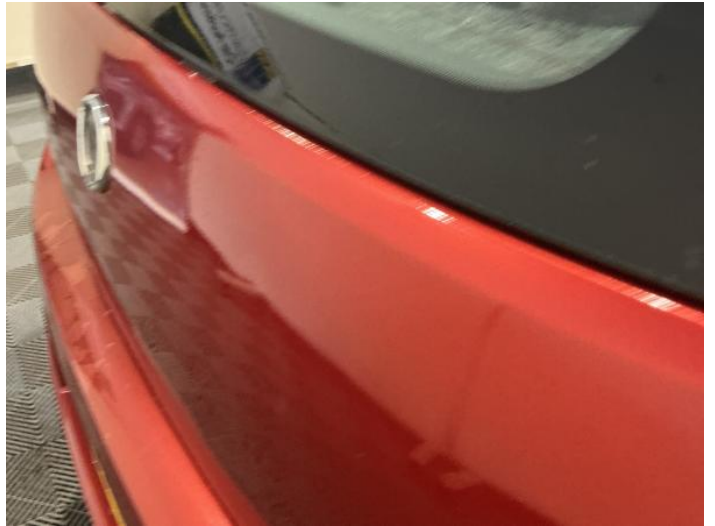
10: Boot Lid  
Dented  
Between 10mm + 30mm

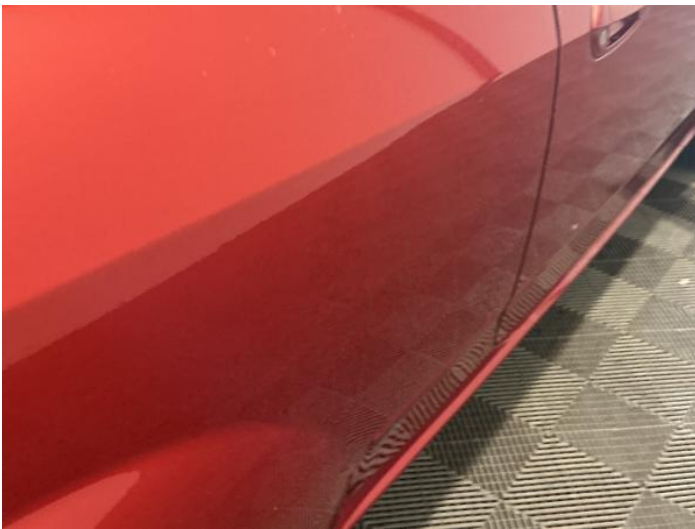
11: Qtr Panel osr  
Dented  
2 Or Less UpTo 10mm

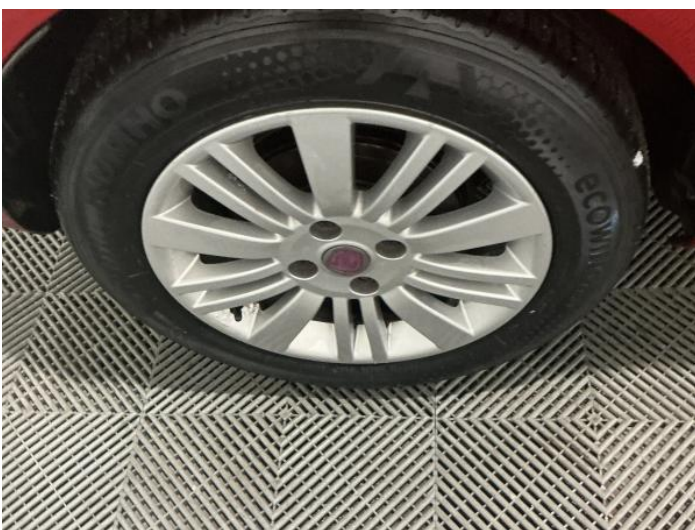
13: Wheel osr  
Scratched  
Over 50mm

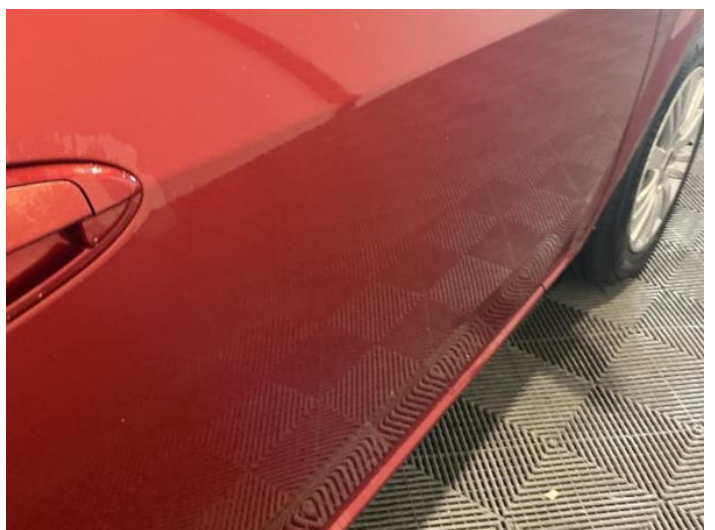
14: Door osf  
Dented  
Over 2 UpTo 10mm

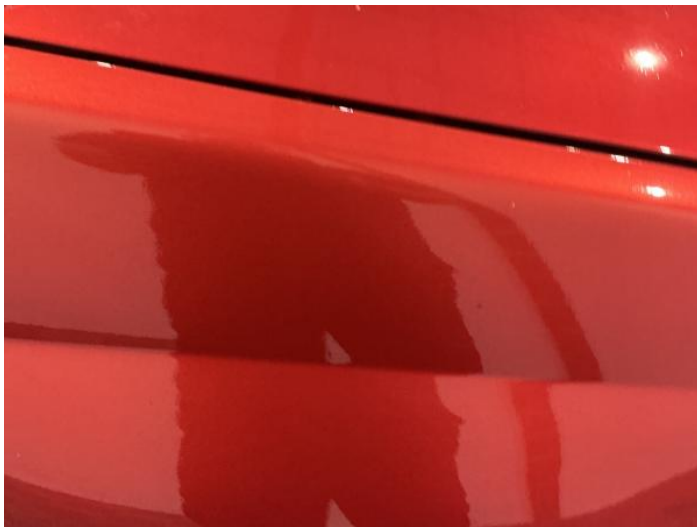
15: Wing osf  
Chipped  
1 To 5

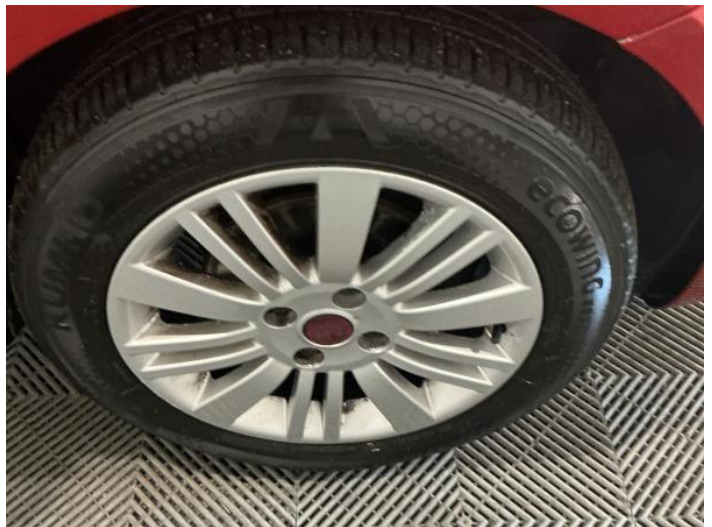
16: Wheel osf  
Scratched  
Over 50mm
