VEHICLE INSPECTION REPORT

LL08CXY

Ford Fiesta 1.4 Zetec Blue 3dr

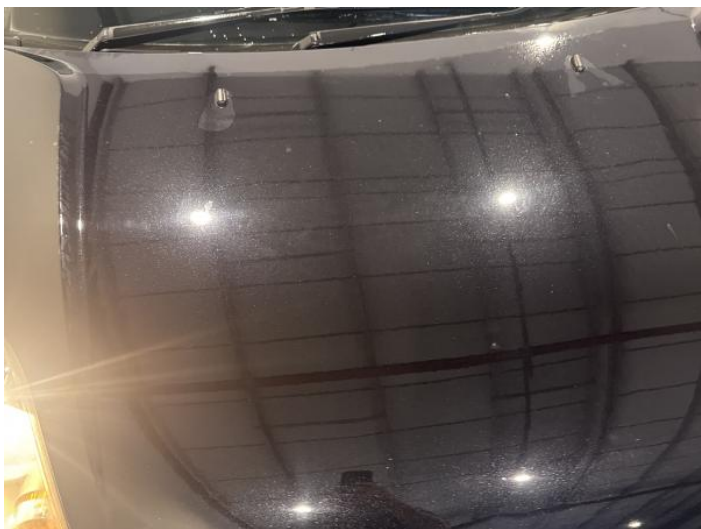
3: Bonnet
Chipped
1 To 5

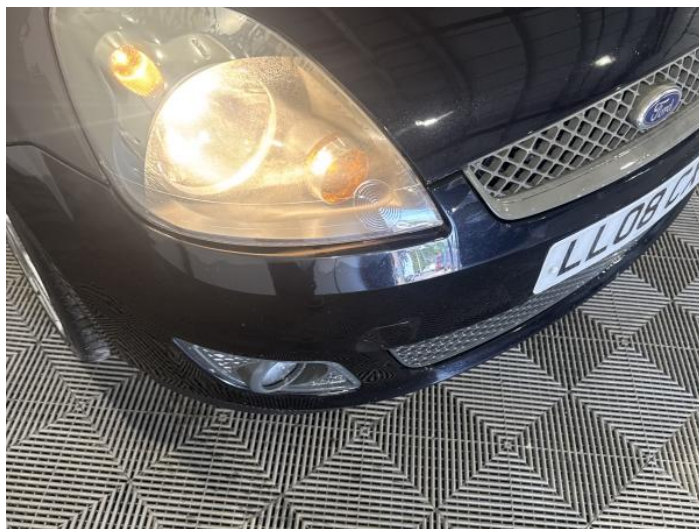
4: Bumper Front
Scratched
25 to 100mm Thru Paint

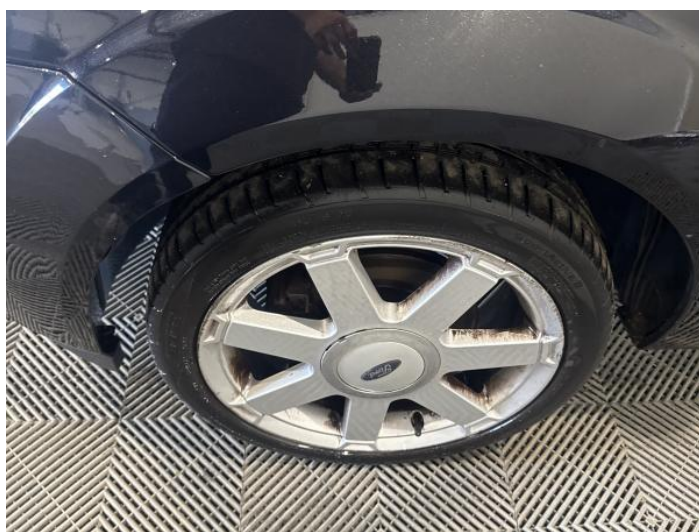
6: Wheel nsf
Scratched
Over 50mm

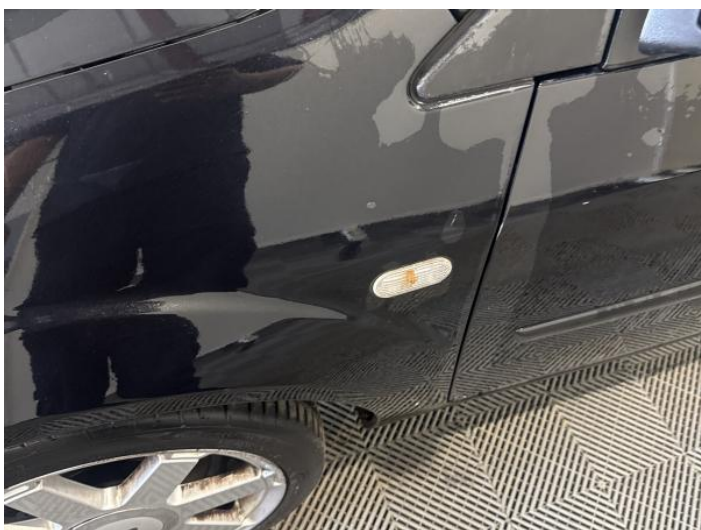
7: Wing nsf
Chipped
1 To 5

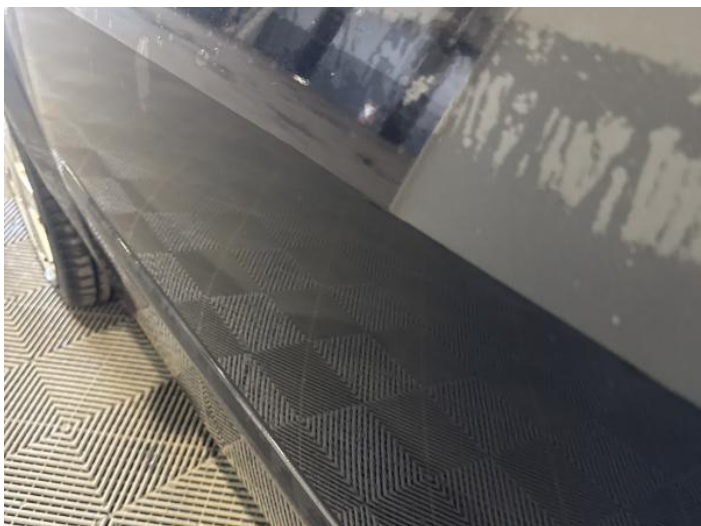
9: Door nsf
Dented
Over 2 UpTo 10mm

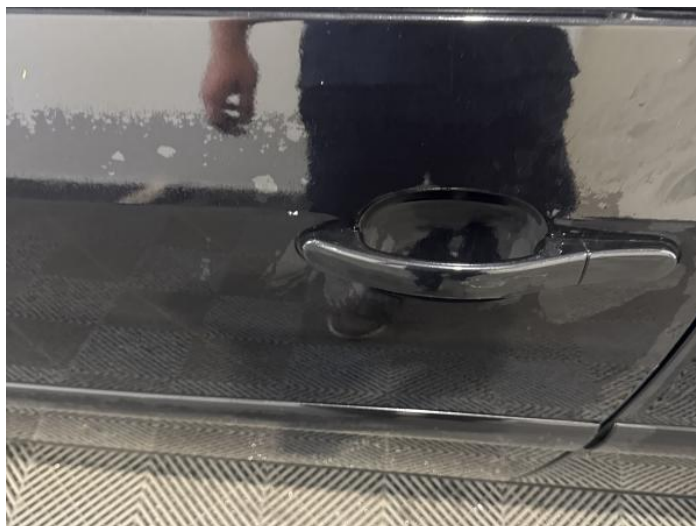
10: Door nsf
Chipped
1 To 5

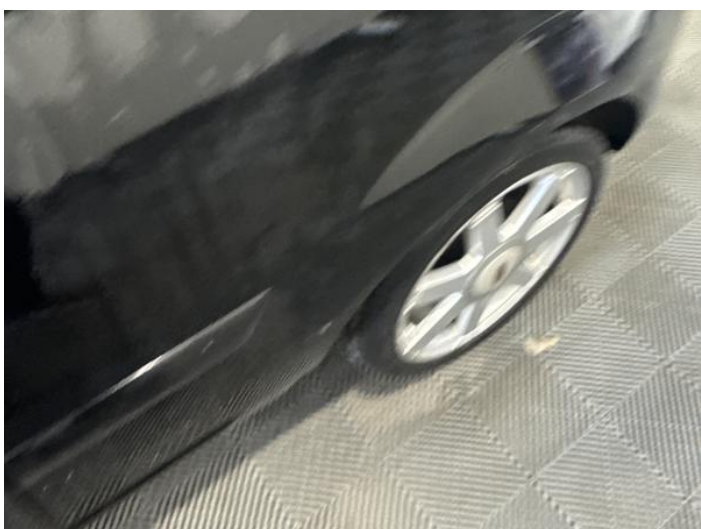
11: Qtr Panel nsr
Dented
With Paint Damage

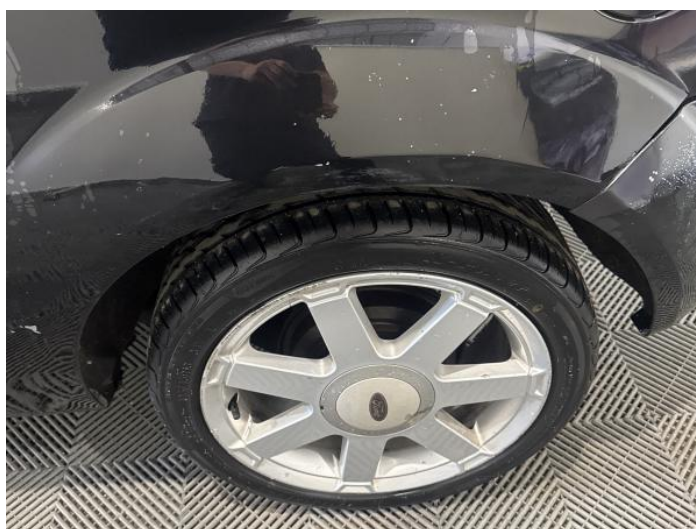
12: Wheel nsr
Scratched
Over 50mm

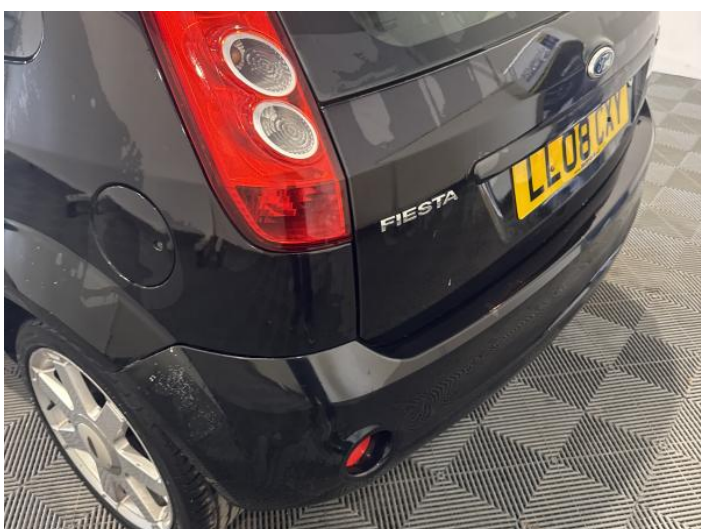
13: Bumper Rear
Scratched
25 to 100mm Thru Paint

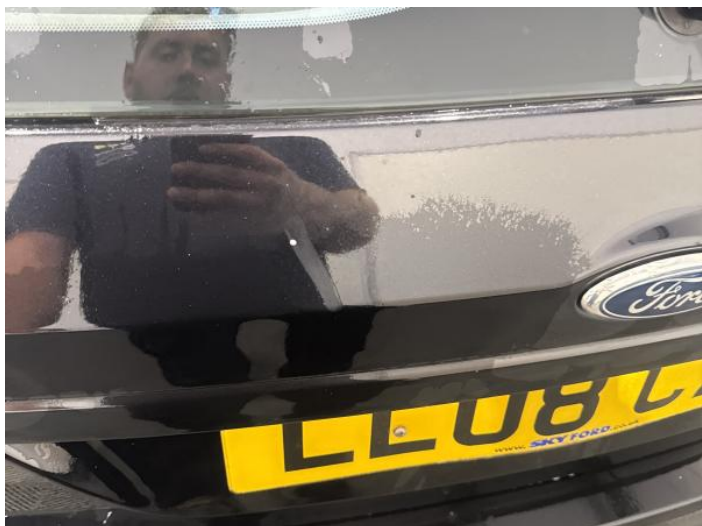
15: Boot Lid
Chipped
1 To 5

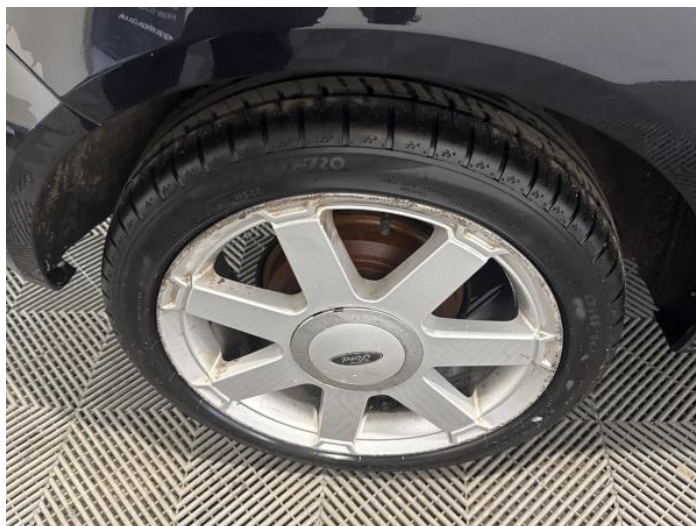
16: Wheel osr
Scratched
Over 50mm

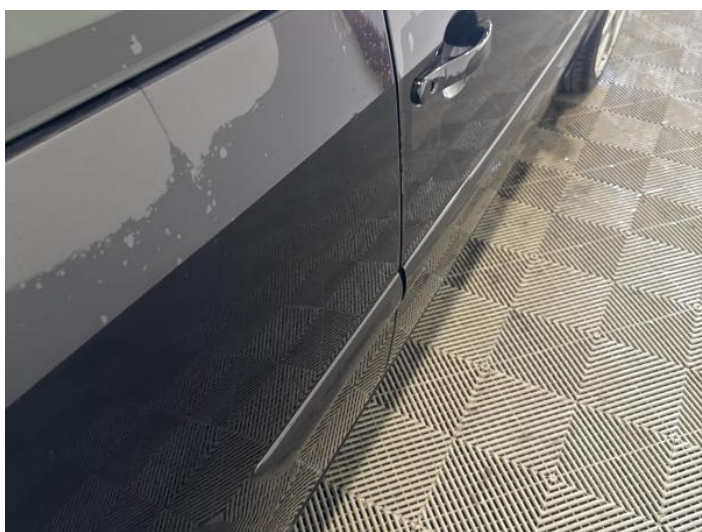
17: Qtr Panel osr
Dented
Between 10mm + 30mm

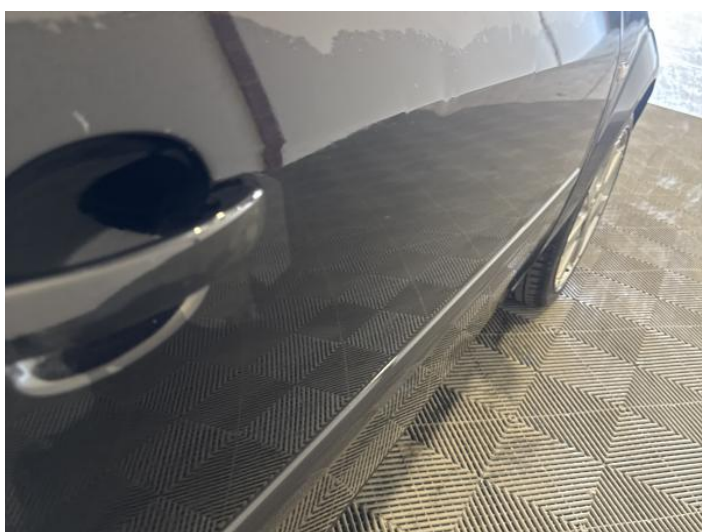
19: Door osf
Dented
Over 2 UpTo 10mm

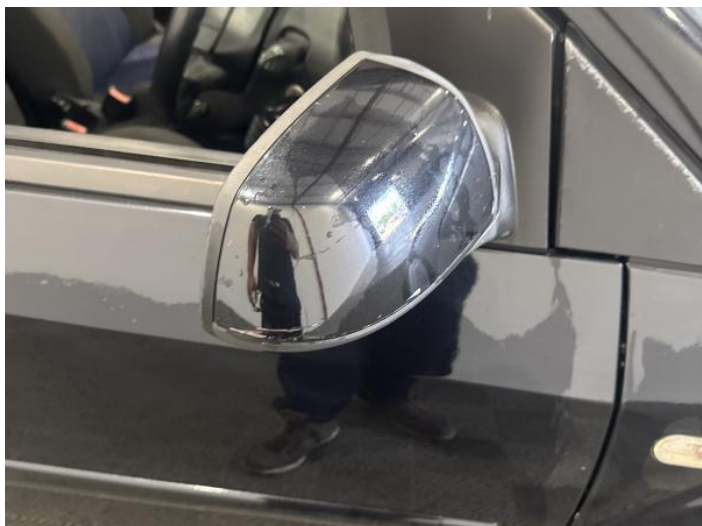
21: Door Mirror Assy osf
Scratched (Painted)
Over 25mm Thru Paint

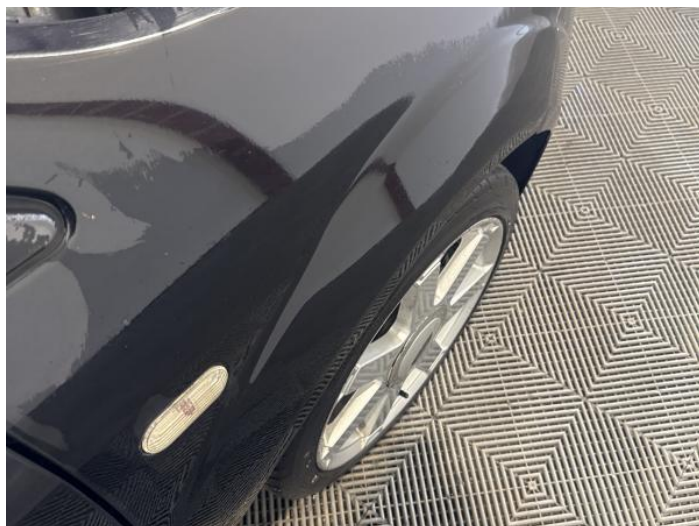
22: Wing osf
Chipped
1 To 5

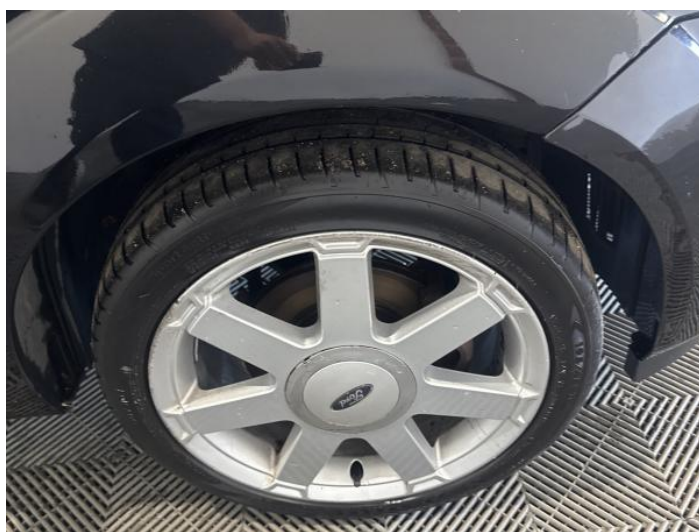
24: Wheel osf
Scratched
Over 50mm
