VEHICLE INSPECTION REPORT

RF66WOU

Volkswagen Sharan 2.0 TDI CR BlueMotion Tech 150 SE Nav 5dr DSG

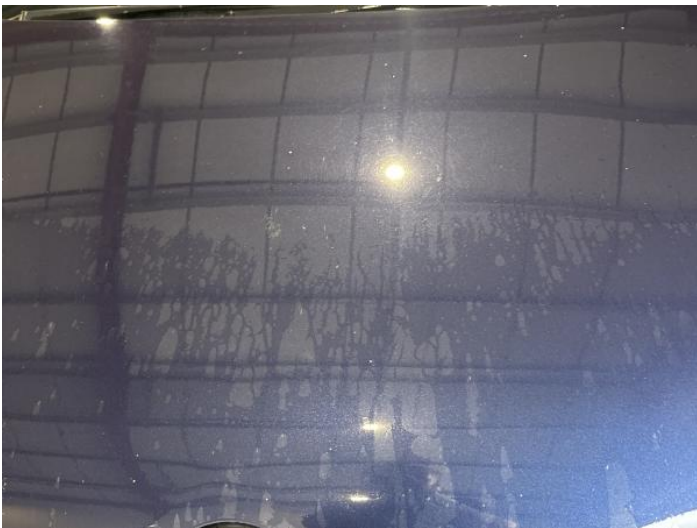
1: Bonnet
Dented
With Paint Damage

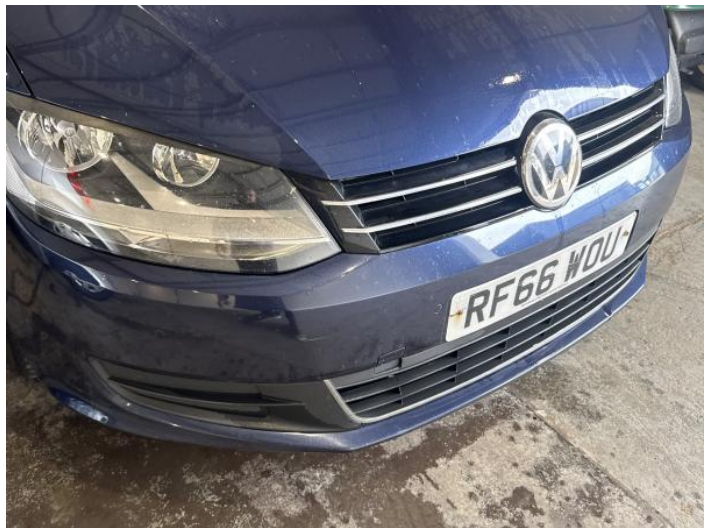
2: Bumper Front
Scratched
Over 100mm Thru Paint

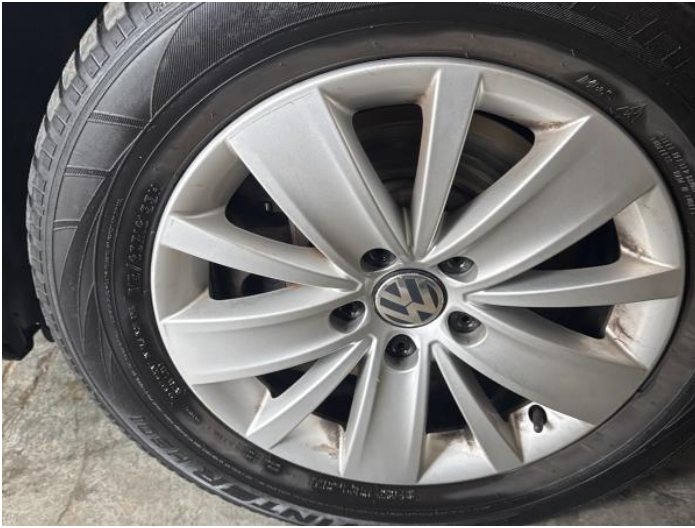
3: Wheel nsf
Scratched
Over 50mm

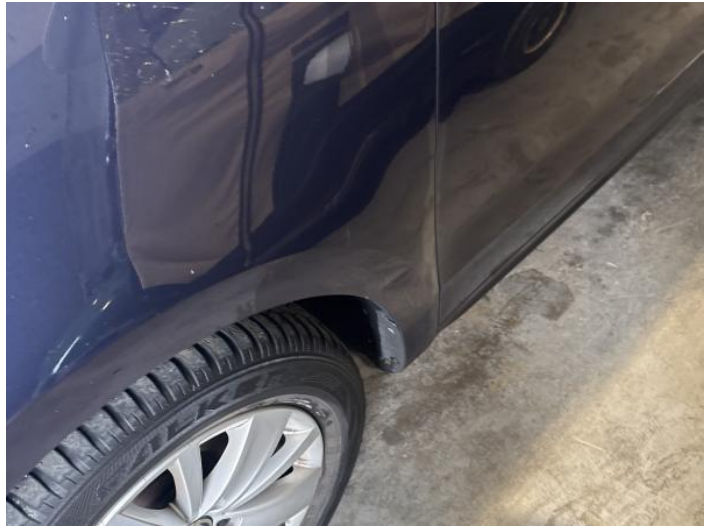
4: Wing nsf
Dented
Over 30mm

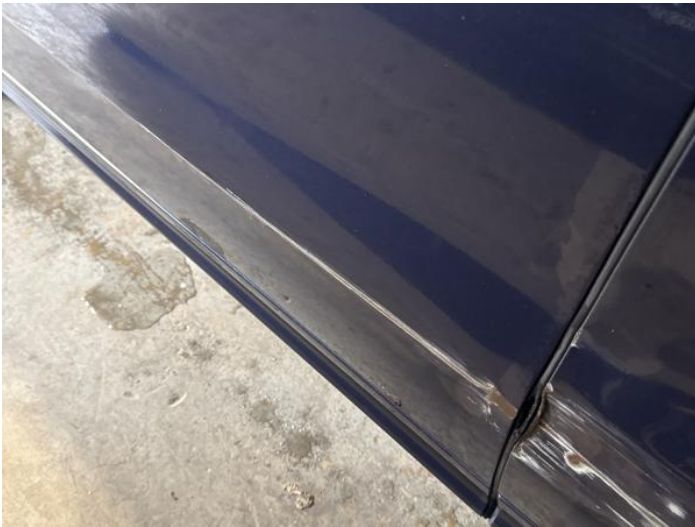
5: Door nsf
Dented
With Paint Damage

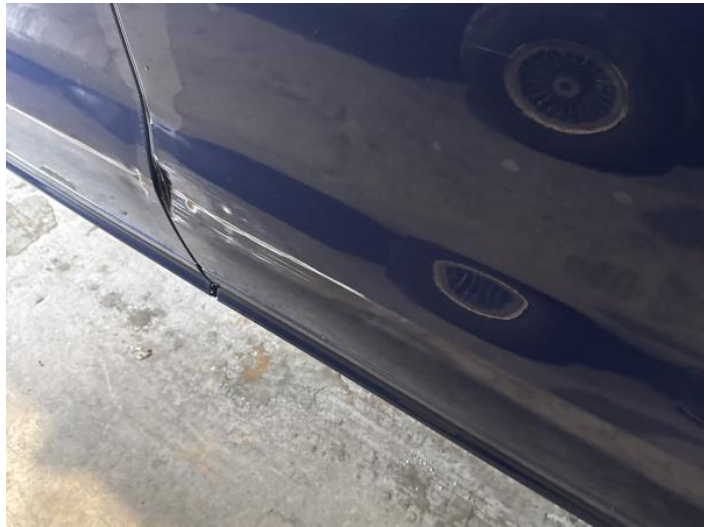
6: Door nsr
Dented
With Paint Damage

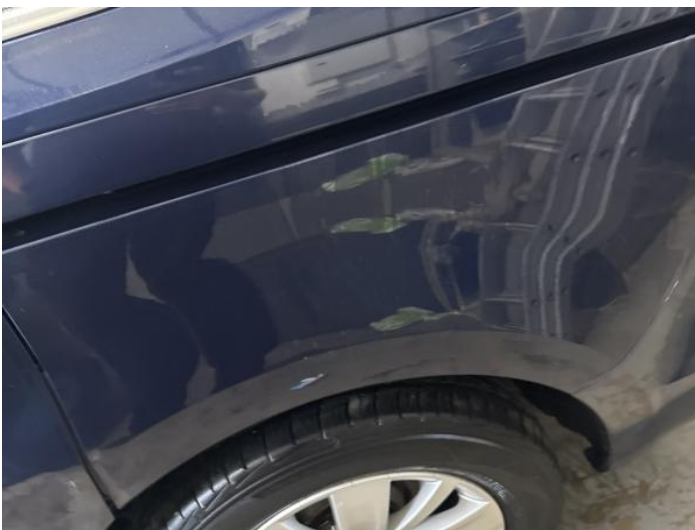
7: Qtr Panel nsr
Dented
With Paint Damage

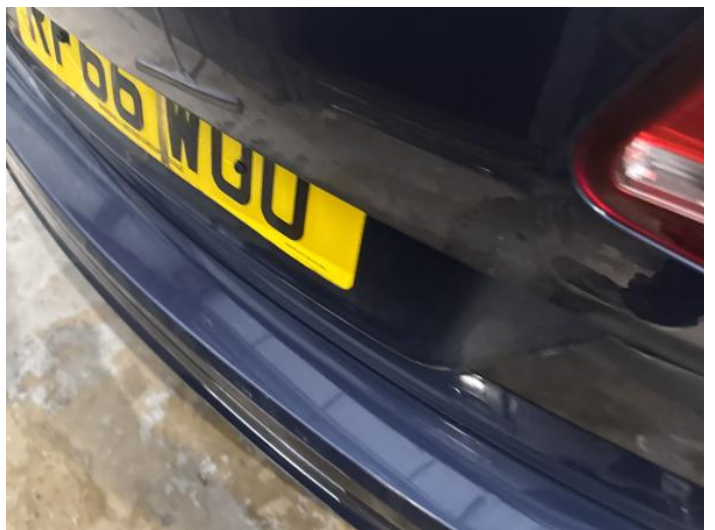
8: Bumper Rear
Scratched
25 to 100mm Thru Paint

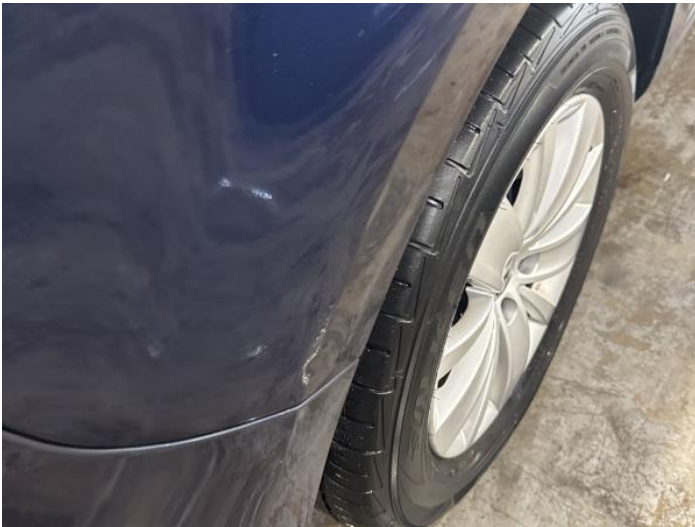
11: Qtr Panel osr
Dented
Over 30mm

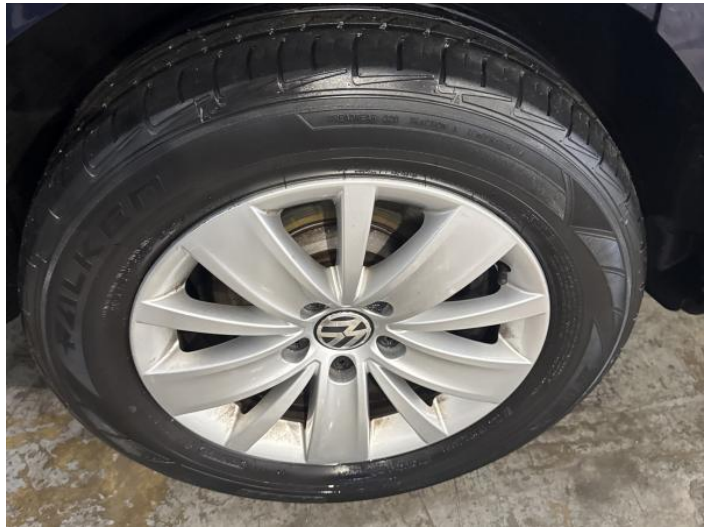
12: Wheel osr
Scratched
Over 50mm

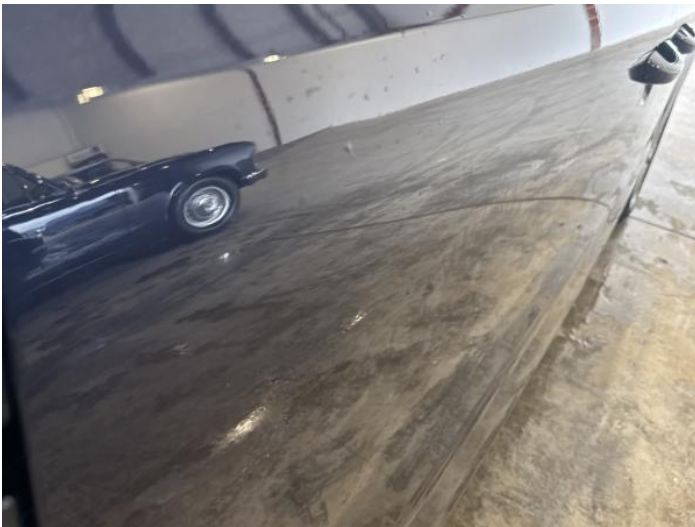
13: Door osr
Dented
Between 10mm + 30mm

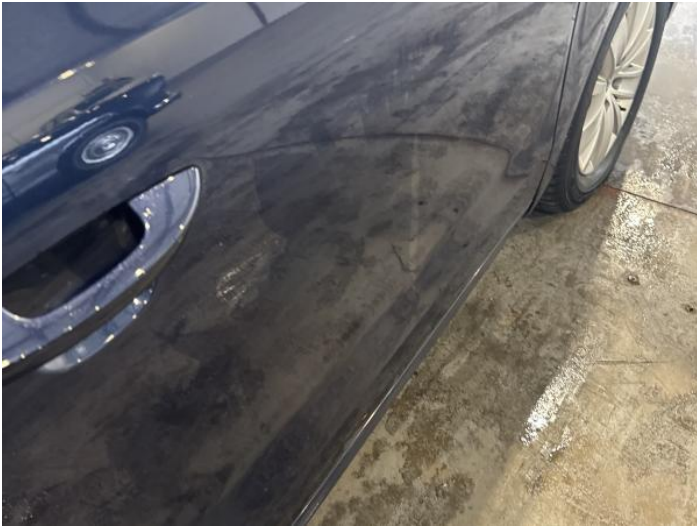
15: Door osf
Chipped
1 To 5

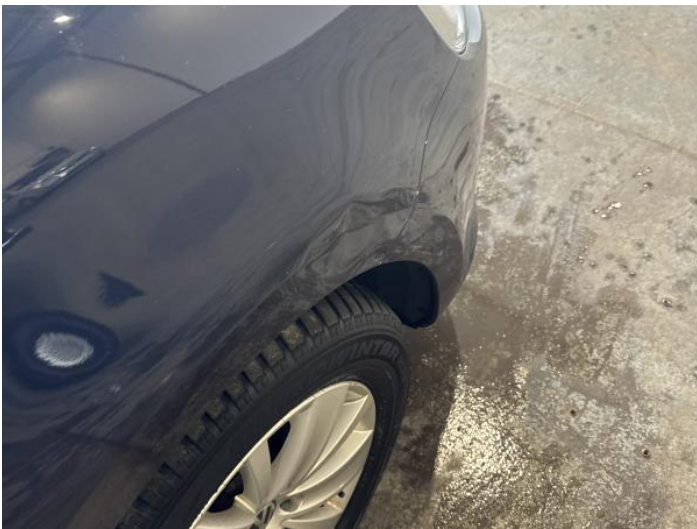
17: Wing osf
Dented
Over 30mm

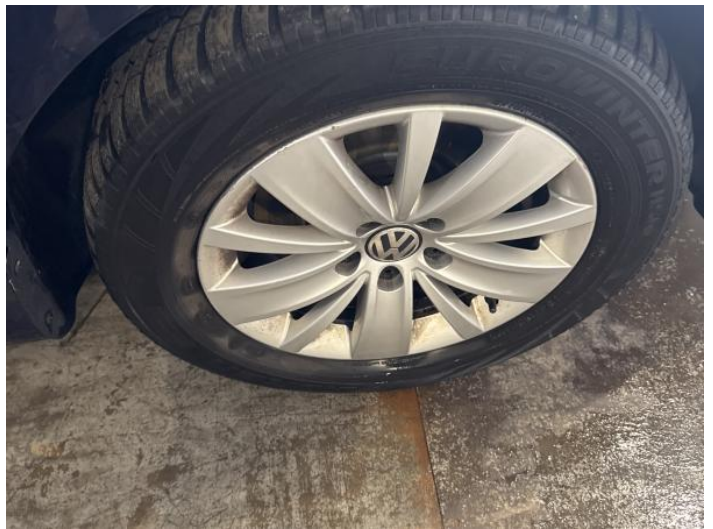
18: Wheel osf
Scratched
Over 50mm

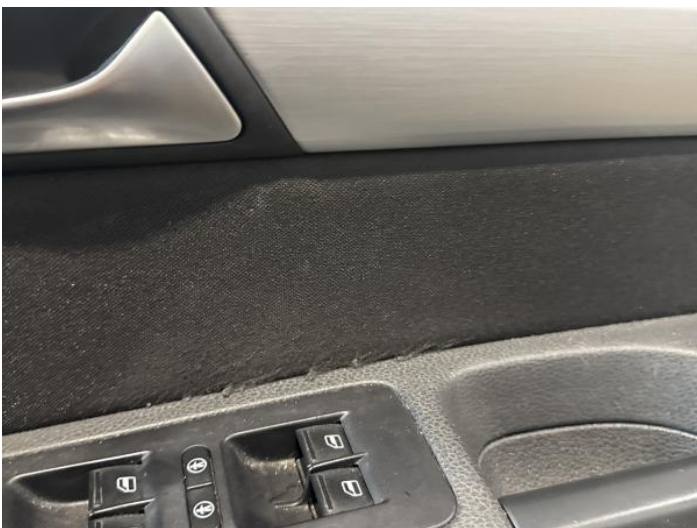
19: Door Pad osf
Torn
UpTo 3mm
