VEHICLE INSPECTION REPORT

Toyota Yaris 1.3 VVT-i TR 5dr

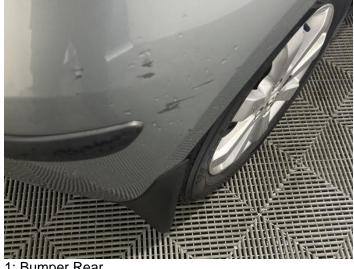
1: Bumper Rear Scratched 25 to 100mm Thru Paint

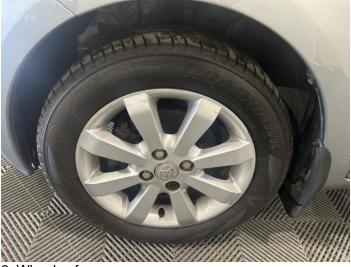
2: Wheel nsf Scratched Over 50mm

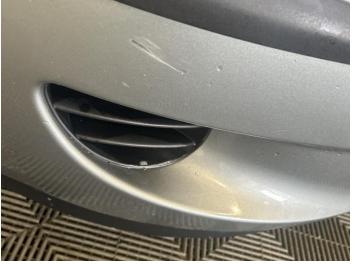
3: Bumper Front Scratched UpTo 25mm Thru Paint

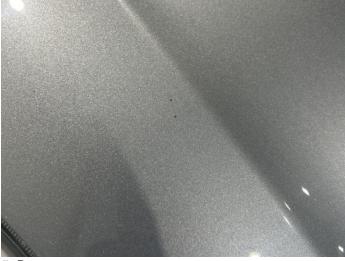
5: Bonnet Chipped 1 To 5
