VEHICLE INSPECTION REPORT

OU64VKH

Skoda Fabia 1.2 TSI 90 SE 5dr

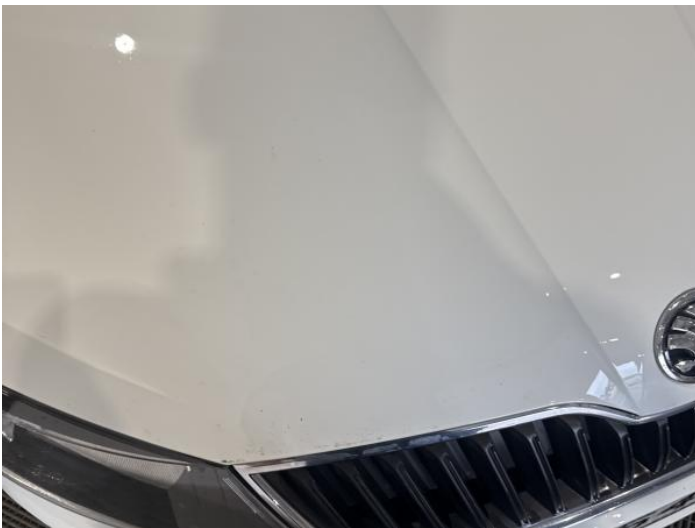
1: Bonnet
Chipped
1 To 5

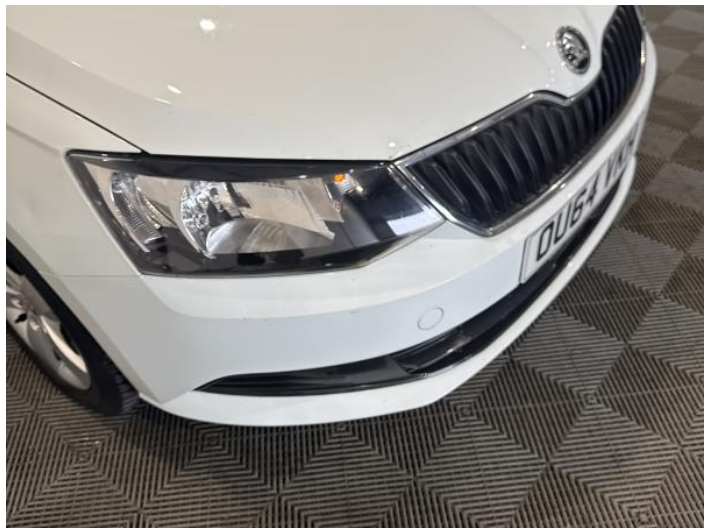
2: Bumper Front
Scratched
25 to 100mm Thru Paint

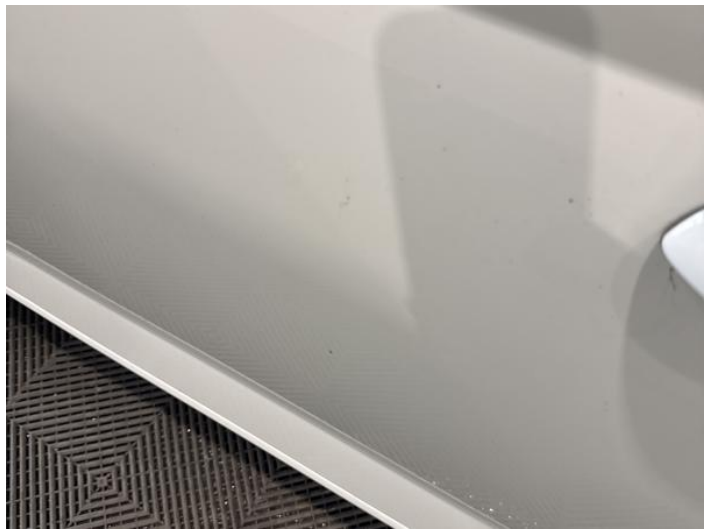
5: Wing nsf
Scratched
Over 25mm Not Thru Paint

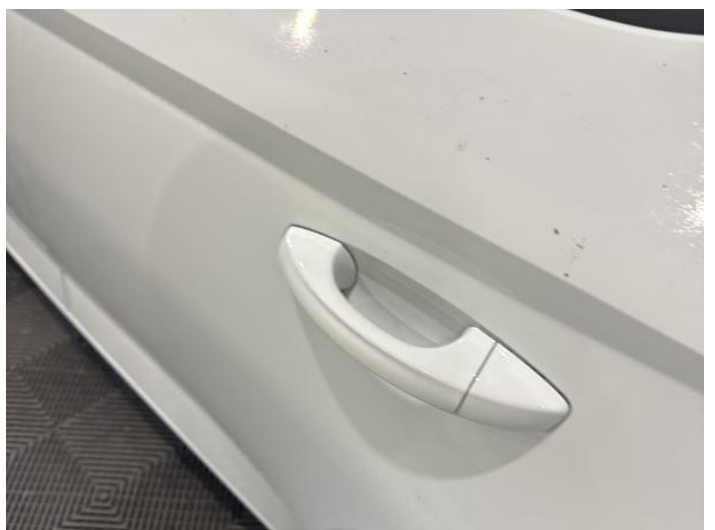
7: Door nsf
Scratched
Over 25mm Not Thru Paint

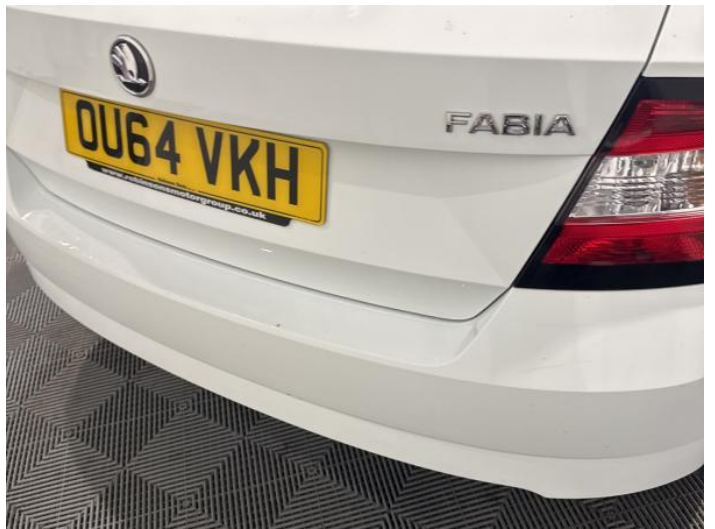
11: Qtr Panel nsr
Scratched
Over 25mm Not Thru Paint

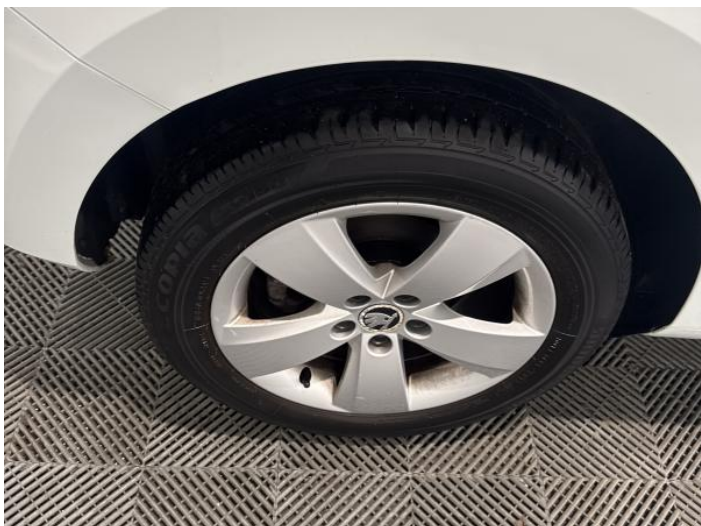
15: Wheel osr
Scratched
Up To 50mm

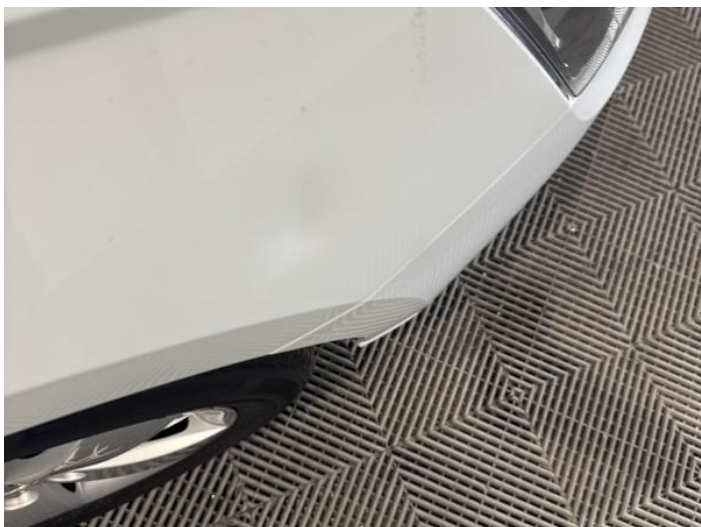
19: Wing osf
Dented
Between 10mm + 30mm

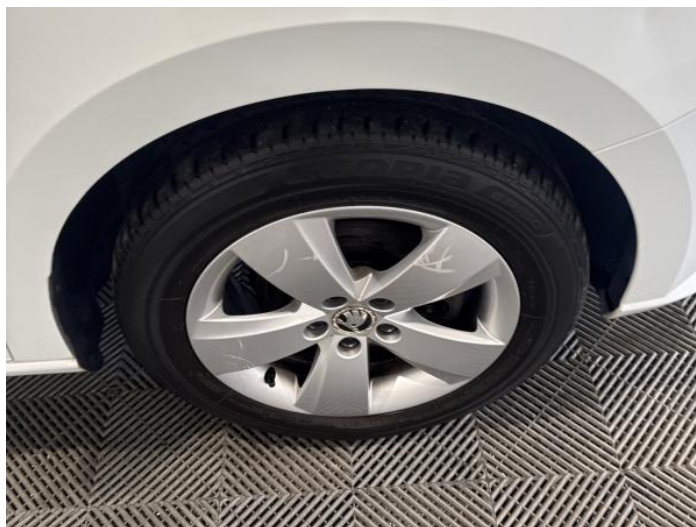
20: Wheel osf
Scratched
Over 50mm
