VEHICLE INSPECTION REPORT

LW17FWP

Vauxhall Insignia 1.5T Elite Nav 5dr

nama
GRADE
4

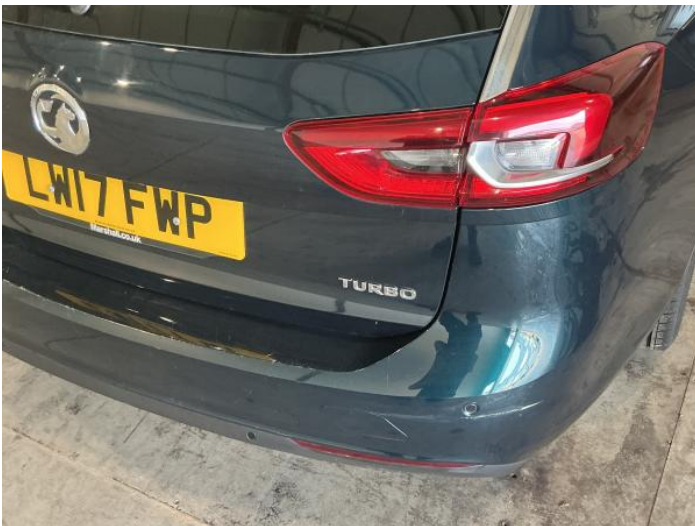
1: Bumper Rear
Scratched
Over 100mm Thru Paint

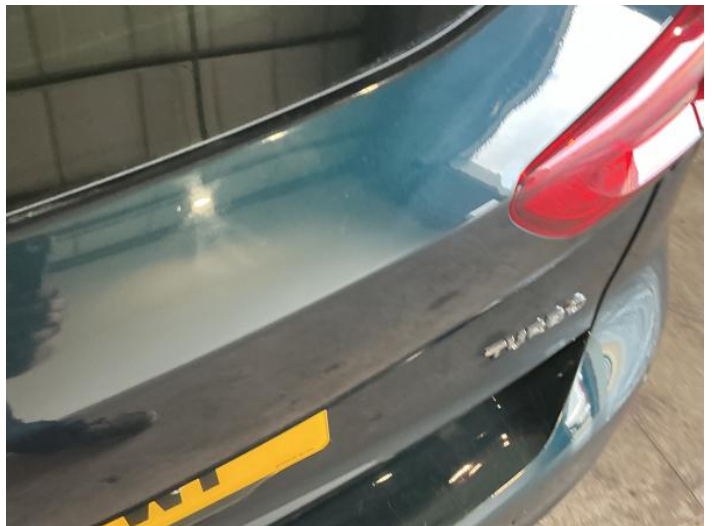
2: Boot Lid
Dented
Between 10mm + 30mm

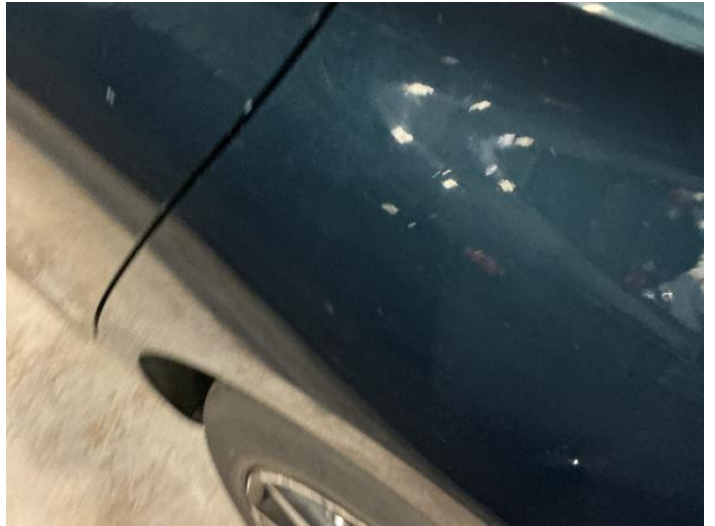
4: Qtr Panel nsr
Dented
Over 2 UpTo 10mm

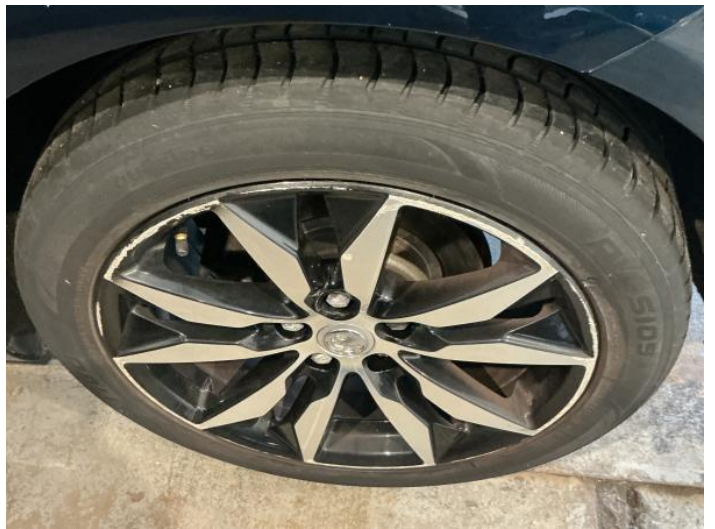
6: Wheel nsr
Scratched
Over 50mm

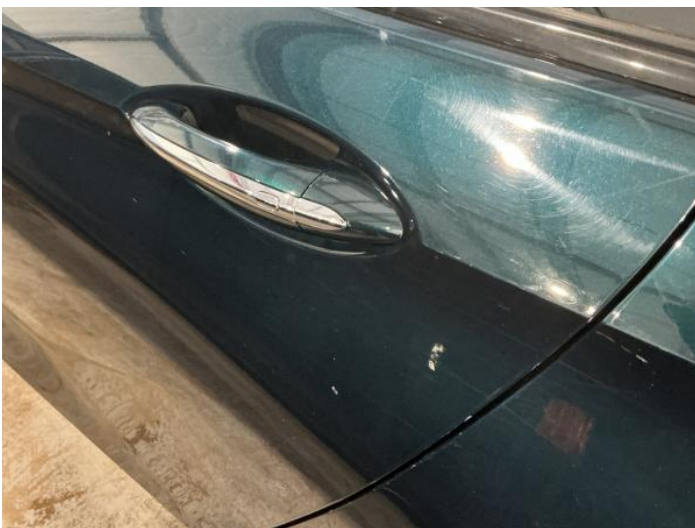
7: Door nsr
Chipped
1 To 5

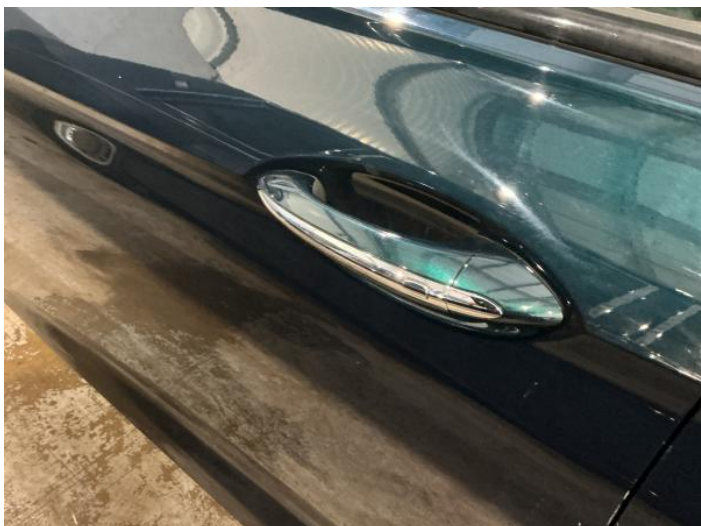
9: Door nsf
Chipped
1 To 5

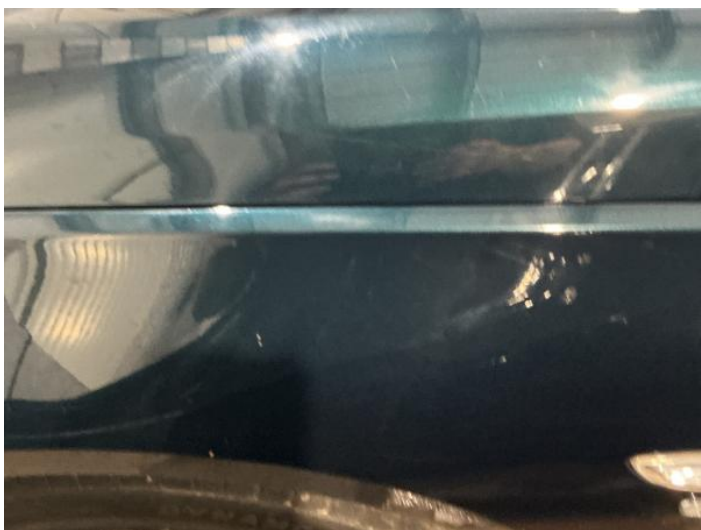
11: Wing nsf
Chipped
1 To 5

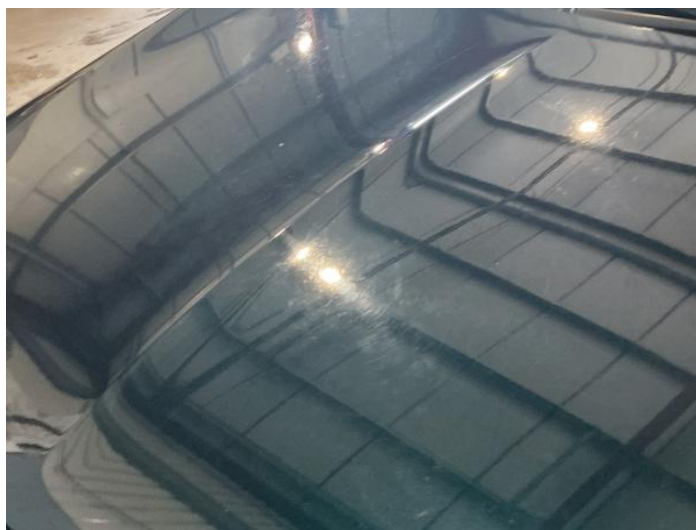
12: Bonnet
Chipped
1 To 5

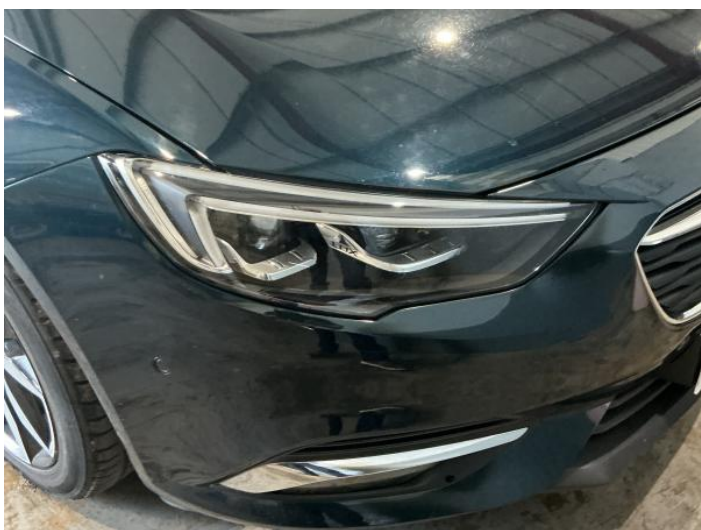
13: Bumper Front
Scratched
25 to 100mm Thru Paint

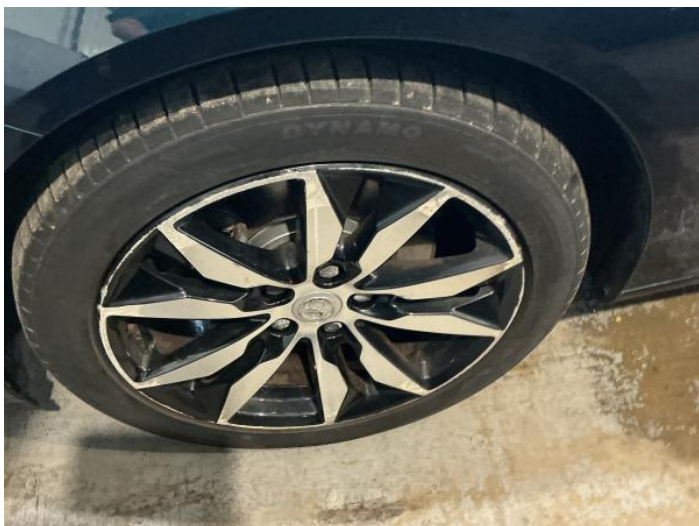
15: Wheel nsf
Scratched
Over 50mm

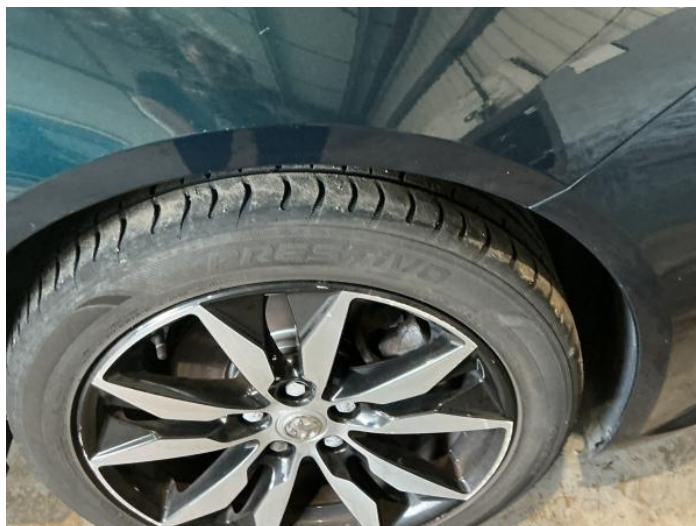
16: Wheel osf
Scratched
Over 50mm

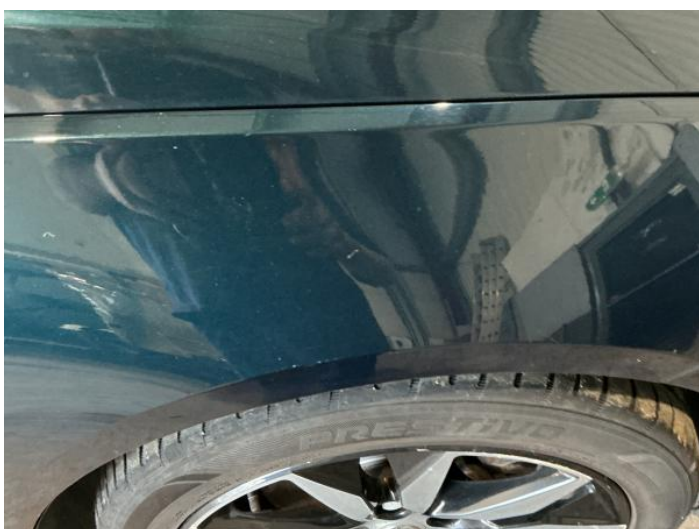
17: Wing osf
Chipped
1 To 5

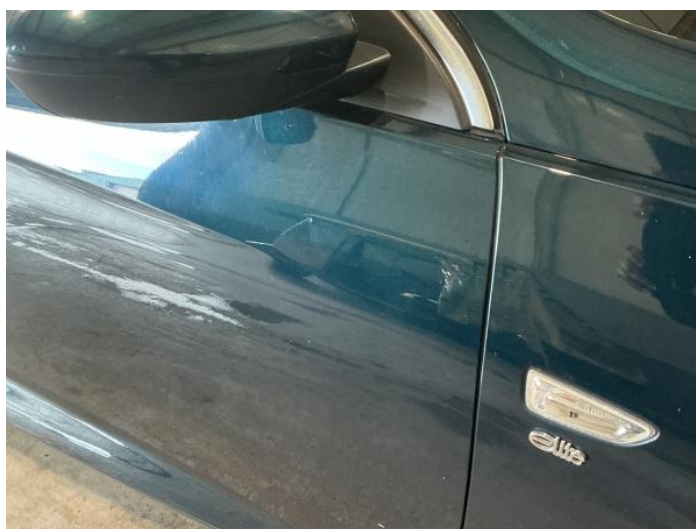
18: Door osf
Chipped
1 To 5

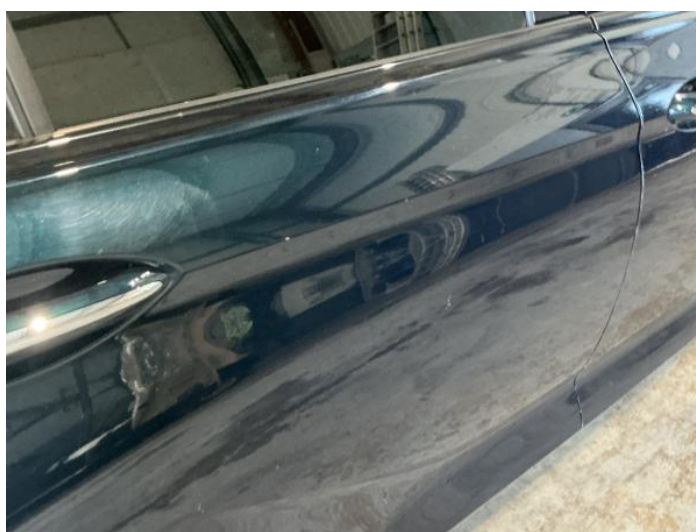
20: Door osr
Chipped
Multiple Chips

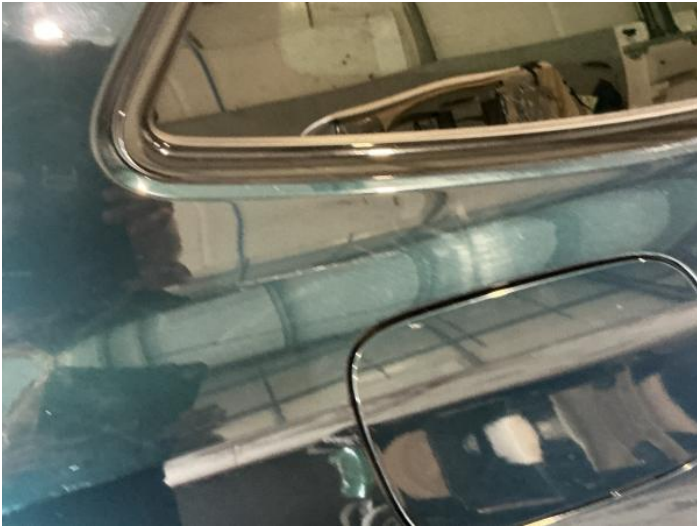
21: Qtr Panel osr
Scratched
Over 25mm Thru Paint

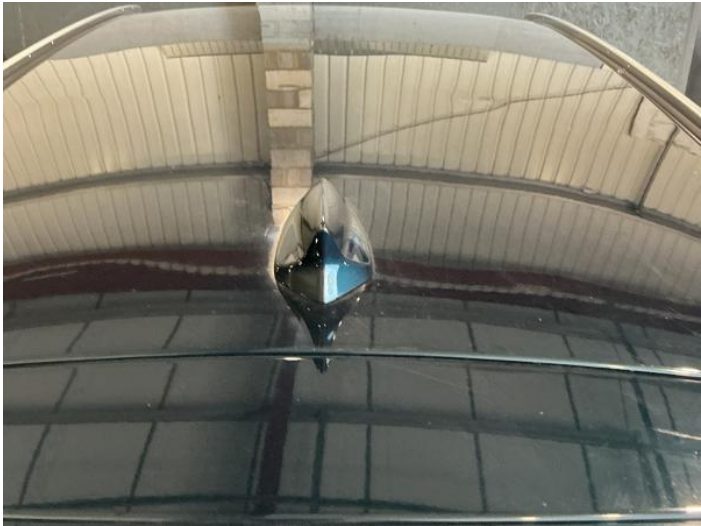
22: Roof
Dented
Over 30mm

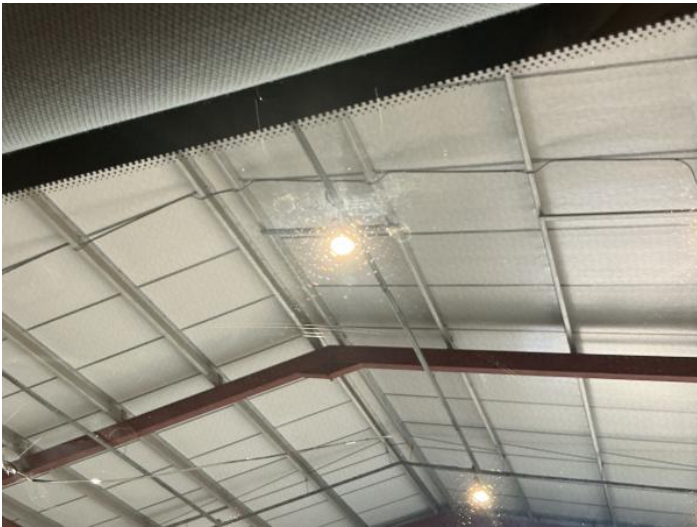
23: Screen Front
Cracked
Replace
