VEHICLE INSPECTION REPORT

GV64HXS

Ford Focus 1.0 EcoBoost Zetec 5dr

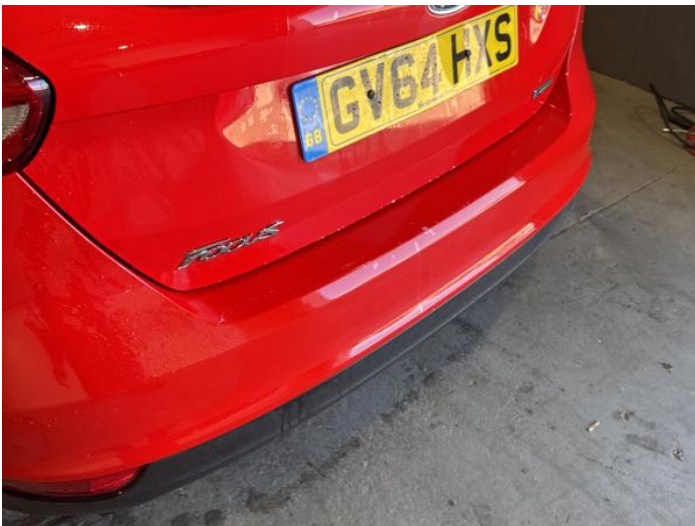
1: Bumper Rear
Chipped
Multiple Chips

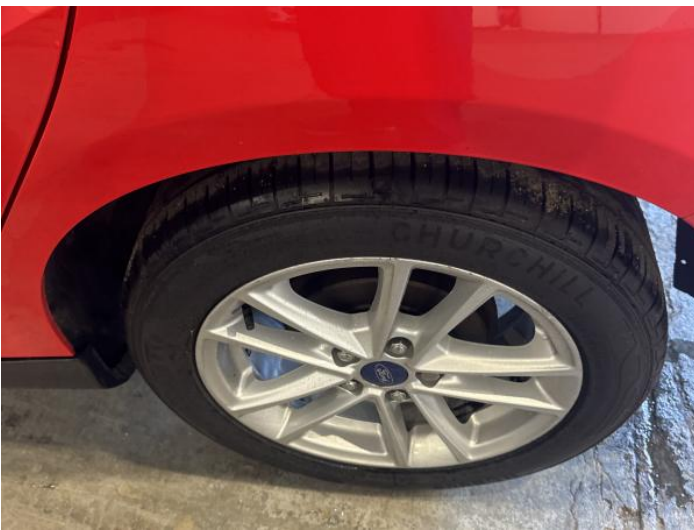
5: Wheel nsr
Scratched
Up To 50mm

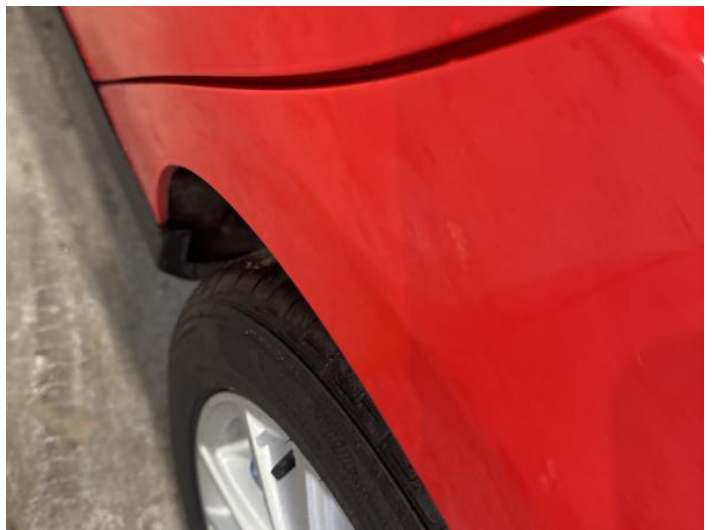
6: Qtr Panel nsr
Dented
Over 2 UpTo 10mm

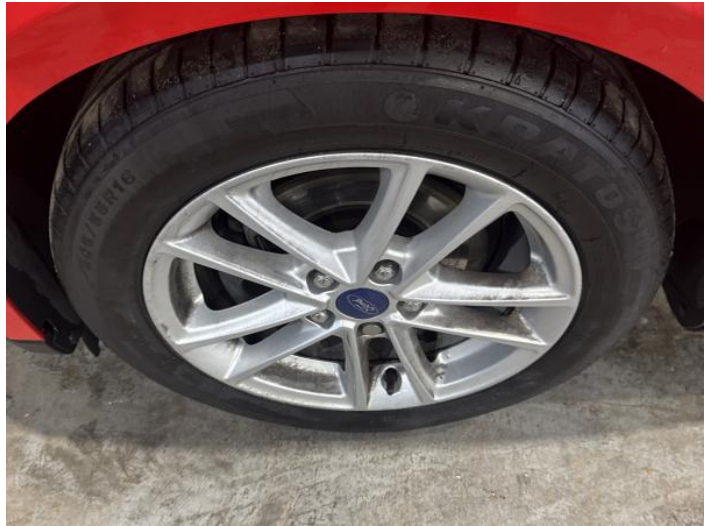
10: Wheel nsf
Scratched
Up To 50mm

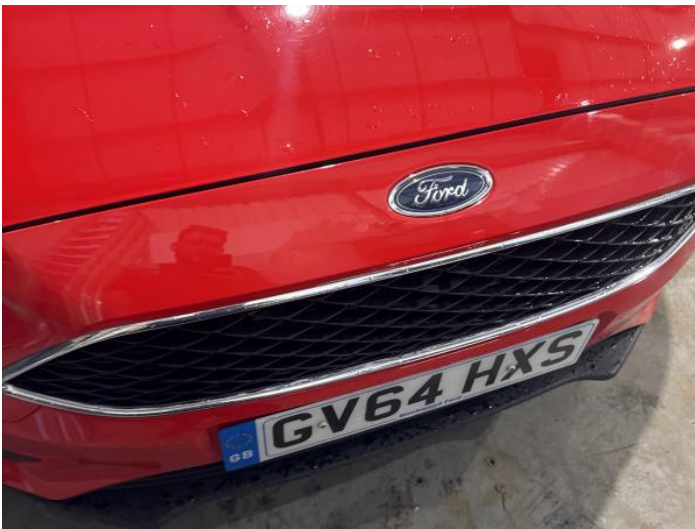
11: Bumper Front
Chipped
Multiple Chips

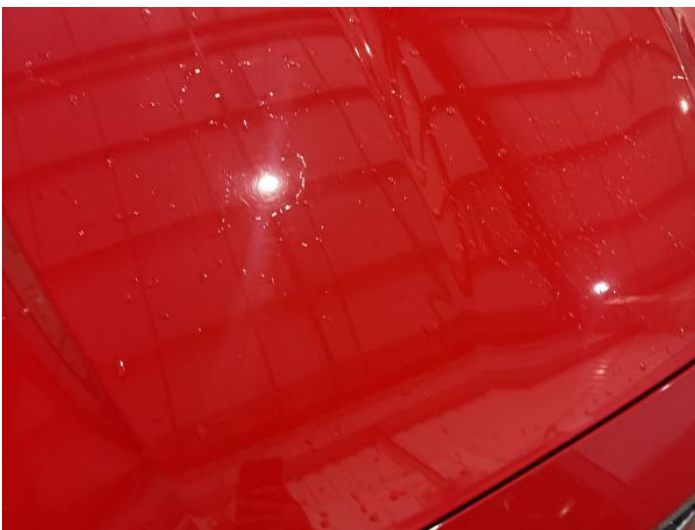
13: Bonnet
Chipped
1 To 5

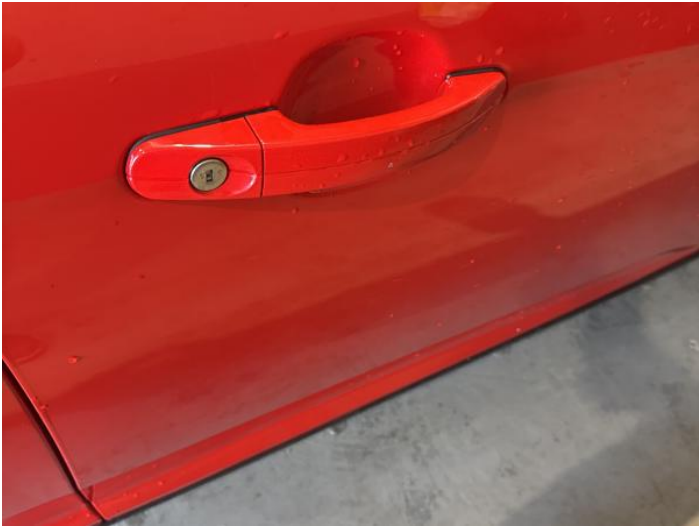
15: Door osf
Dented
Over 2 UpTo 10mm

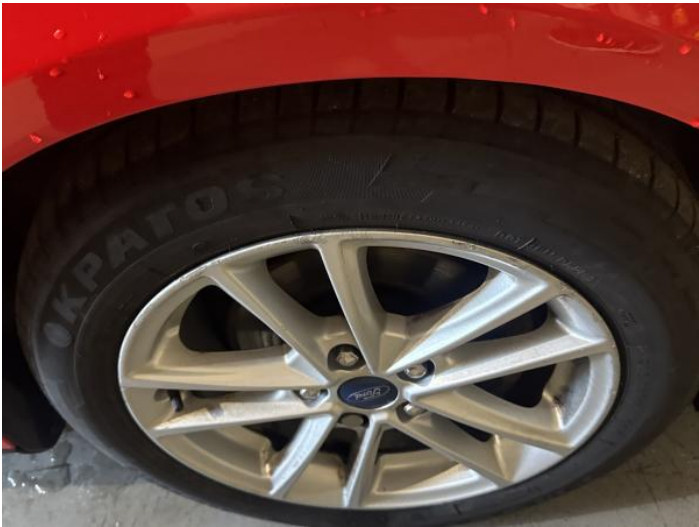
17: Wheel osf
Scratched
Over 50mm
