## **VEHICLE INSPECTION REPORT**

LR18NPN

### Toyota Prius 1.8 VVTi Business Edition Plus 5dr CVT

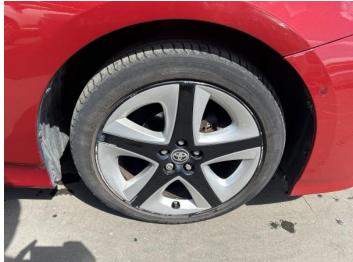
1: Wheel osf Scratched Over 50mm

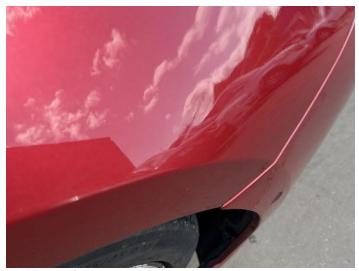
2: Wing osf Dented Between 10mm + 30mm

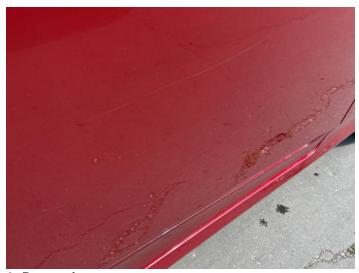
3: Door osf Scratched Over 25mm Not Thru Paint

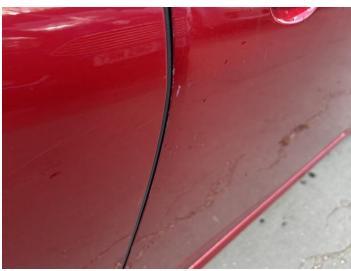
4: Door osf Chipped Edge Chip

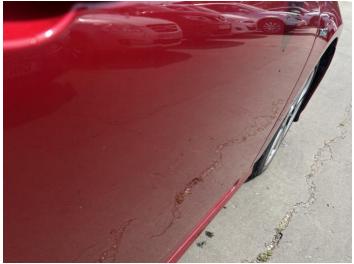
5: Door osf Dented Over 2 UpTo 10mm

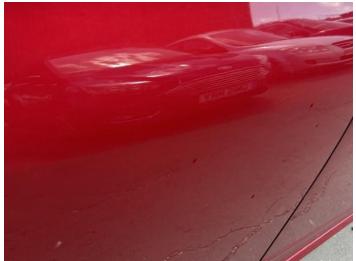
6: Door osr Scratched Over 25mm Not Thru Paint

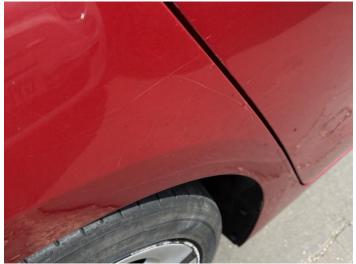
7: Qtr Panel osr Scratched Over 25mm Not Thru Paint

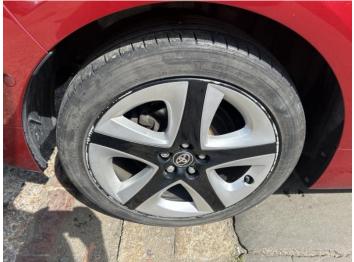
8: Wheel osr Scratched Over 50mm

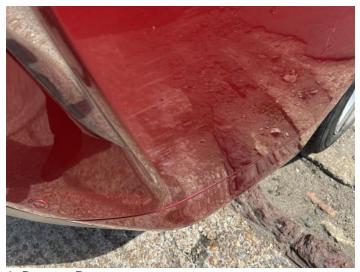
9: Bumper Rear Scratched 25 to 100mm Thru Paint

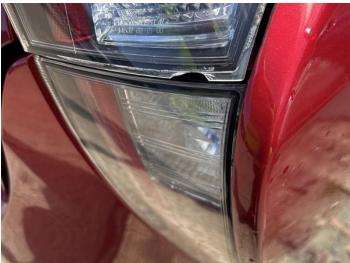
10: Lamp osr Broken Replace

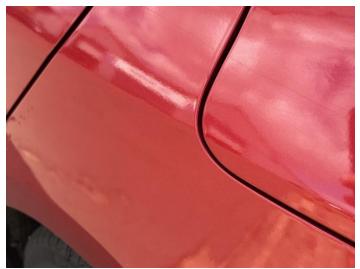
11: Qtr Panel nsr Poor Previous Repair Poor Paint

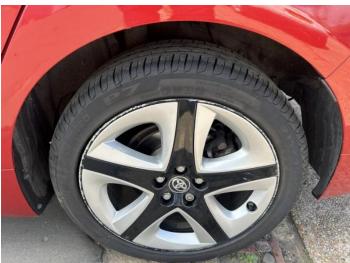
12: Wheel nsr Scratched Over 50mm

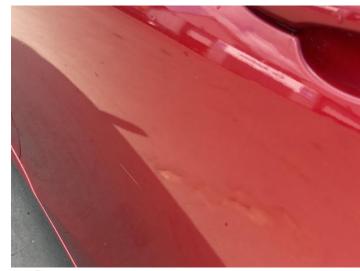
13: Door nsr Poor Previous Repair Poor Paint

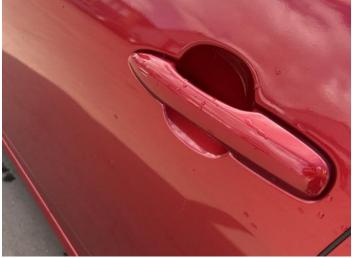
14: Door nsf Poor Previous Repair Poor Paint

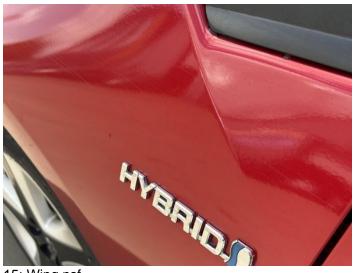
15: Wing nsf Poor Previous Repair Poor Paint

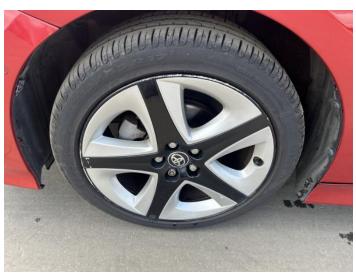
16: Wheel nsf Scratched Over 50mm

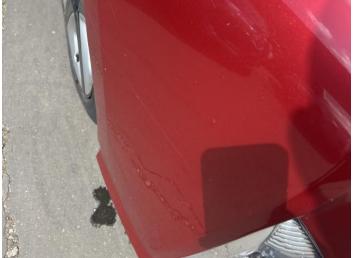
17: Bumper Front Scratched Over 25mm Not Thru Paint

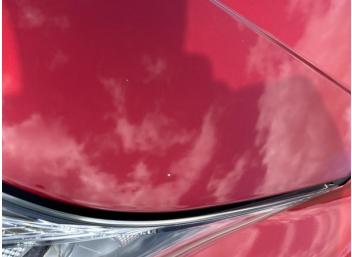
18: Bonnet Chipped 1 To 5

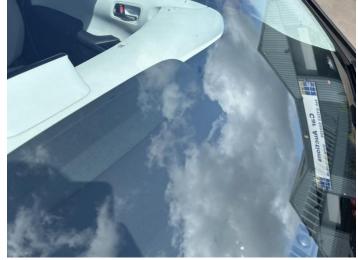
19: Screen Front Chipped UpTo 10mm
