VEHICLE INSPECTION REPORT

RO64XCC

Mazda 6 2.2d SE-L Nav 4dr

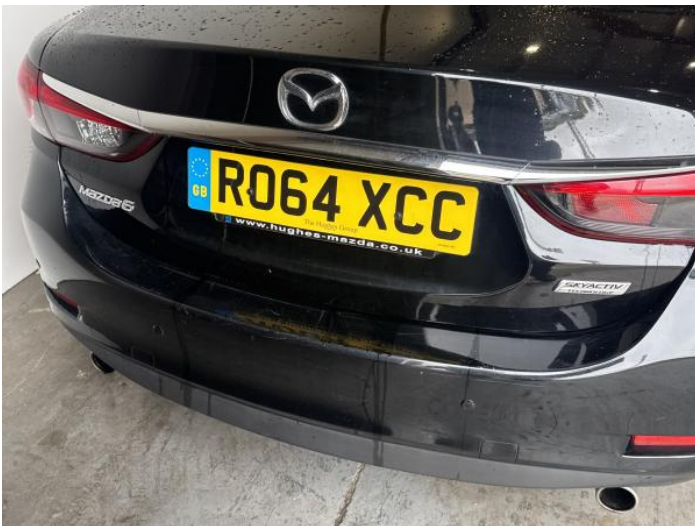
1: Bumper Rear
Scratched
Over 100mm Thru Paint

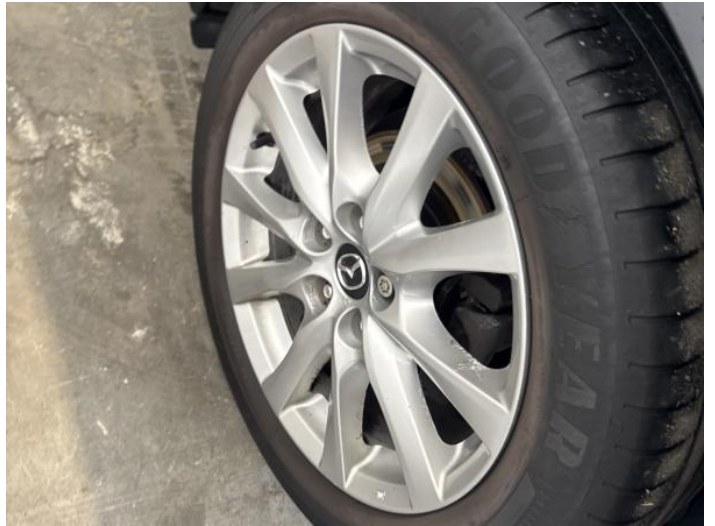
3: Qtr Panel nsr
Scratched
Over 25mm Not Thru Paint

4: Wheel nsr
Scratched
Up To 50mm

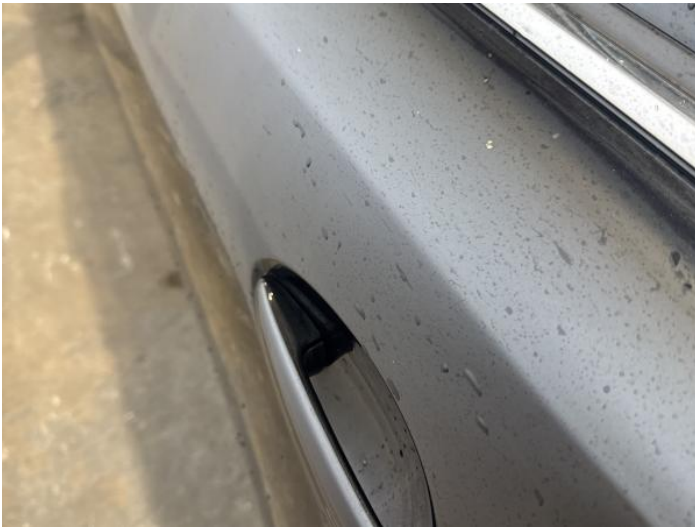
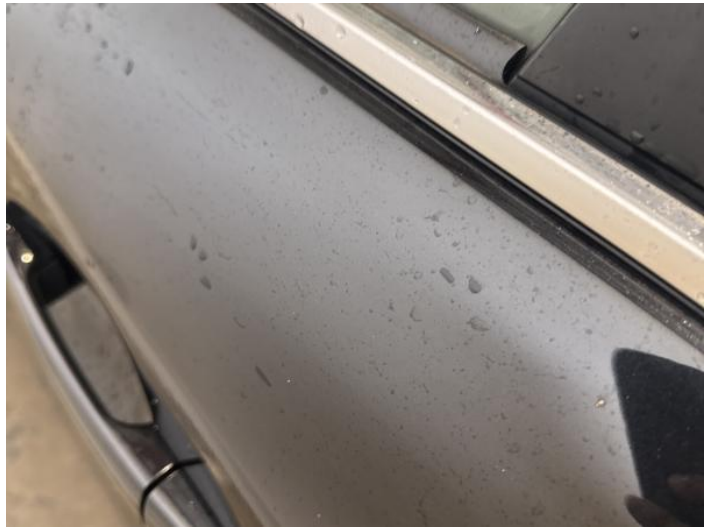
5: Door nsr
Poor Previous Repair
Poor Paint

6: Door nsf
Poor Previous Repair
Poor Paint

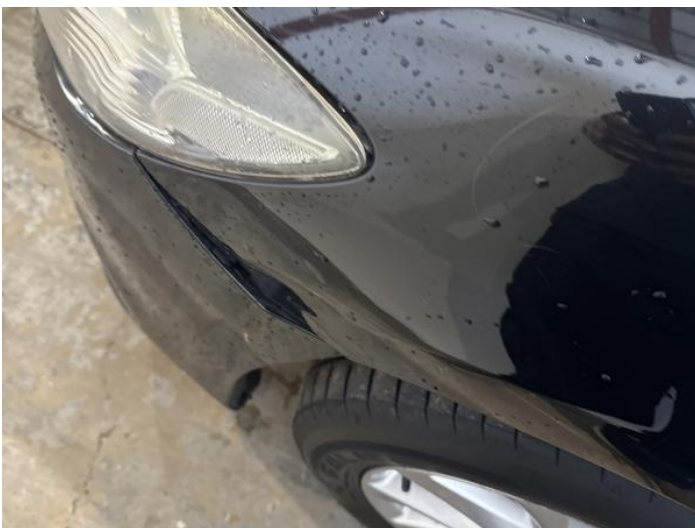
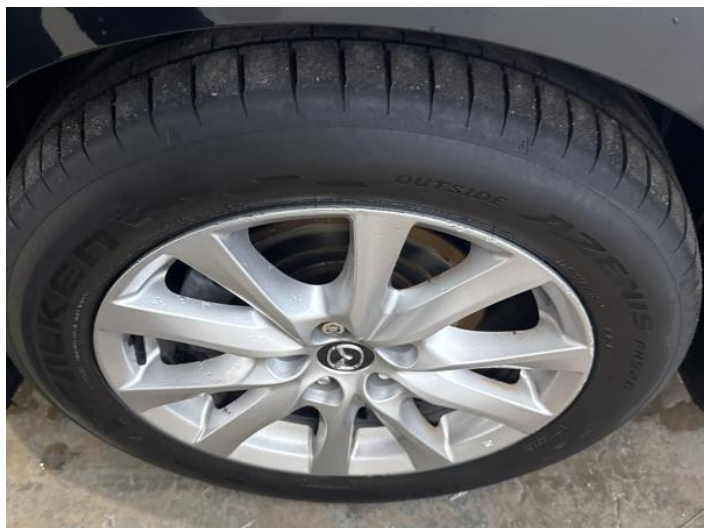
7: Wing nsf
Dented
Over 30mm

8: Wheel nsf
Scratched
Over 50mm

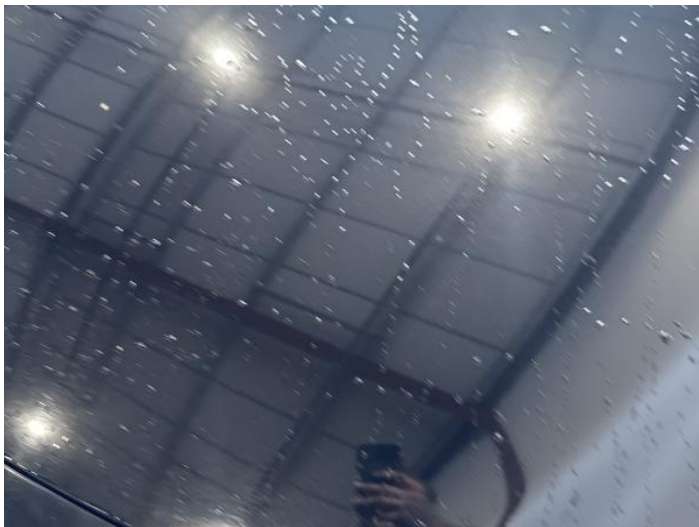
9: Bonnet
Chipped
1 To 5

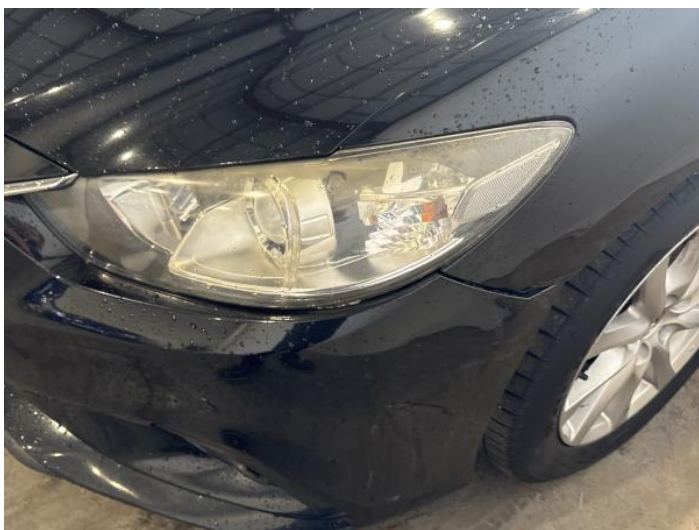
11: Bumper Front
Scratched
25 to 100mm Thru Paint

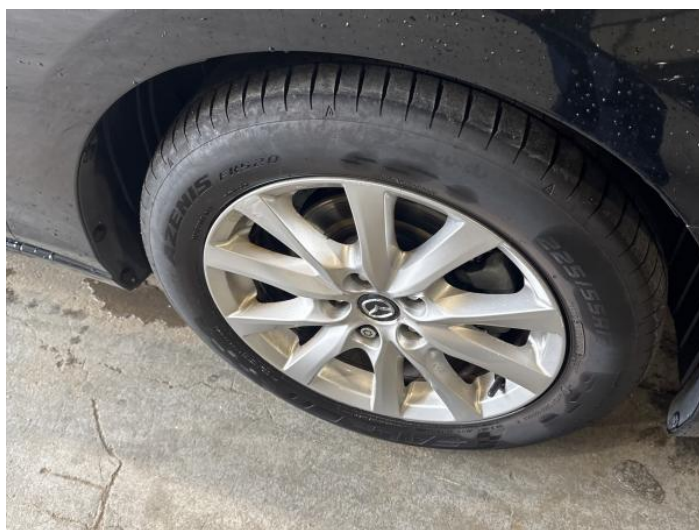
14: Wheel osf
Scratched
Over 50mm

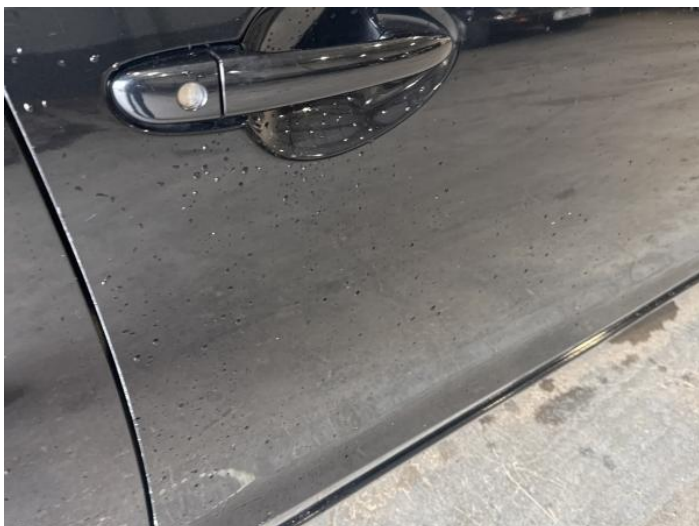
15: Door osf
Chipped
1 To 5

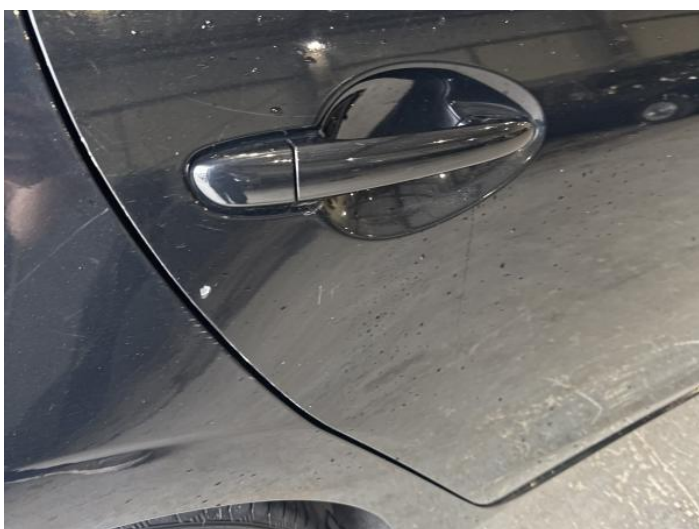
17: Door osr
Chipped
1 To 5

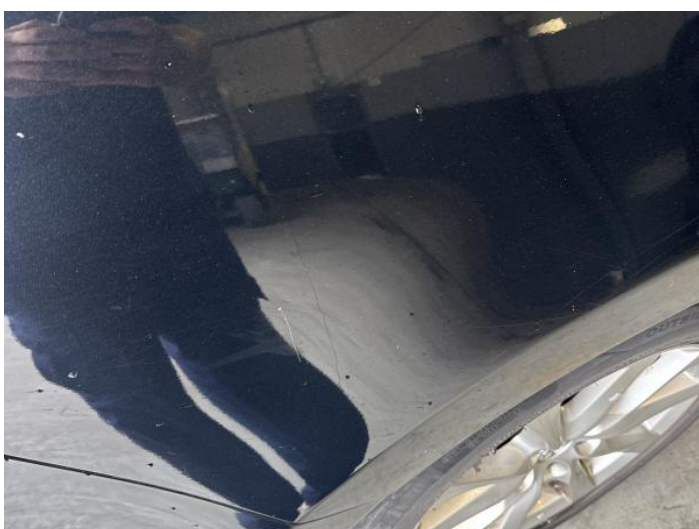
19: Qtr Panel osr
Poor Previous Repair
Poor Paint

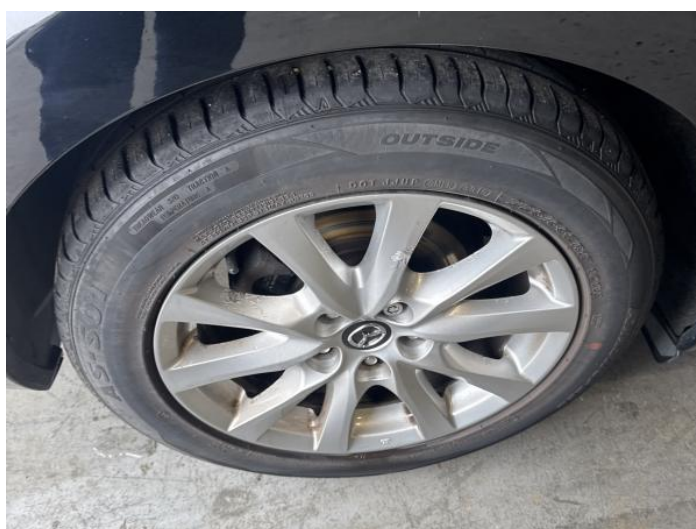
20: Wheel osr
Scratched
Over 50mm
