VEHICLE INSPECTION REPORT

GV14NVB

Toyota Aygo 1.0 VVT-i X-Pression 5dr

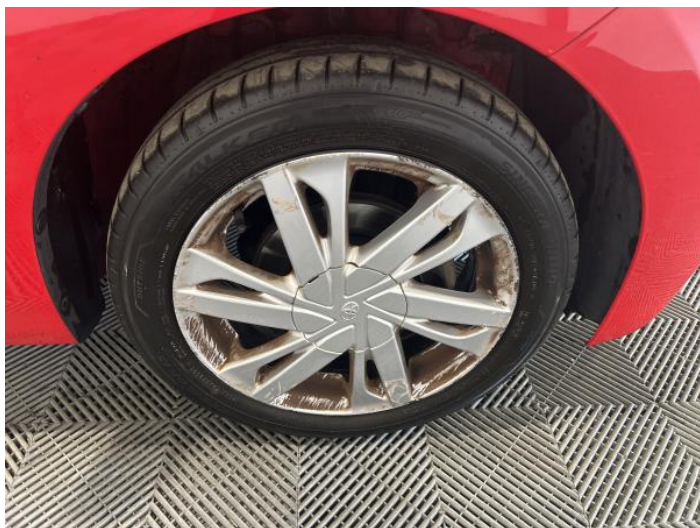
1: Wheel osf
Scratched
Over 50mm

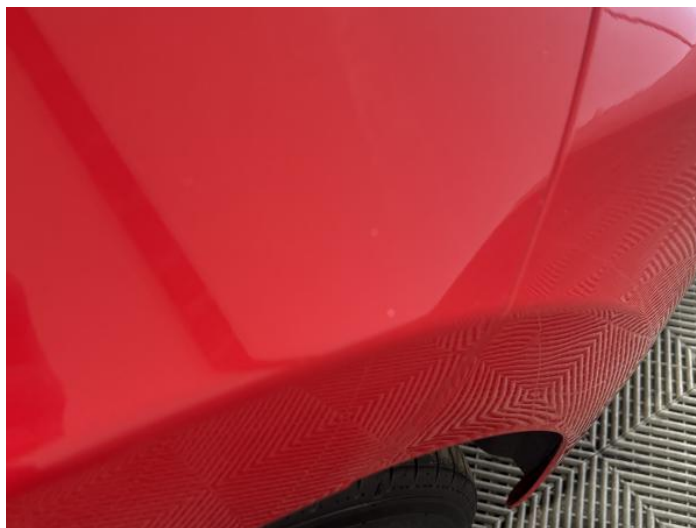
2: Wing osf
Chipped
1 To 5

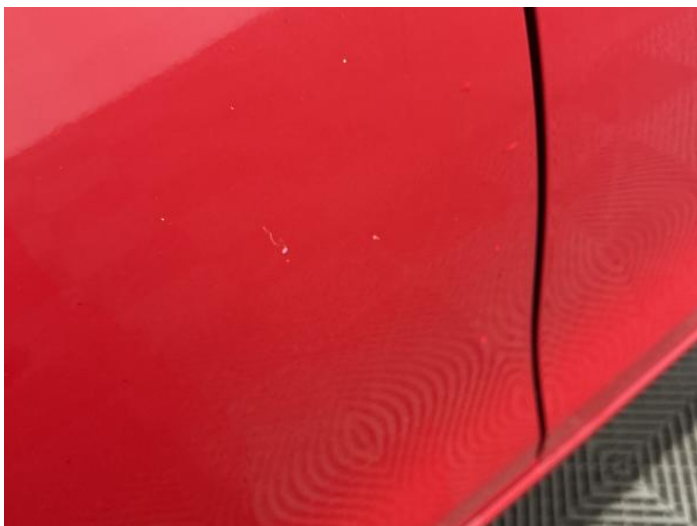
4: Door osr
Chipped
1 To 5

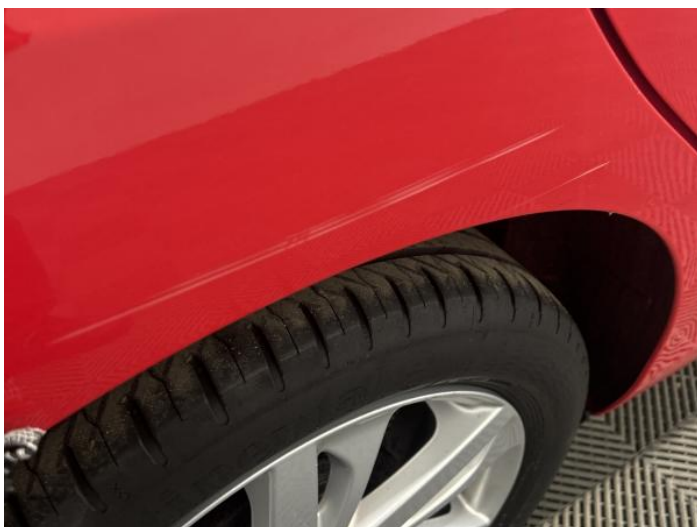
6: Qtr Panel osr
Scratched
Over 25mm Thru Paint

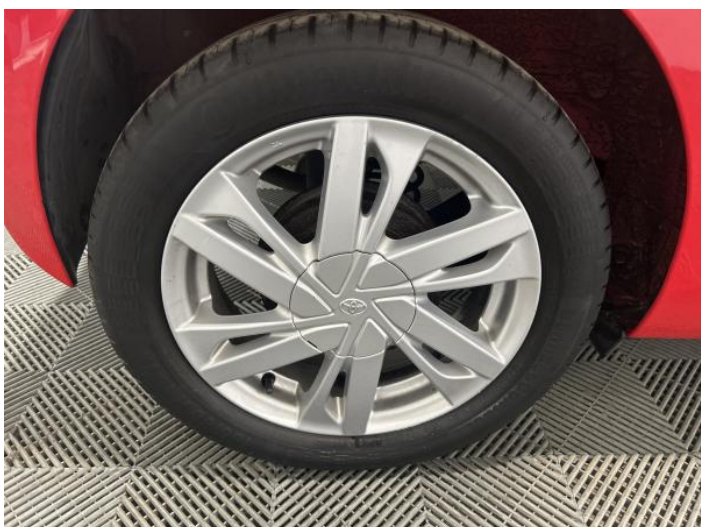
7: Wheel osr
Scratched
Up To 50mm

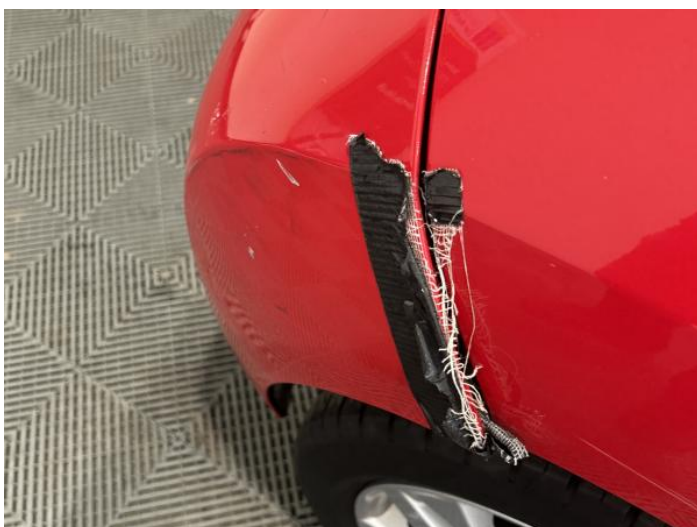
8: Bumper Rear
Insecure
Action Required

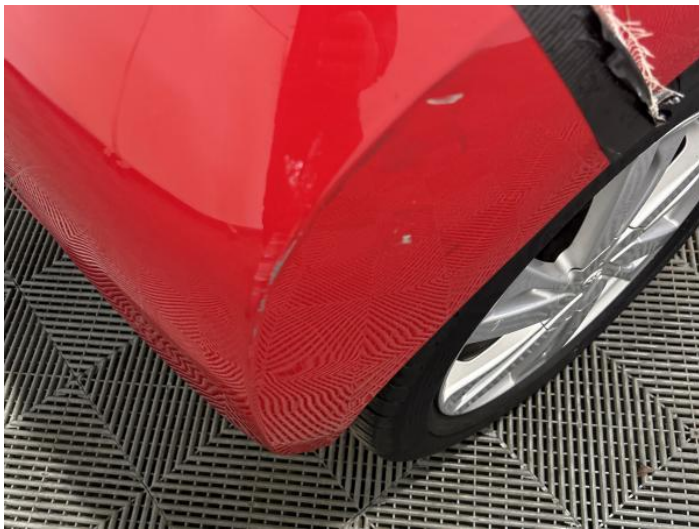
9: Bumper Rear
Scratched
25 to 100mm Thru Paint

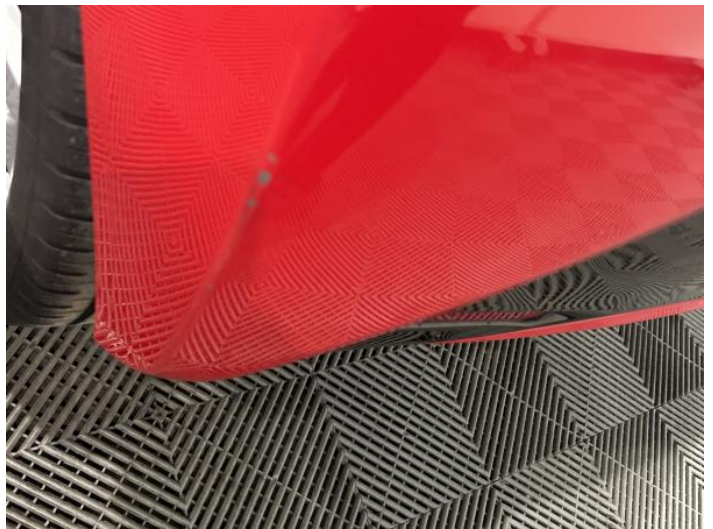
10: Bumper Rear
Chipped
1 To 5

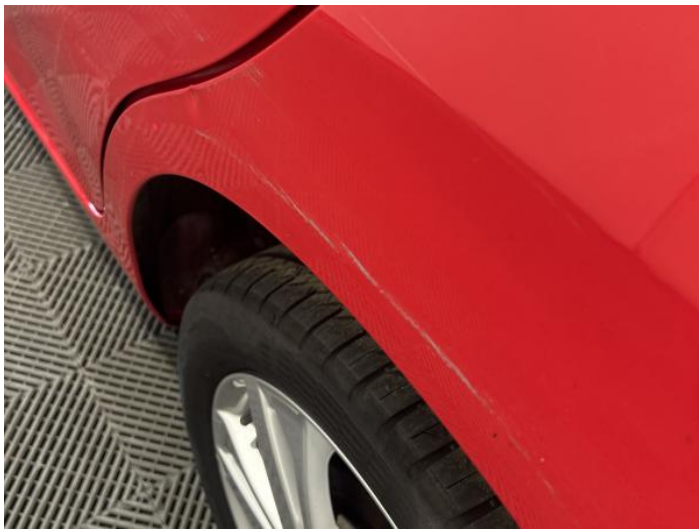
11: Qtr Panel nsr
Dented
With Paint Damage

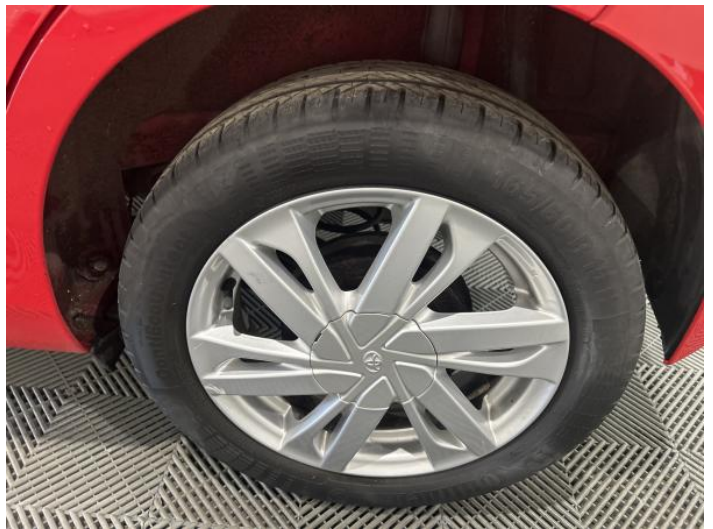
12: Wheel nsr
Scratched
Up To 50mm

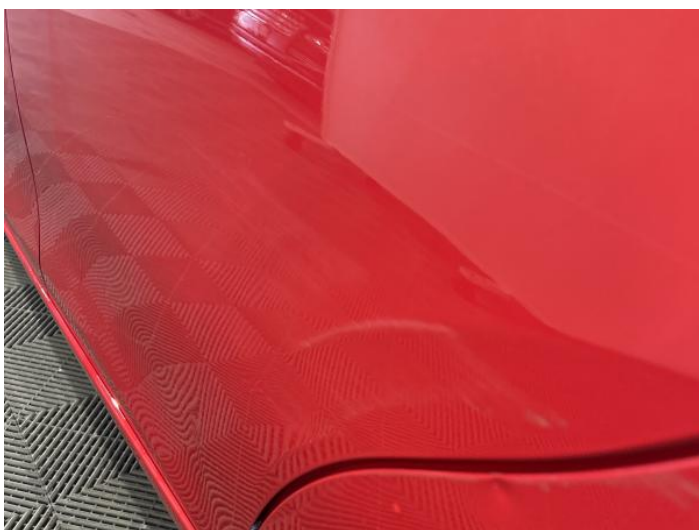
13: Door nsr
Dented
With Paint Damage

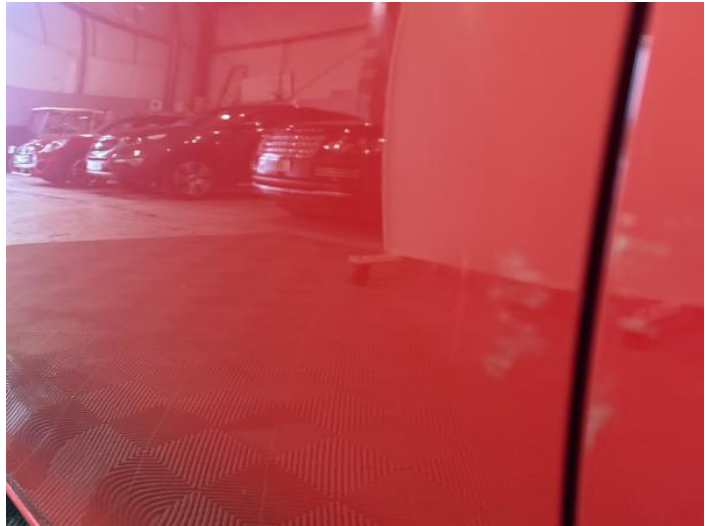
16: Door nsf
Scratched
Over 25mm Not Thru Paint

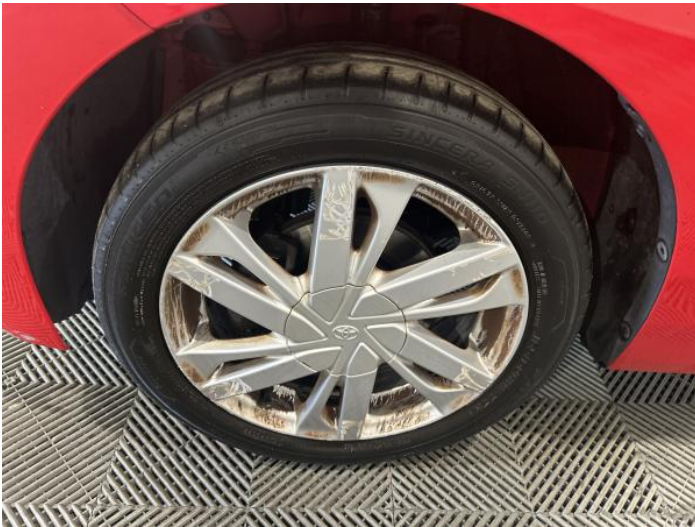
17: Wheel nsf
Scratched
Over 50mm

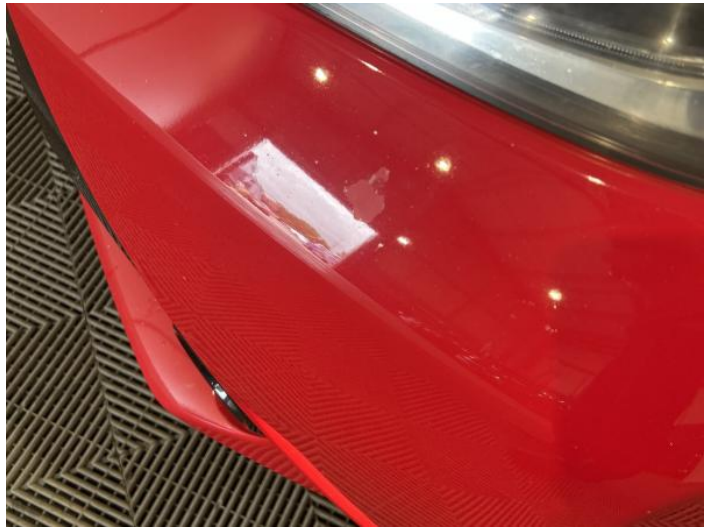
18: Bumper Front
Poor Previous Repair
Paint Flake

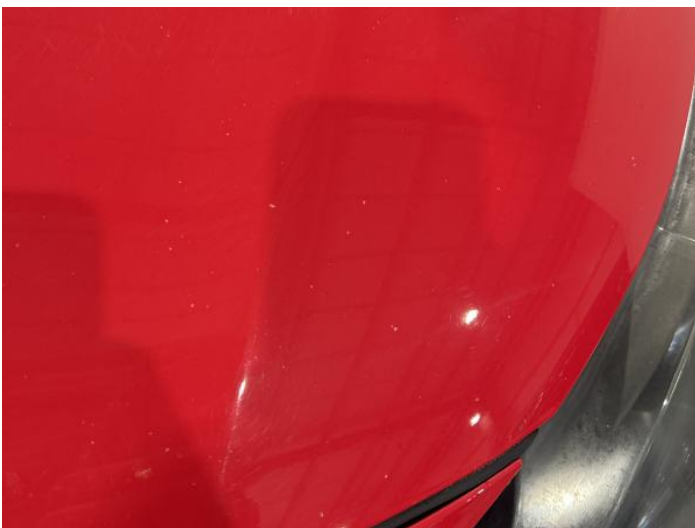
19: Bonnet
Chipped
Multiple Chips

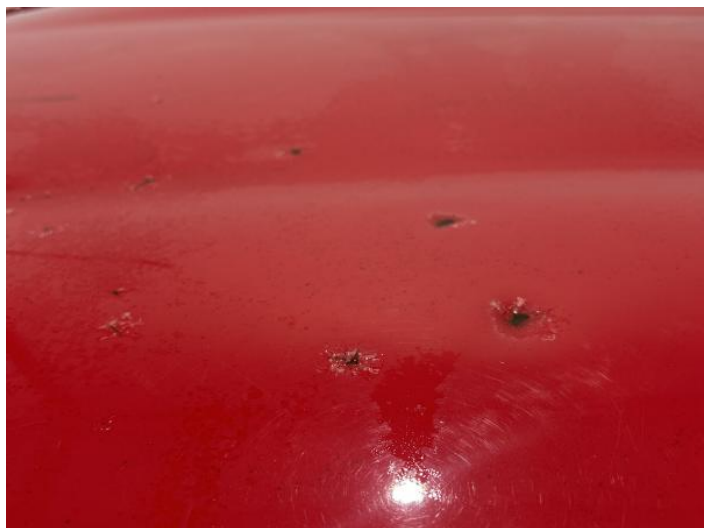
20: Roof
Dented
With Paint Damage

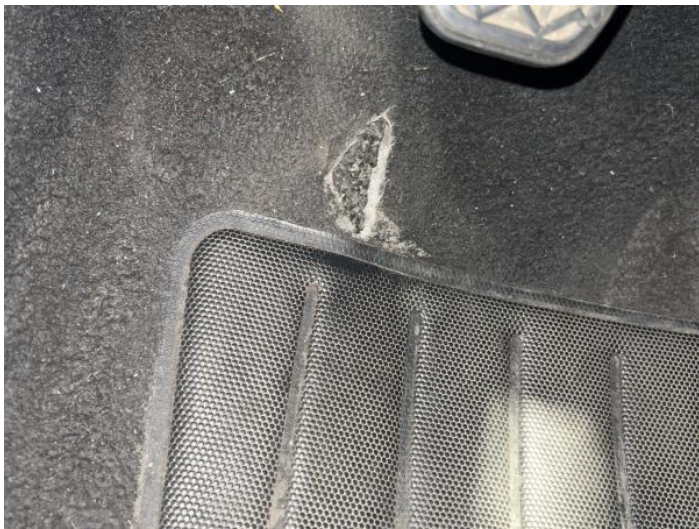
21: Carpets Front
Holed
UpTo 3mm
