VEHICLE INSPECTION REPORT

GX15YWZ

Mazda 3 2.2d Sport Nav 5dr

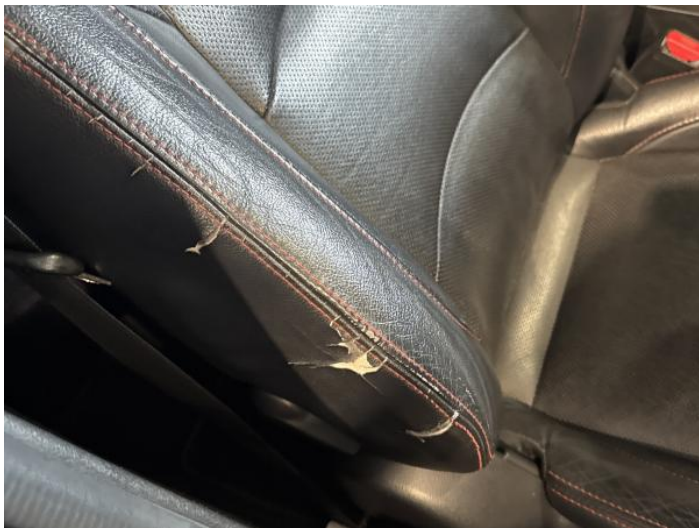
1: Seat Back Cover osf
Torn
Over 3mm

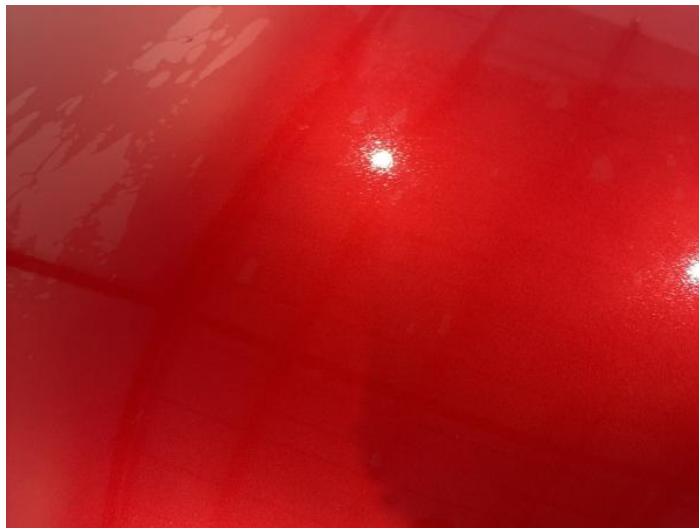
2: Bonnet
Chipped
1 To 5

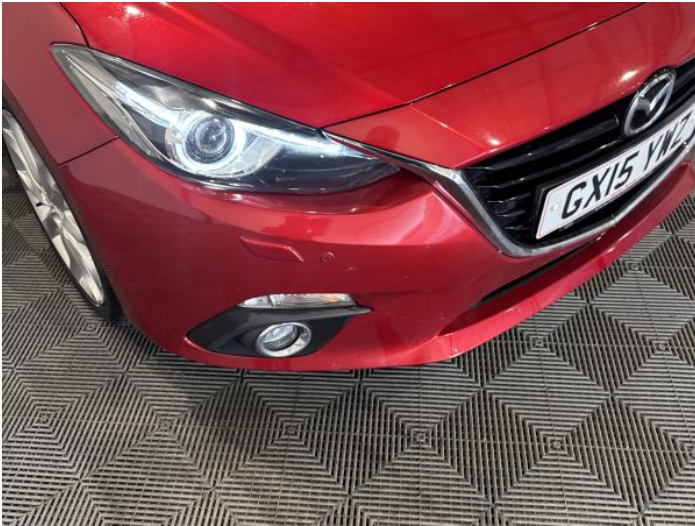
3: Bumper Front
Poor Previous Repair
Poor Paint

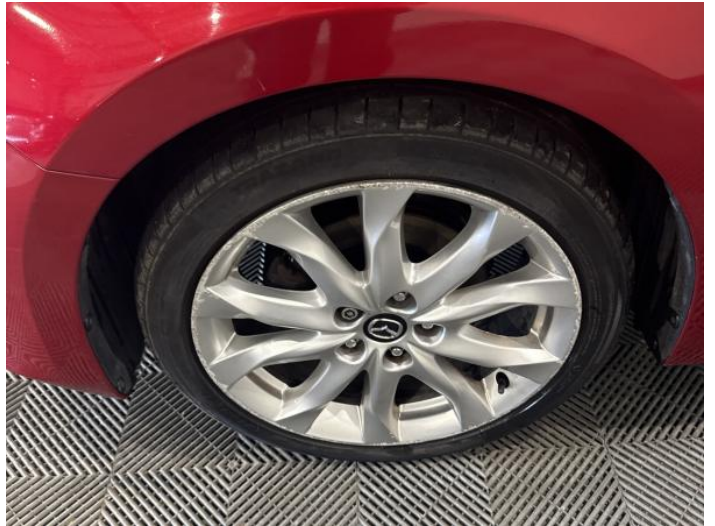
4: Wheel nsf
Scratched
Over 50mm

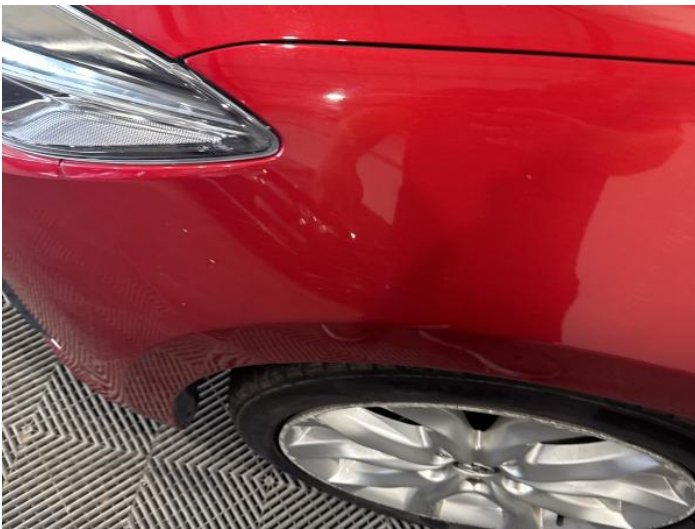
5: Wing nsf
Chipped
1 To 5

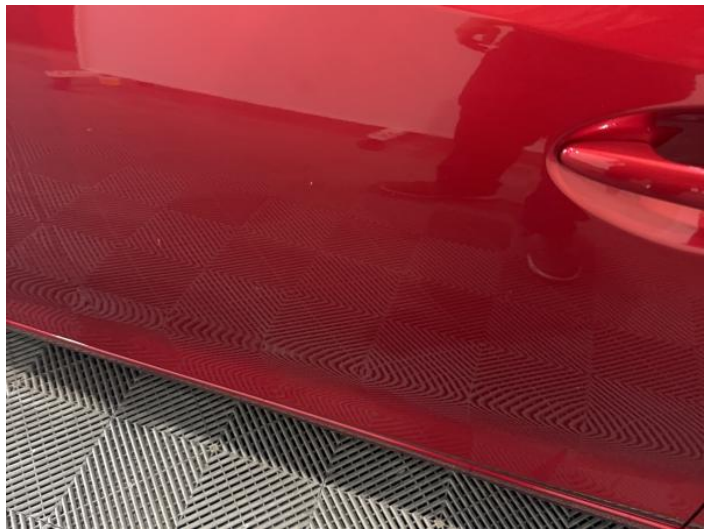
6: Door nsf
Chipped
1 To 5

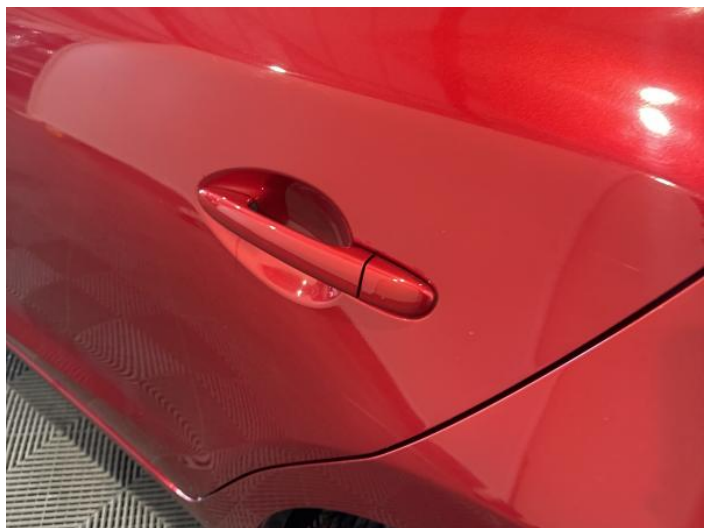
8: Door nsr
Chipped
1 To 5

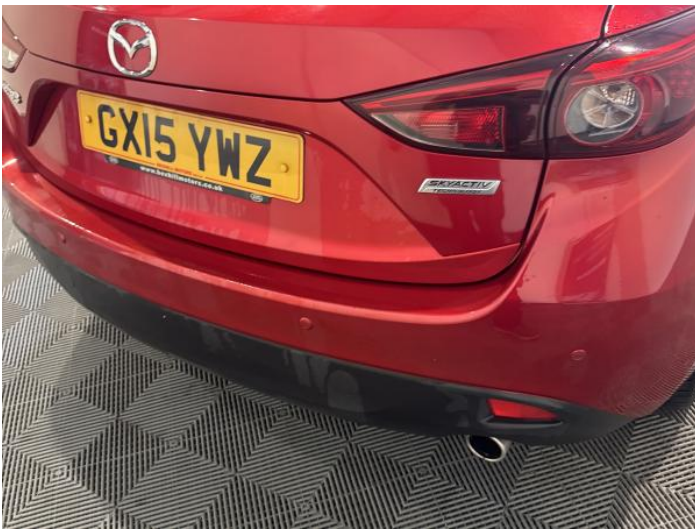
11: Bumper Rear
Scratched
25 to 100mm Thru Paint

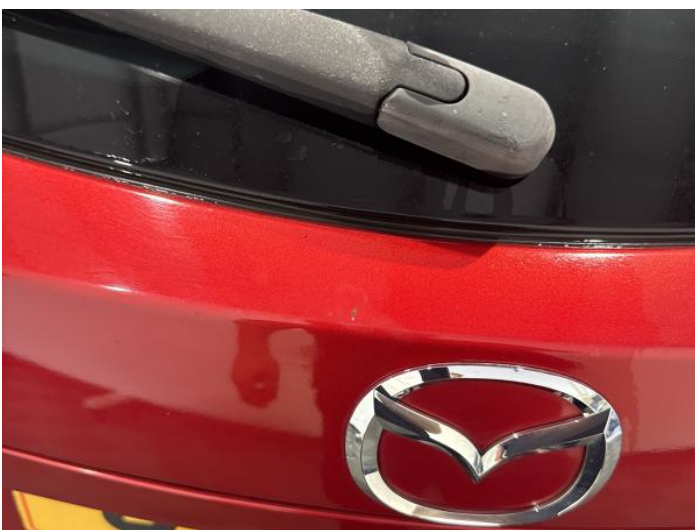
13: Boot Lid
Chipped
1 To 5

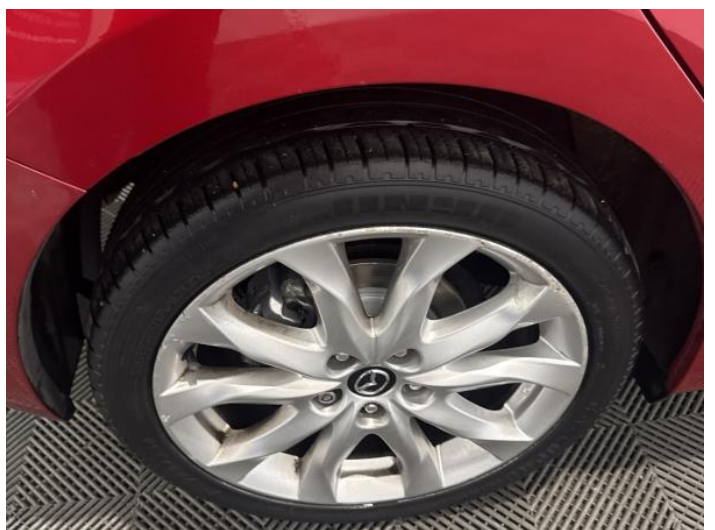
14: Wheel osr
Scratched
Over 50mm

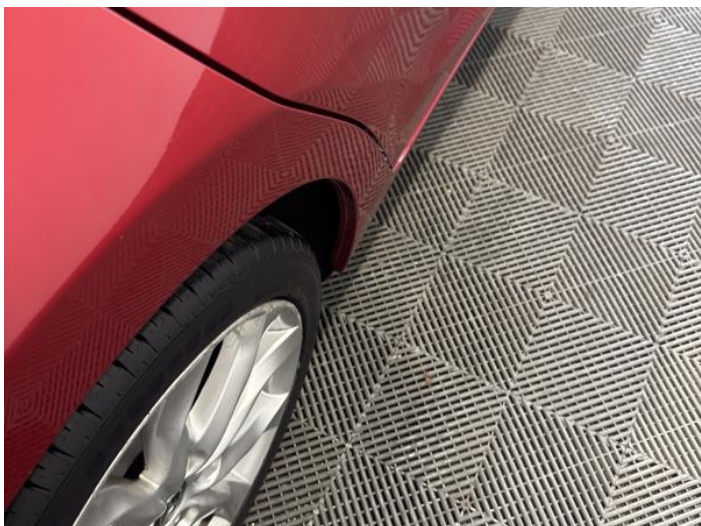
15: Qtr Panel osr
Dented
Between 10mm + 30mm

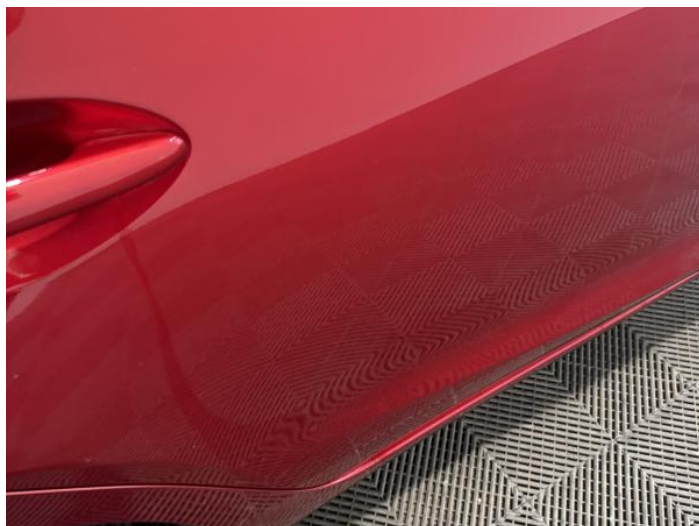
16: Door osr
Chipped
1 To 5

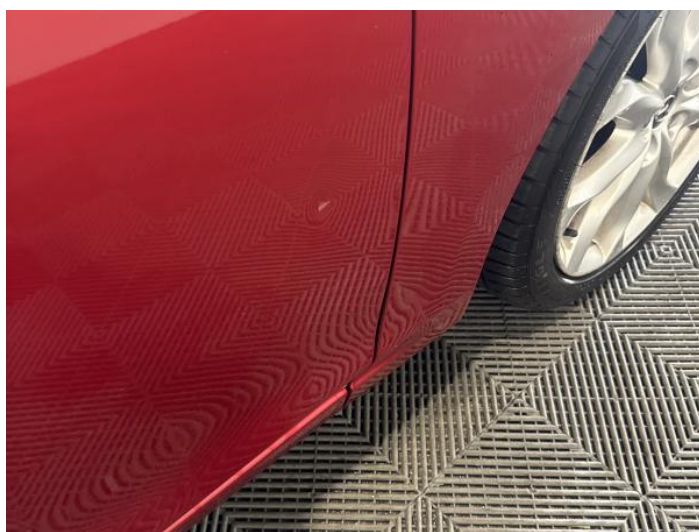
18: Door osf
Dented
Between 10mm + 30mm

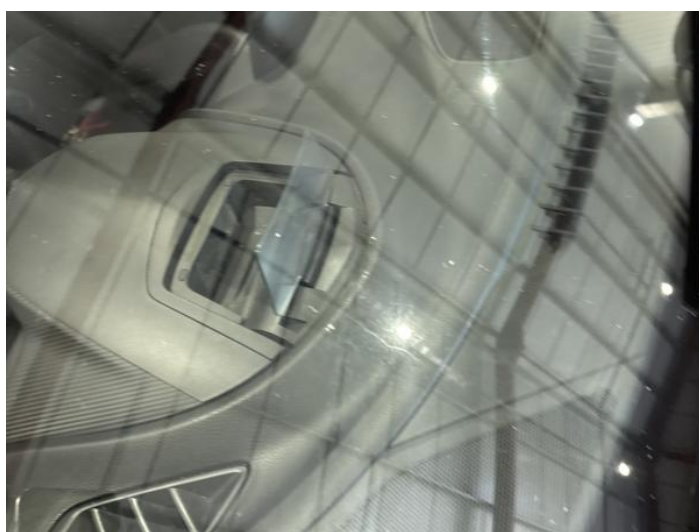
20: Screen Front
Chipped
UpTo 10mm
