VEHICLE INSPECTION REPORT

PO12WHA

Volkswagen Passat 2.0 TDI 170 Bluemotion Tech Sport 5dr

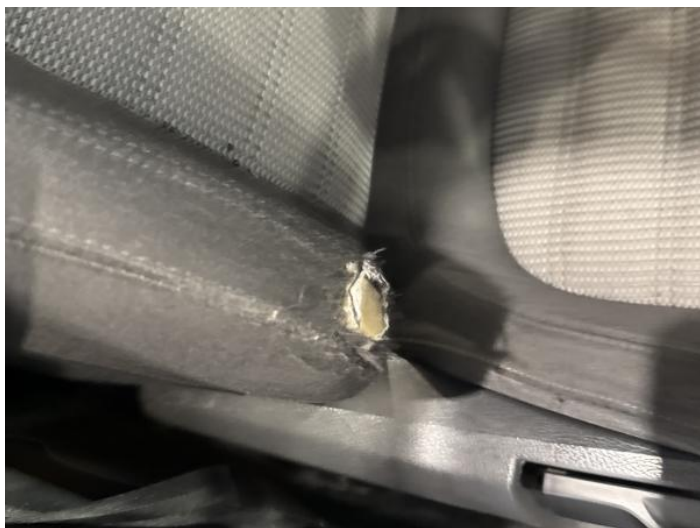
1: Seat Back Cover osf
Torn
Over 3mm

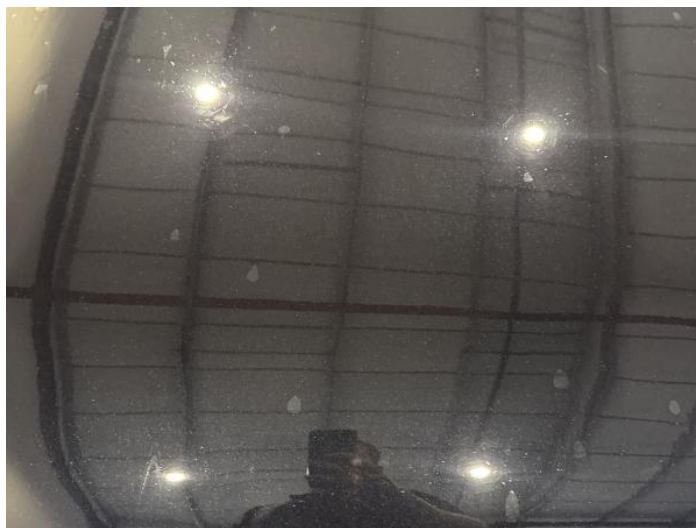
2: Bonnet
Chipped
1 To 5

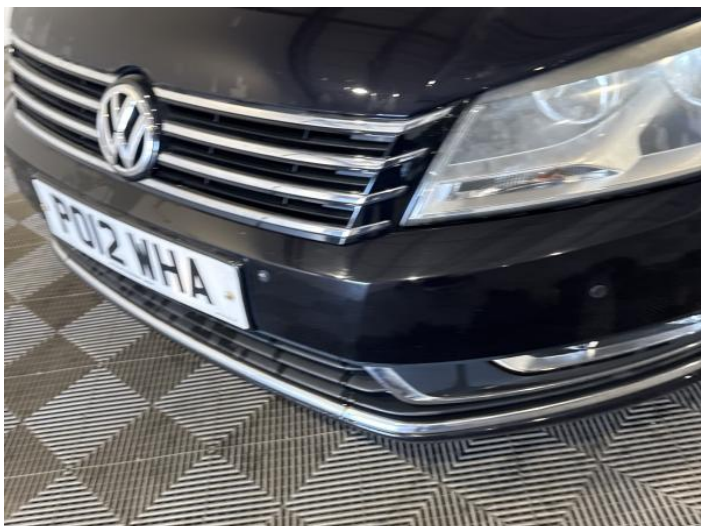
3: Bumper Front
Chipped
Multiple Chips

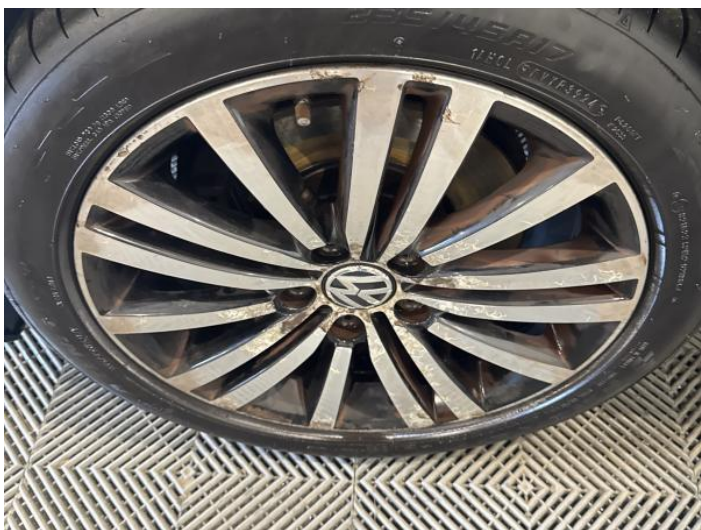
5: Wheel nsf
Scratched
Over 50mm

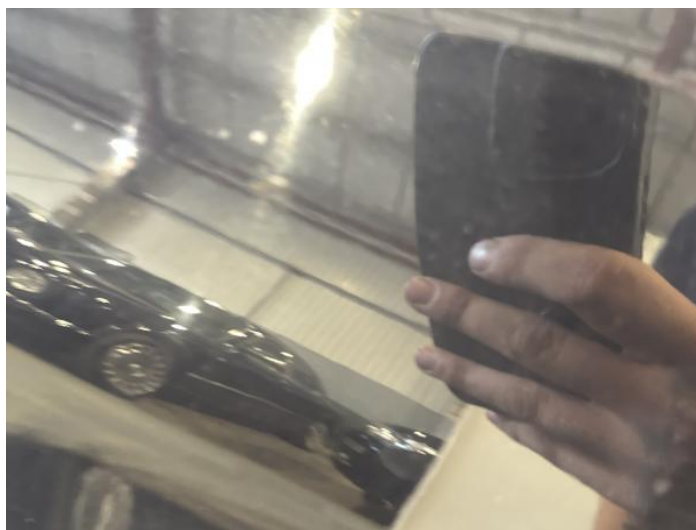
6: Wing nsf
Chipped
1 To 5

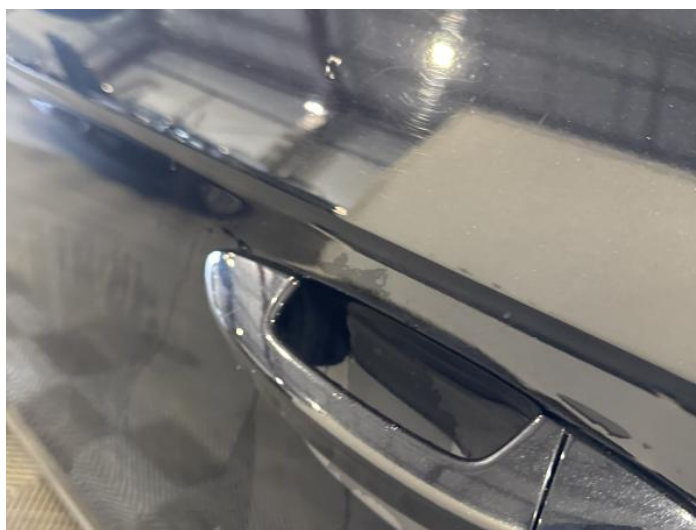
8: Door nsf
Chipped
1 To 5

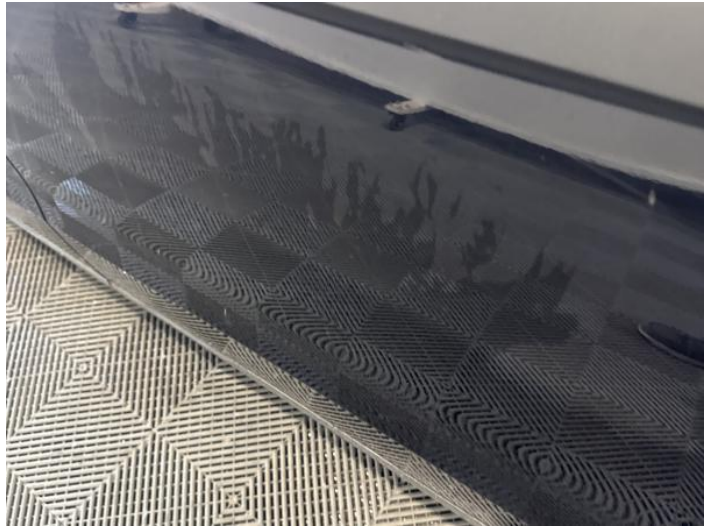
10: Door nsr
Chipped
1 To 5

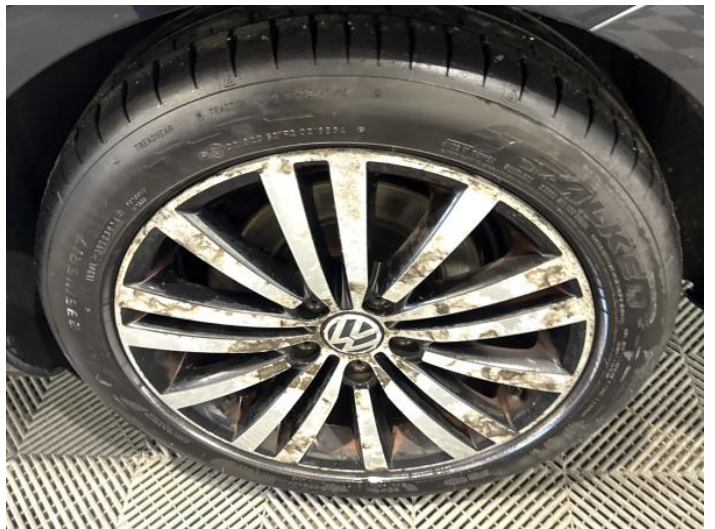
12: Wheel nsr
Scratched
Over 50mm

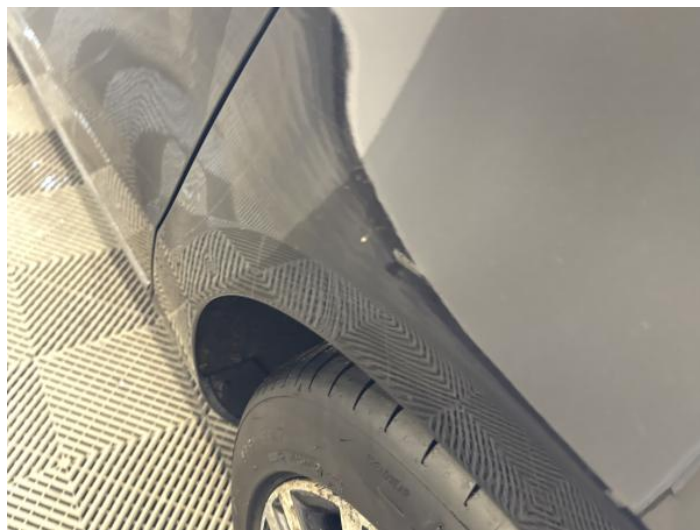
13: Qtr Panel nsr
Dented
Over 2 UpTo 10mm

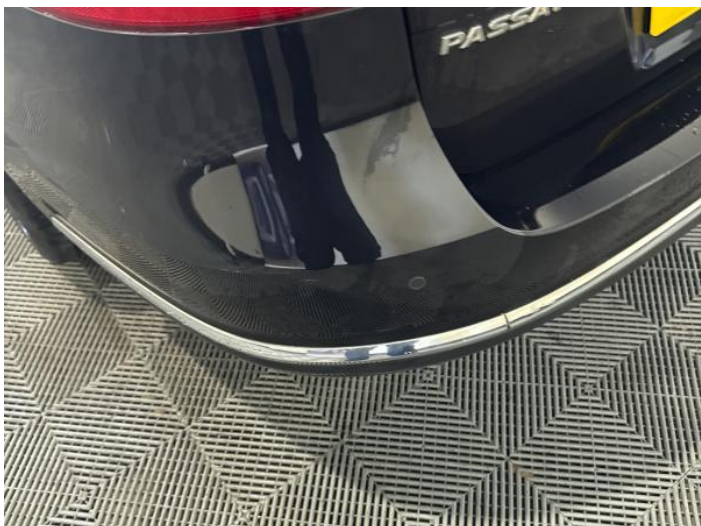
15: Bumper Rear
Scratched
25 to 100mm Thru Paint

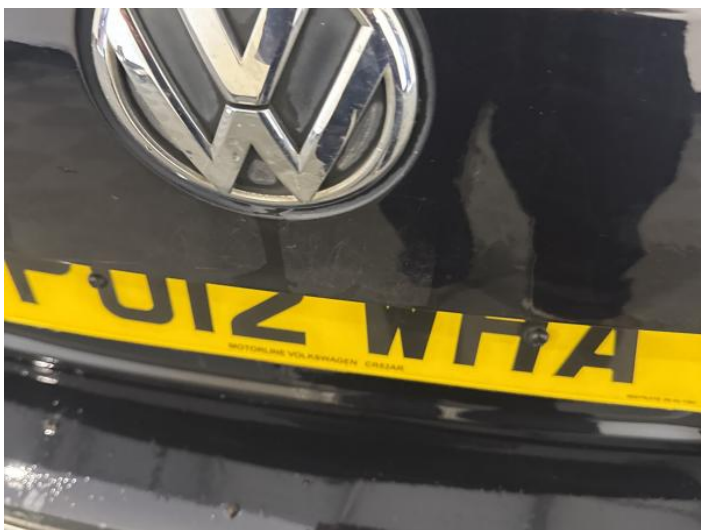
17: Boot Lid
Dented
Between 10mm + 30mm

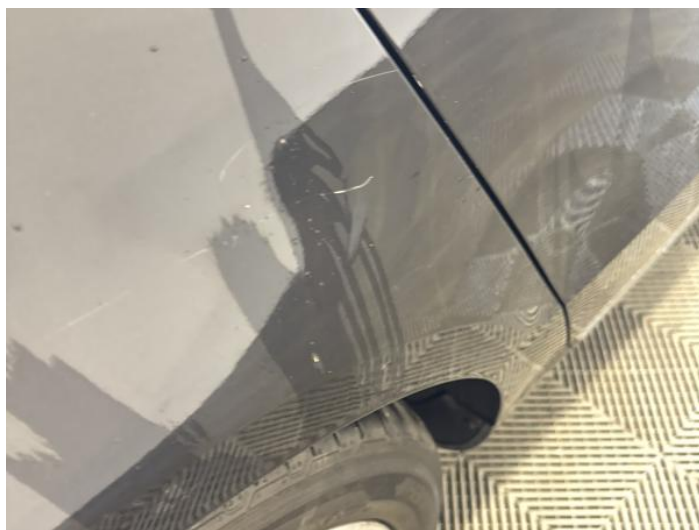
18: Qtr Panel osr
Scratched
UpTo 25mm Thru Paint

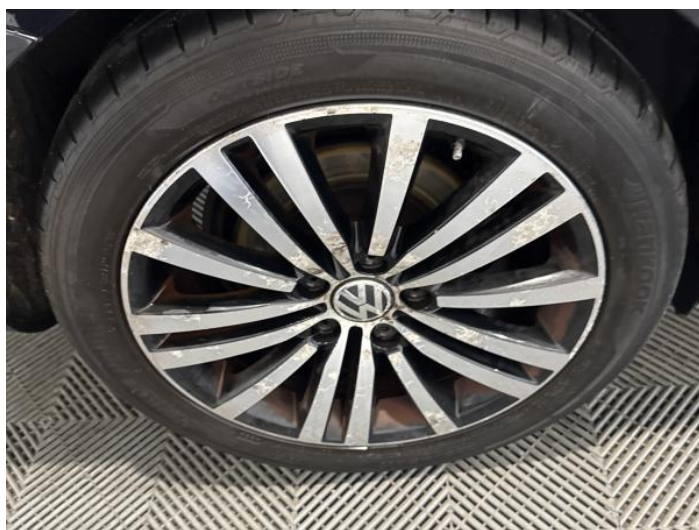
20: Wheel osr
Scratched
Over 50mm

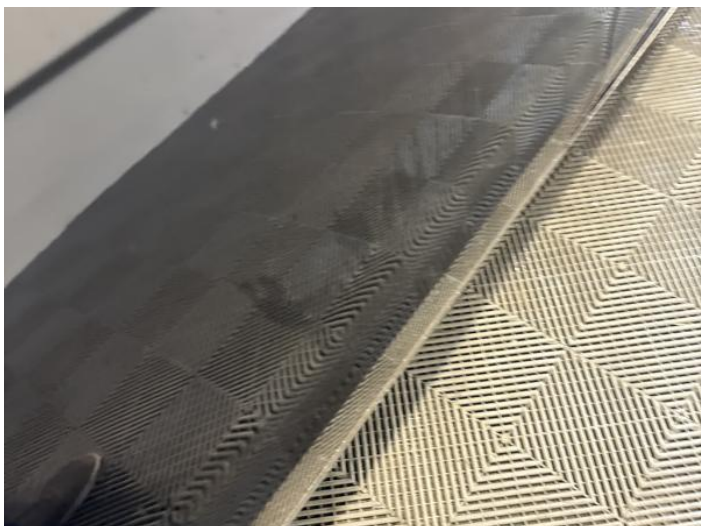
21: Door osr
Chipped
1 To 5

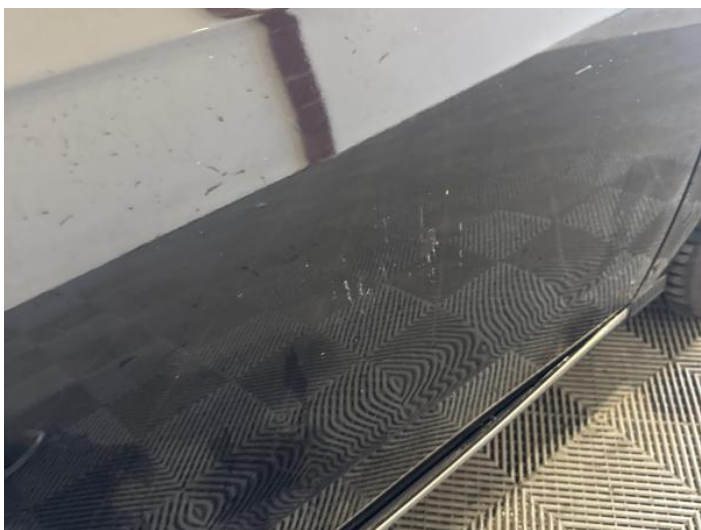
23: Door osf
Chipped
Multiple Chips

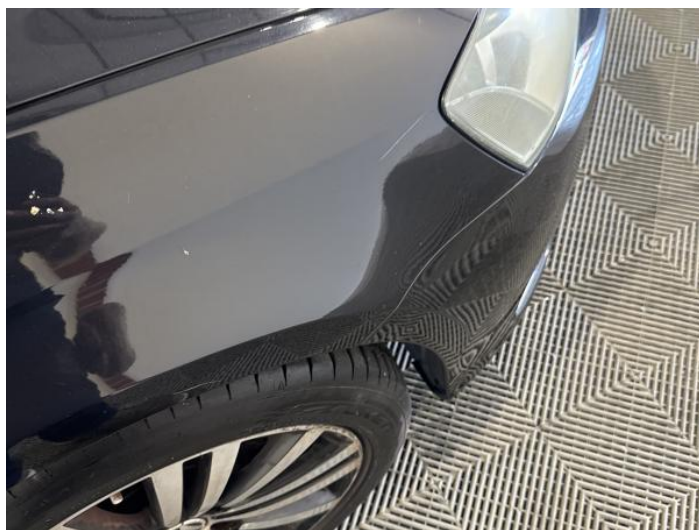
24: Wing osf
Scratched
Over 25mm Thru Paint

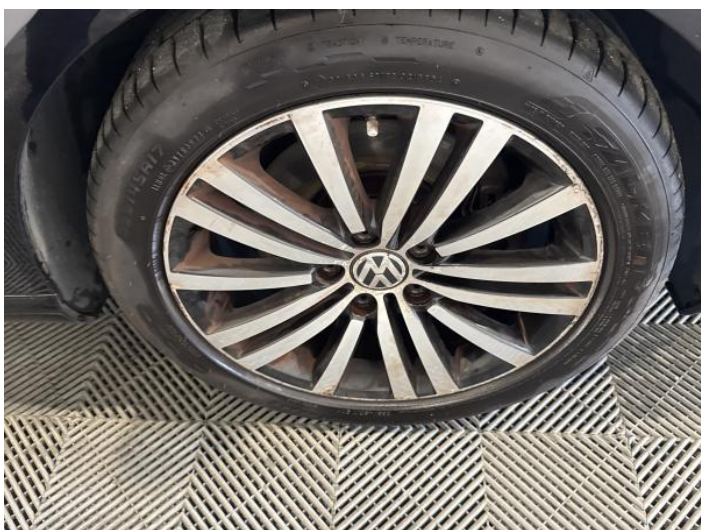
25: Wheel osf
Scratched
Over 50mm
