# VEHICLE INSPECTION REPORT

**BK59XUX**

## Volkswagen Polo 1.2 70 SE 5dr

nama  
GRADE  
3

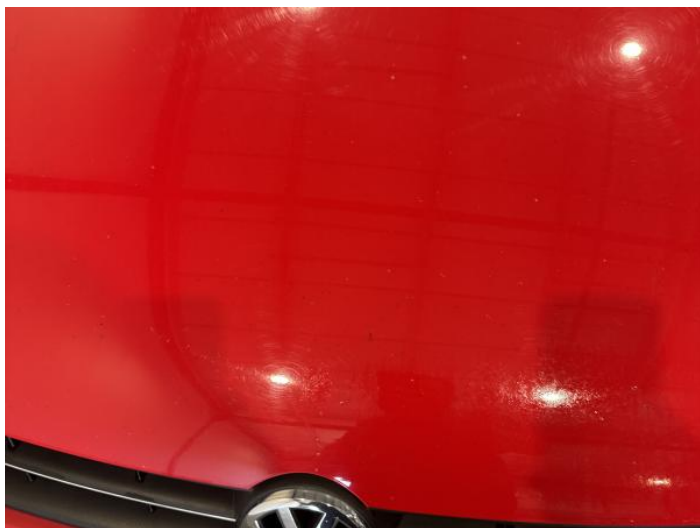
1: Bonnet  
Chipped  
1 To 5

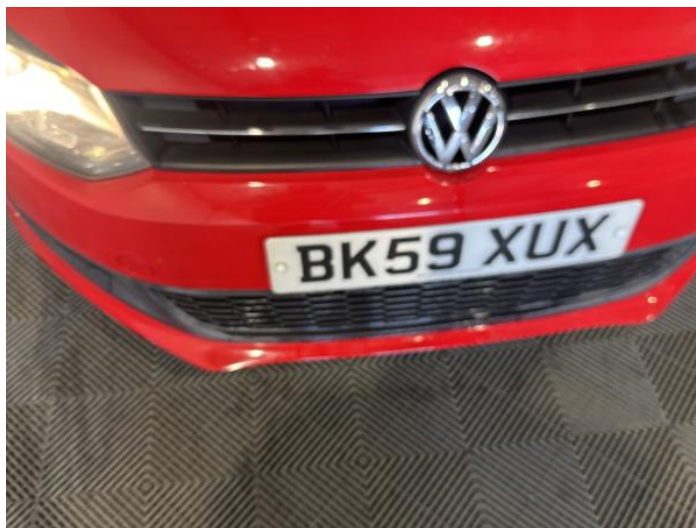
2: Bumper Front  
Poor Previous Repair  
Poor Colour

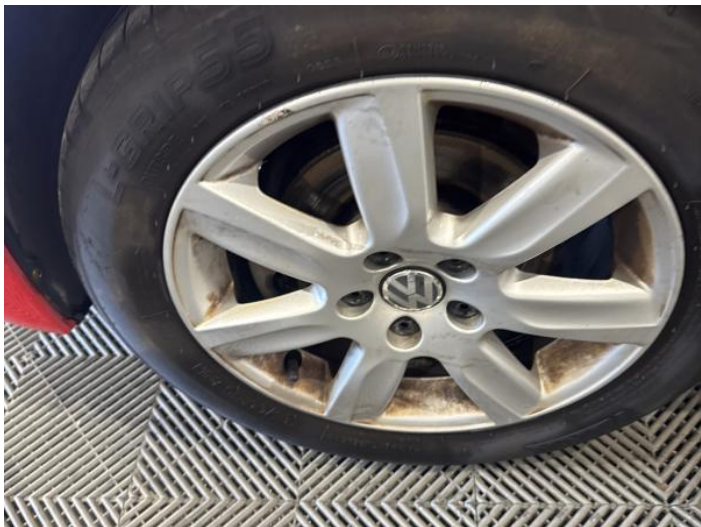
3: Wheel nsf  
Scratched  
Over 50mm

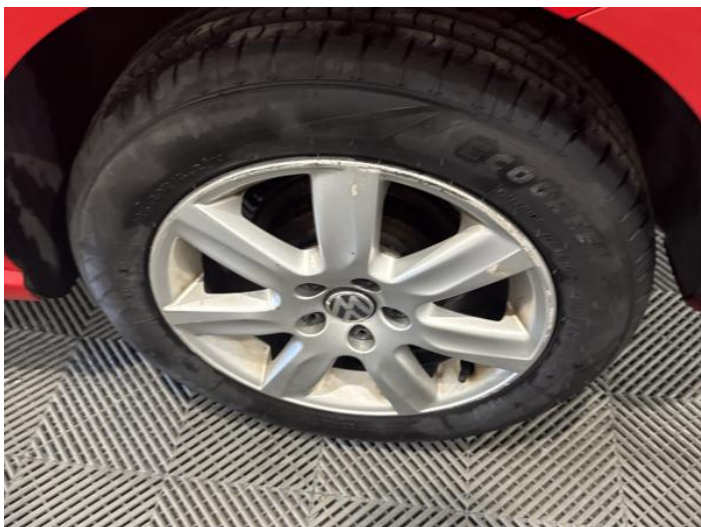
7: Wheel nsr  
Scratched  
Over 50mm

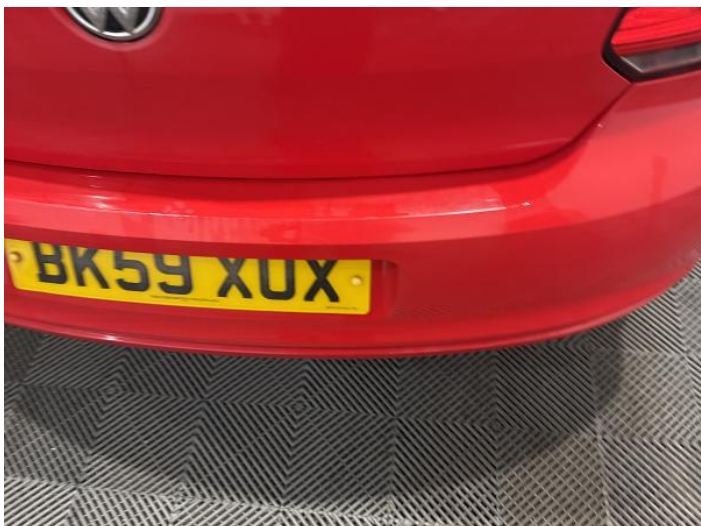
9: Bumper Rear  
Scratched  
25 to 100mm Thru Paint

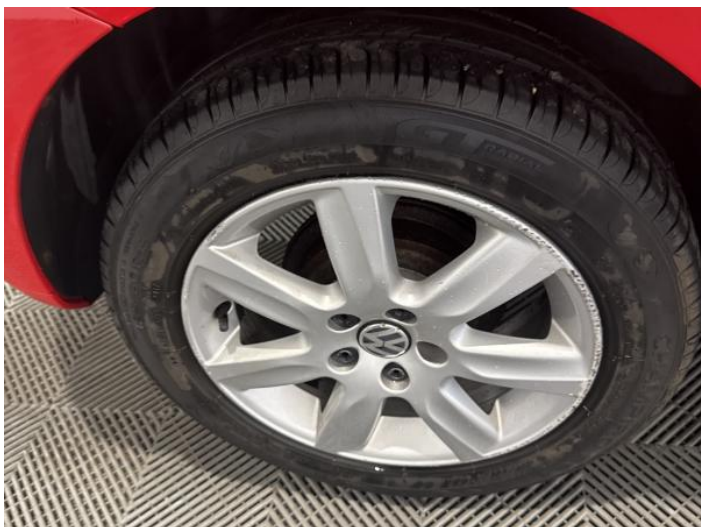
13: Wheel osr  
Scratched  
Over 50mm

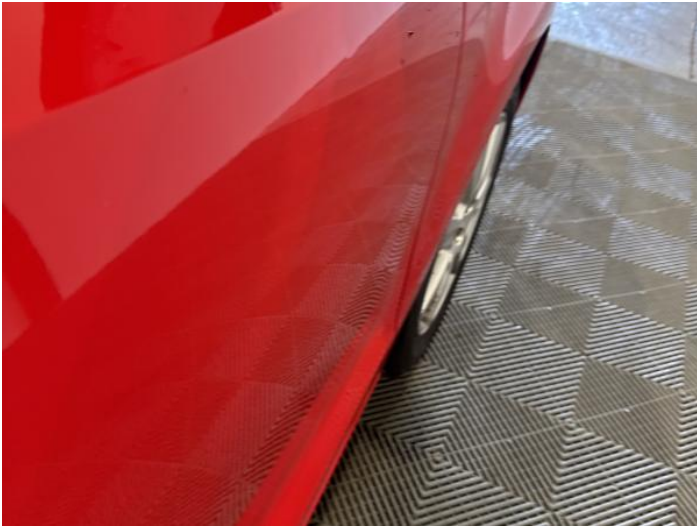
15: Door osf  
Dented  
2 Or Less UpTo 10mm

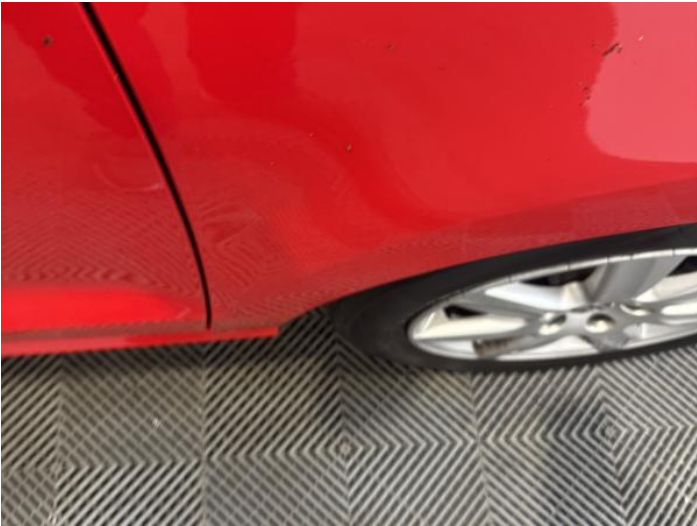
16: Wing osf  
Dented  
Over 30mm

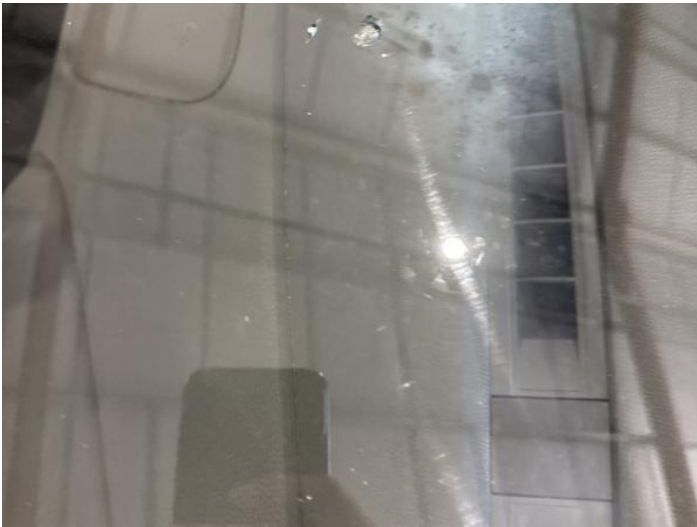
17: Screen Front  
Chipped  
UpTo 10mm

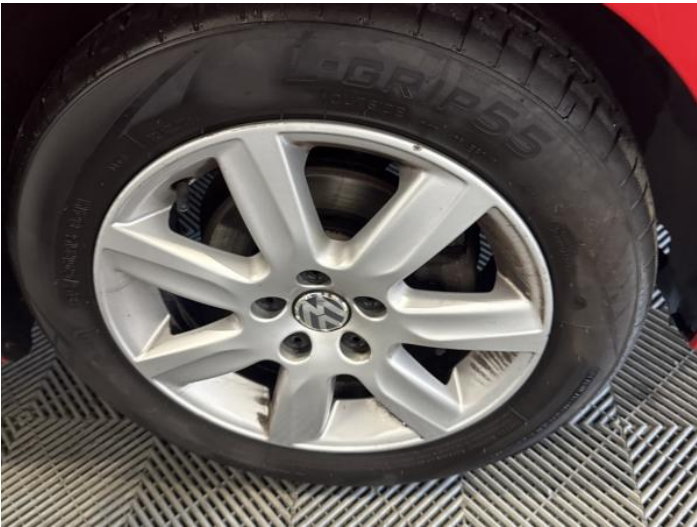
18: Wheel osf  
Scratched  
Over 50mm
