# VEHICLE INSPECTION REPORT

**FT12KJZ**

## Volkswagen Polo 1.2 60 Match 5dr

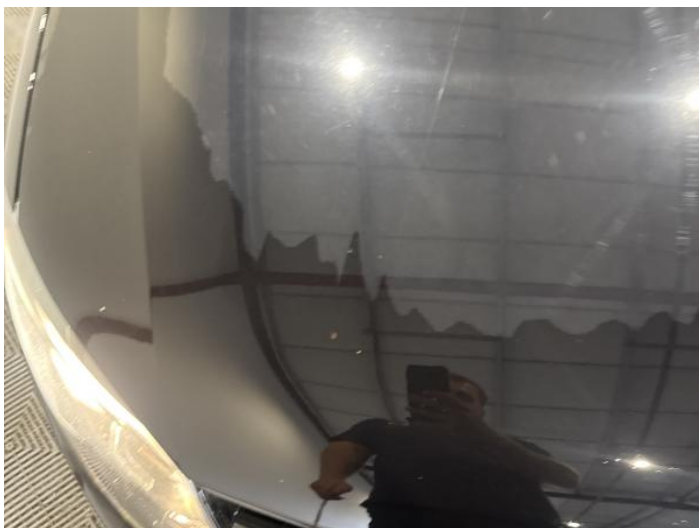
1: Bonnet  
Chipped  
1 To 5

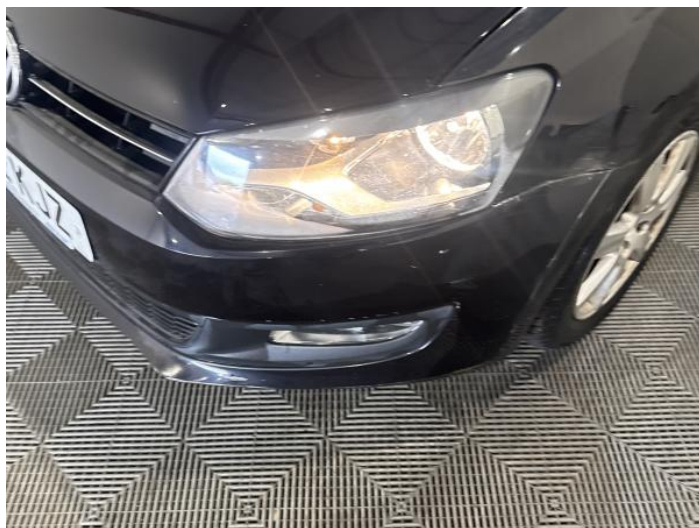
2: Bumper Front  
Scratched  
25 to 100mm Thru Paint

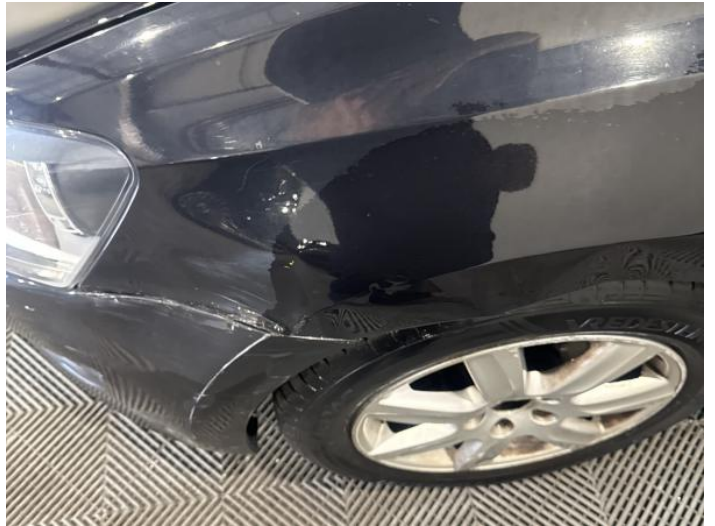
4: Wing nsf  
Dented  
With Paint Damage

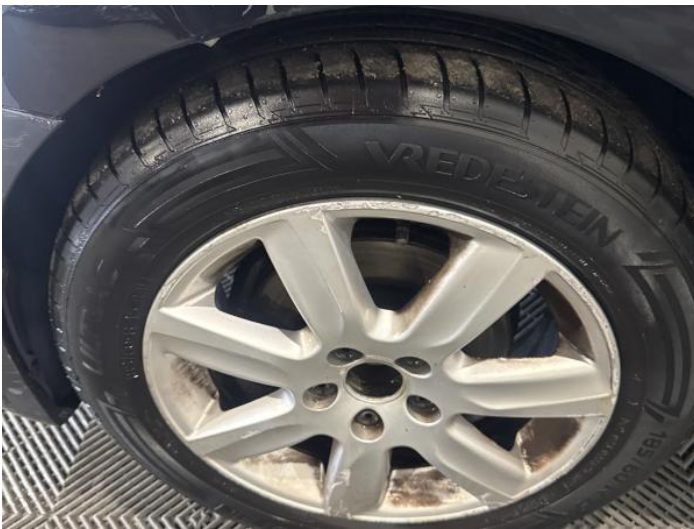
5: Wheel nsf  
Scratched  
Over 50mm

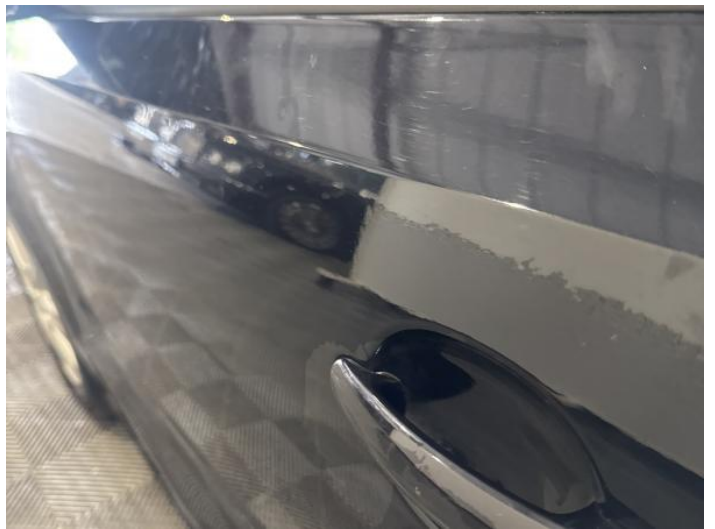
6: Door nsf  
Dented  
Over 2 UpTo 10mm

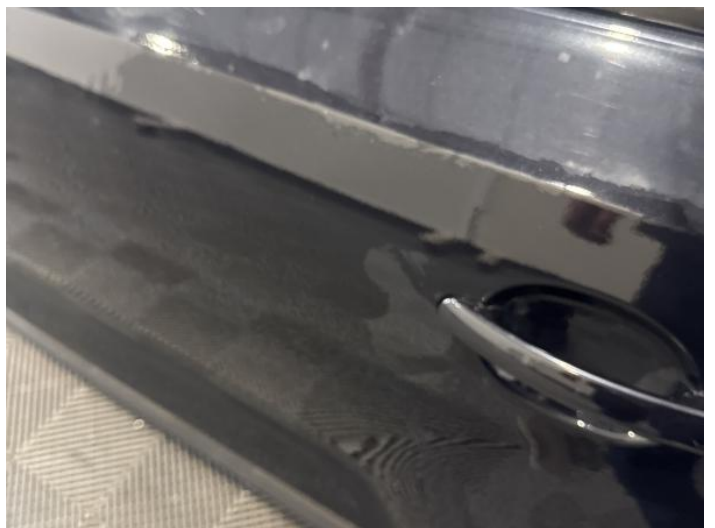
7: Door nsf  
Scratched  
Over 25mm Not Thru Paint

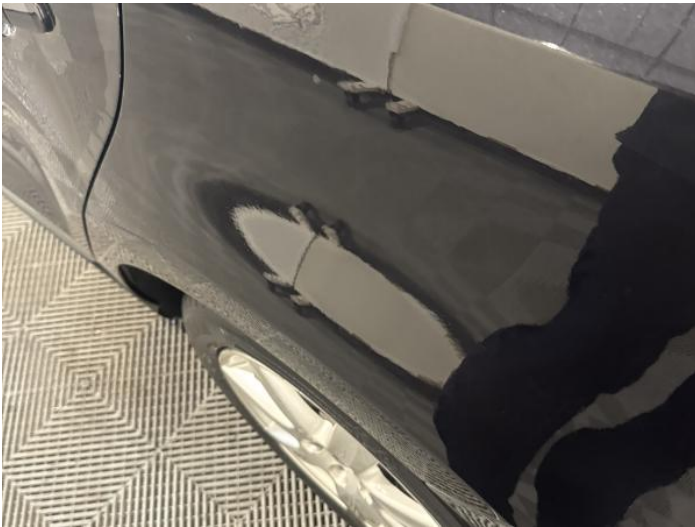
11: Qtr Panel nsr  
Dented  
Over 2 UpTo 10mm

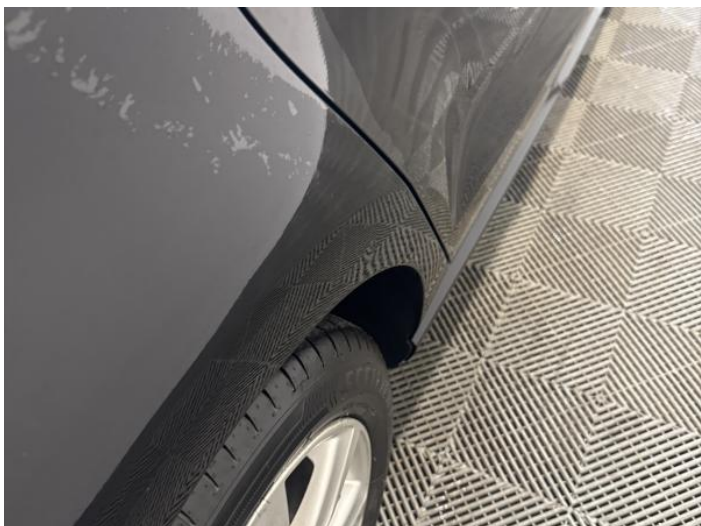
15: Qtr Panel osr  
Dented  
Between 10mm + 30mm

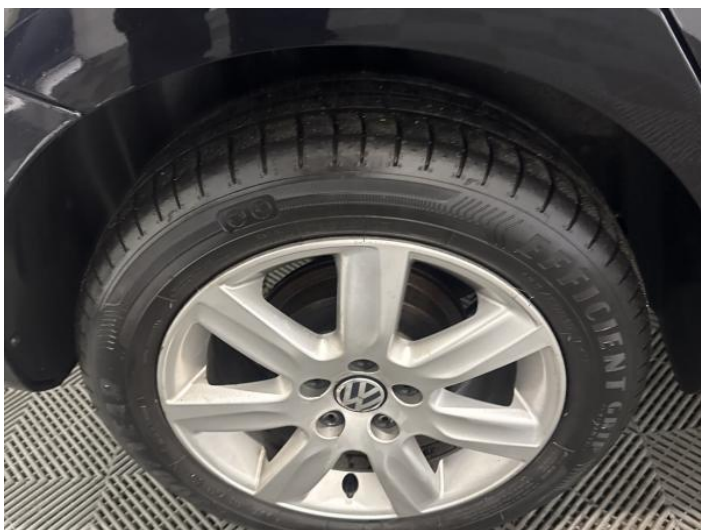
17: Wheel osr  
Scratched  
Over 50mm

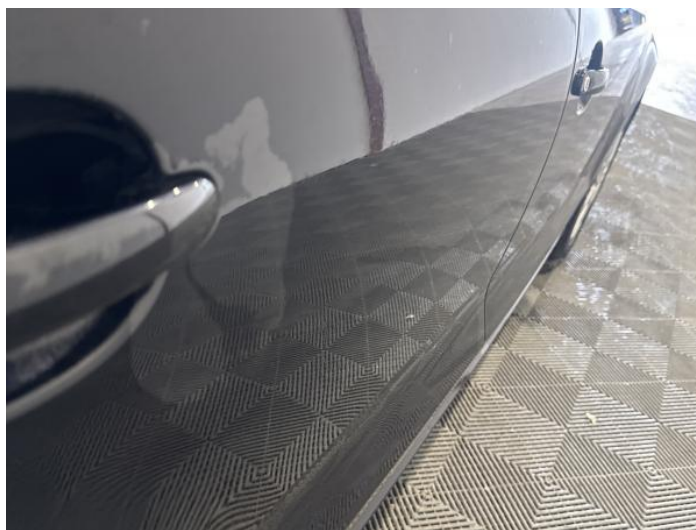
18: Door osr  
Dented  
Over 30mm

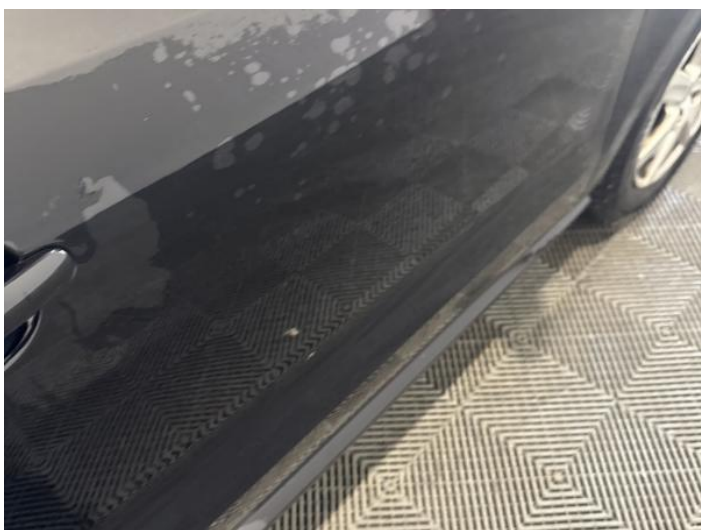
19: Door osf  
Chipped  
1 To 5

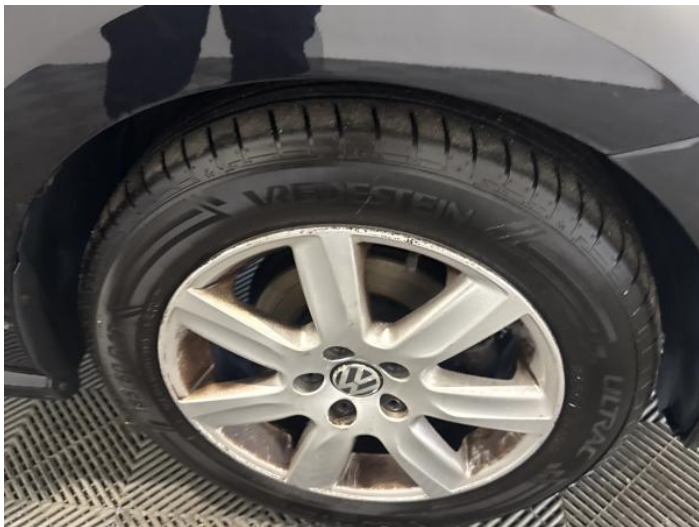
21: Wheel osf  
Scratched  
Over 50mm

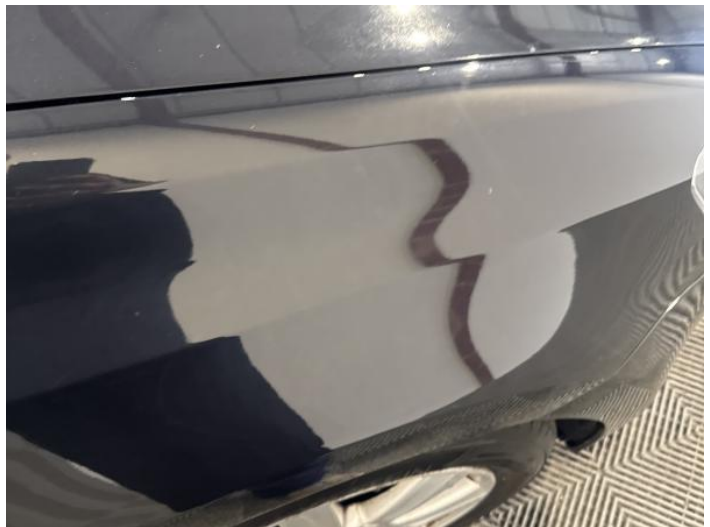
22: Wing osf  
Chipped  
1 To 5
