VEHICLE INSPECTION REPORT

WN68SXB

Mitsubishi L200 Double Cab DI-D 178 Barbarian 4WD Auto

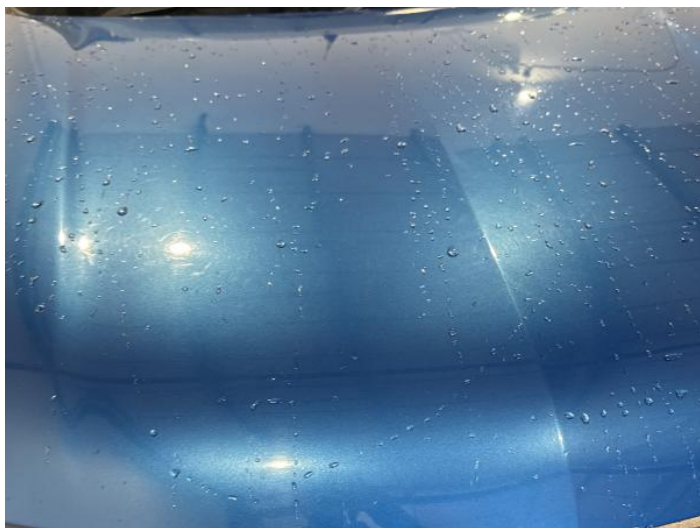
1: Bonnet
Chipped
1 To 5

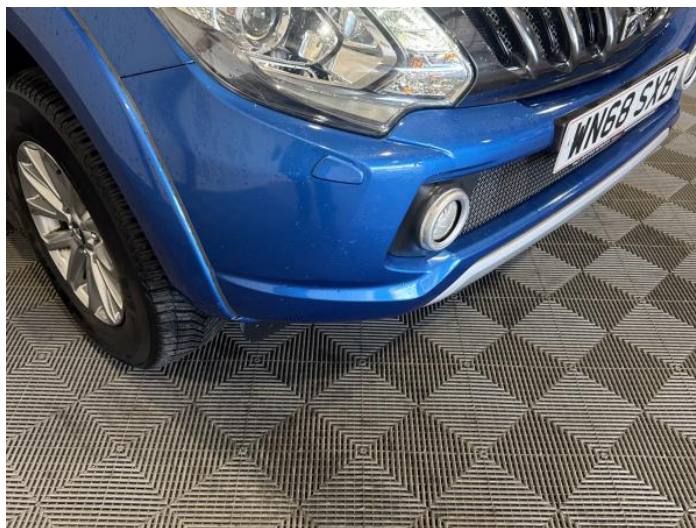
2: Bumper Front
Scratched
Over 100mm Thru Paint

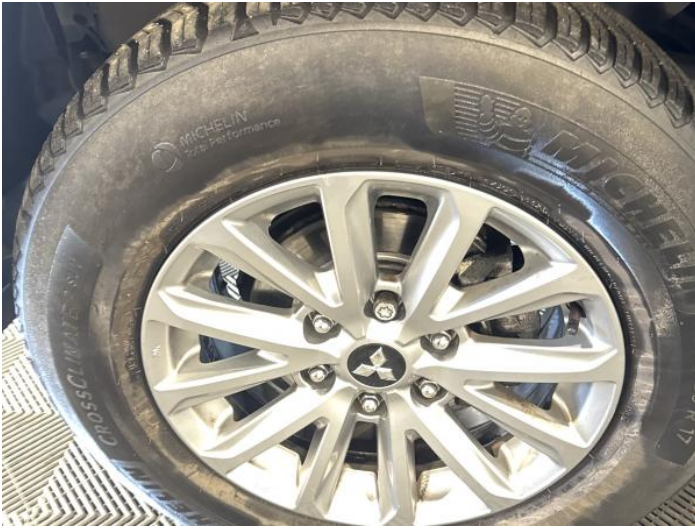
3: Wheel nsf
Scratched
Up To 50mm

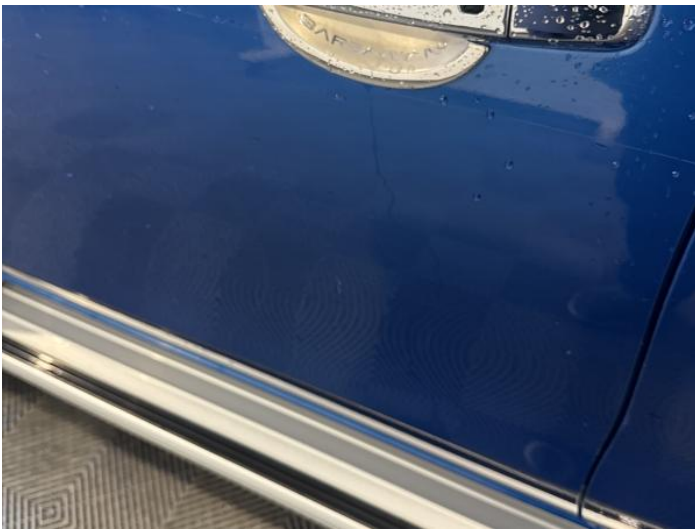
5: Door nsf
Chipped
1 To 5

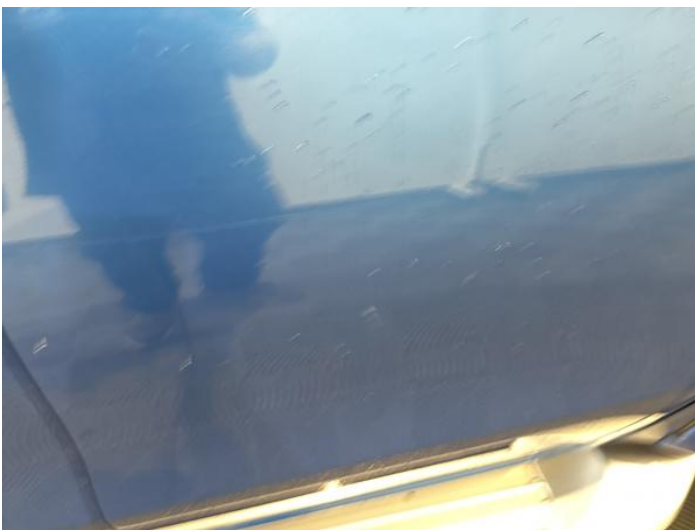
7: Door nsr
Chipped
Multiple Chips

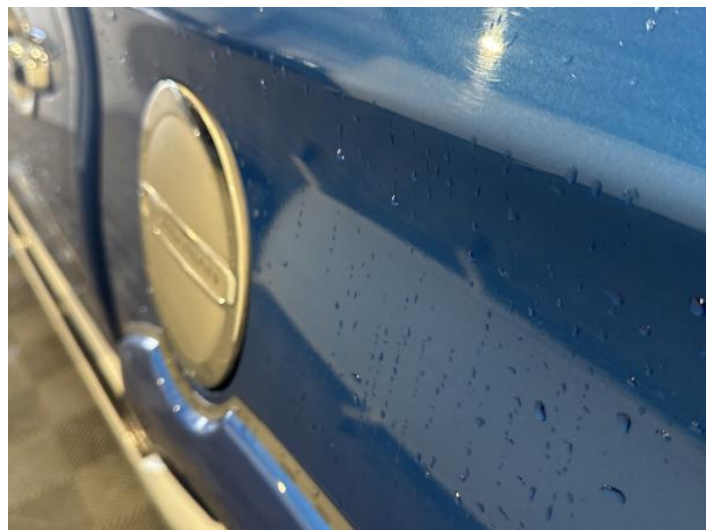
8: Qtr Panel nsr
Dented
Over 2 UpTo 10mm

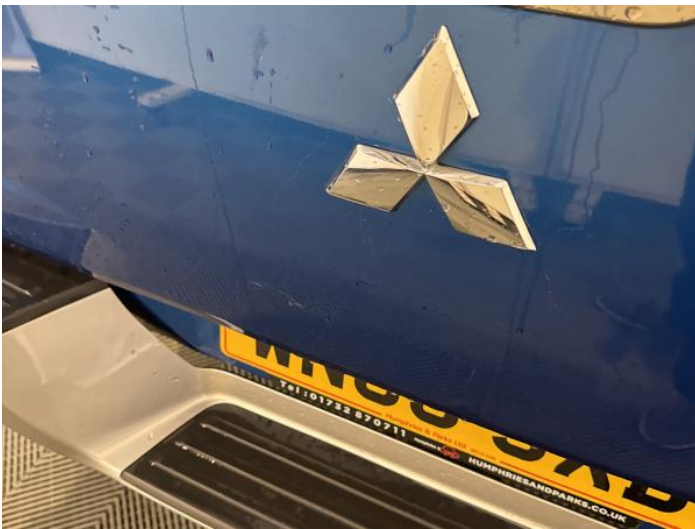
11: Boot Lid
Scratched
Up To 25mm Thru Paint

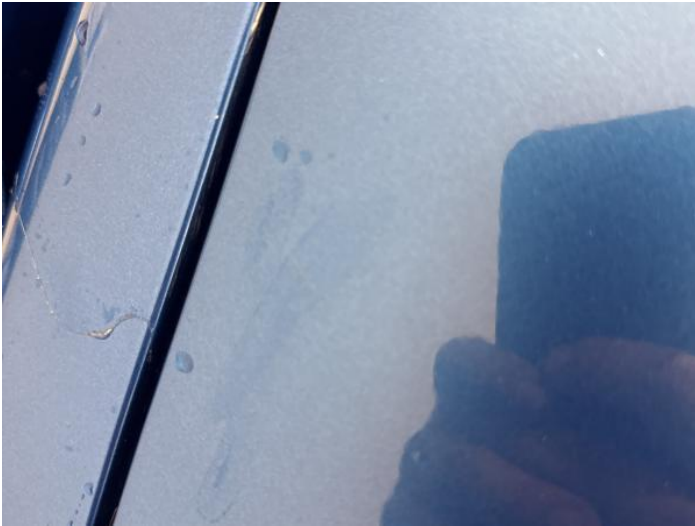
15: Door osr
Scratched
UpTo 25mm Thru Paint

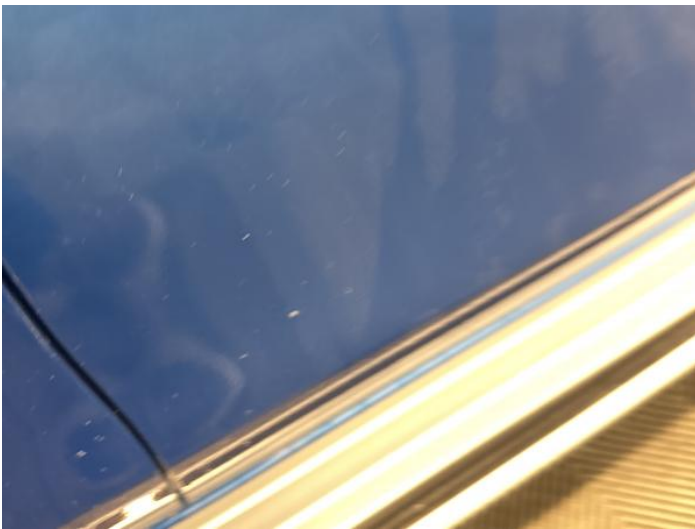
17: Door osf
Chipped
1 To 5

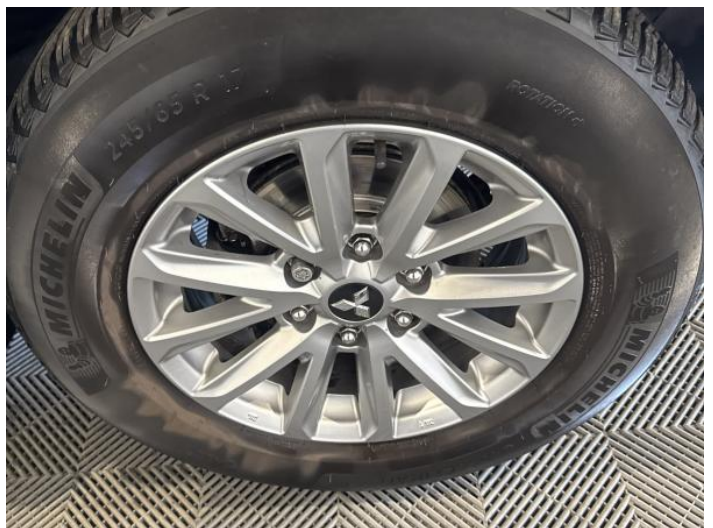
20: Wheel osf
Scratched
Up To 50mm

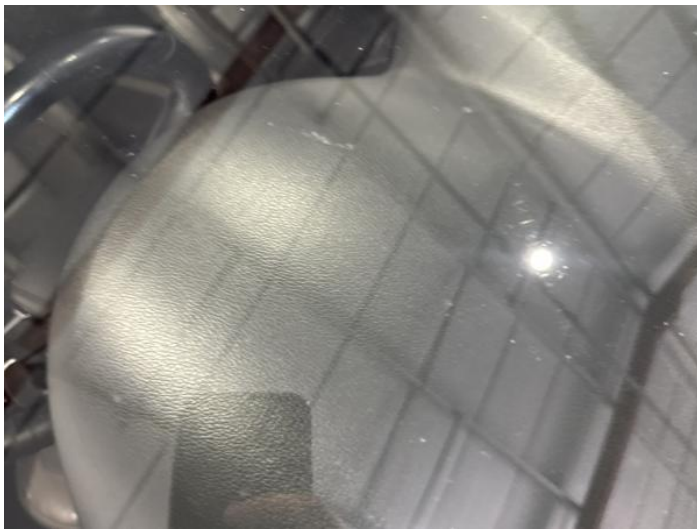
21: Screen Front
Chipped
UpTo 10mm

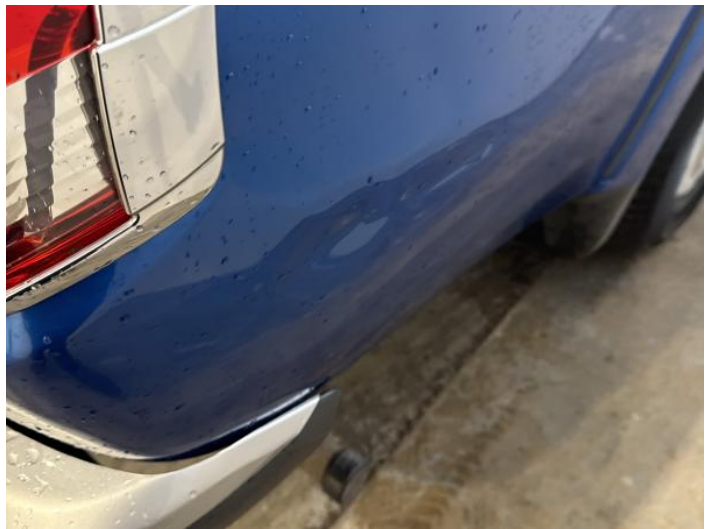
22: Qtr Panel osr
Dented
Over 30mm
