VEHICLE INSPECTION REPORT

ST15HGG

BMW 4 Series 435d xDrive M Sport 5dr Auto [Professional Media]

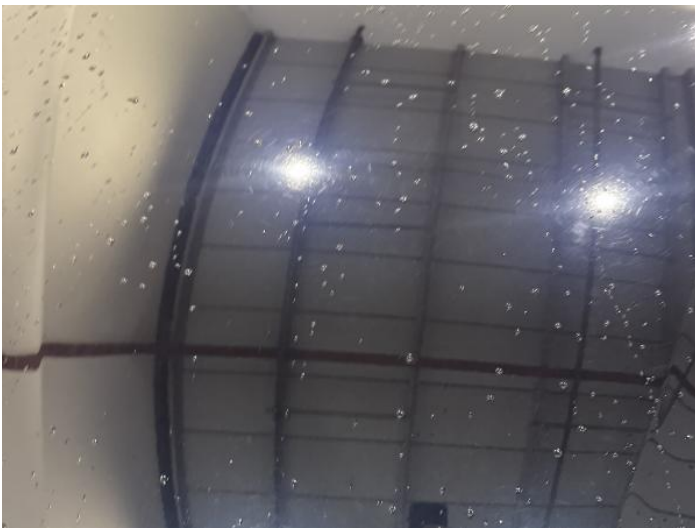
1: Bonnet
Chipped
1 To 5

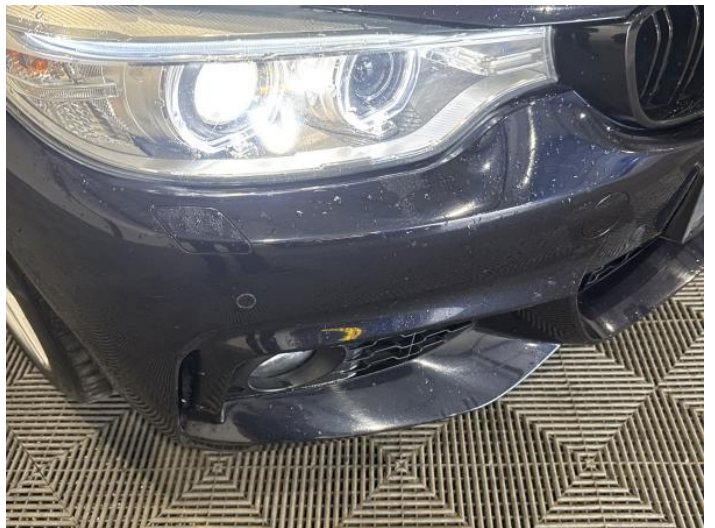
2: Bumper Front
Scratched
Over 100mm Thru Paint

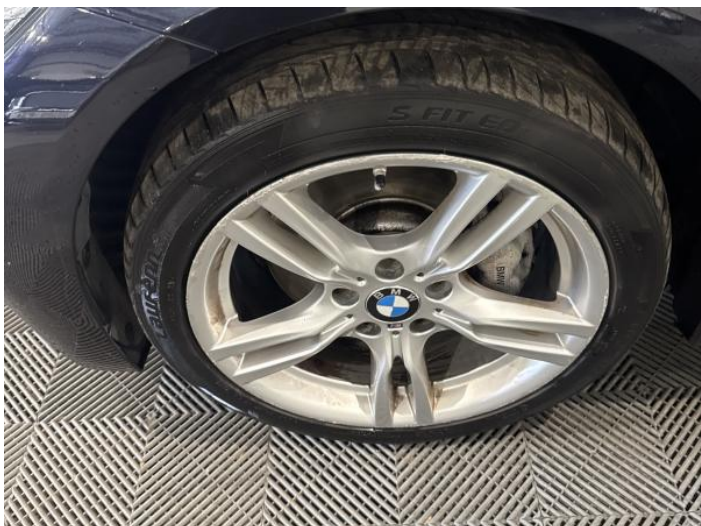
3: Wheel nsf
Scratched
Over 50mm

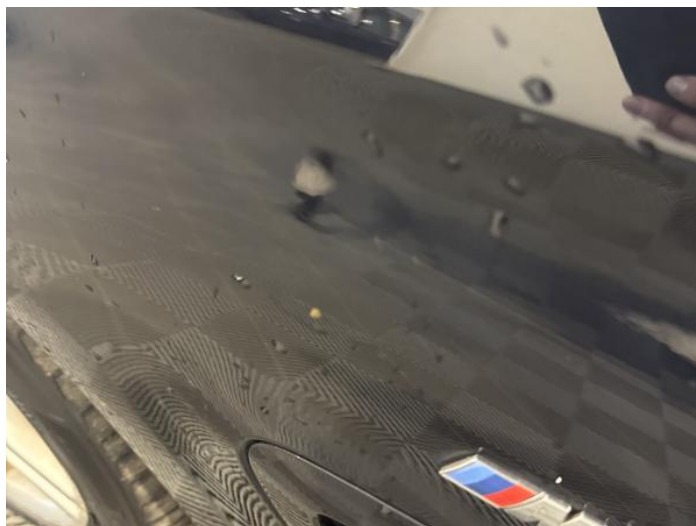
4: Wing nsf
Chipped
1 To 5

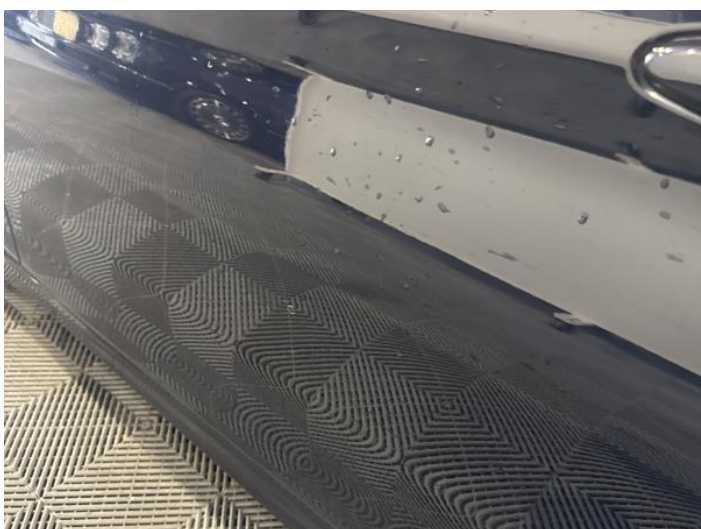
5: Door nsf
Chipped
1 To 5

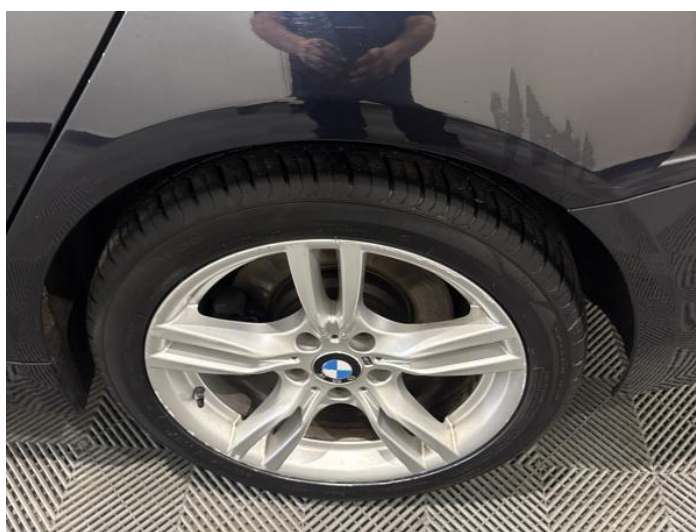
8: Wheel nsr
Scratched
Over 50mm

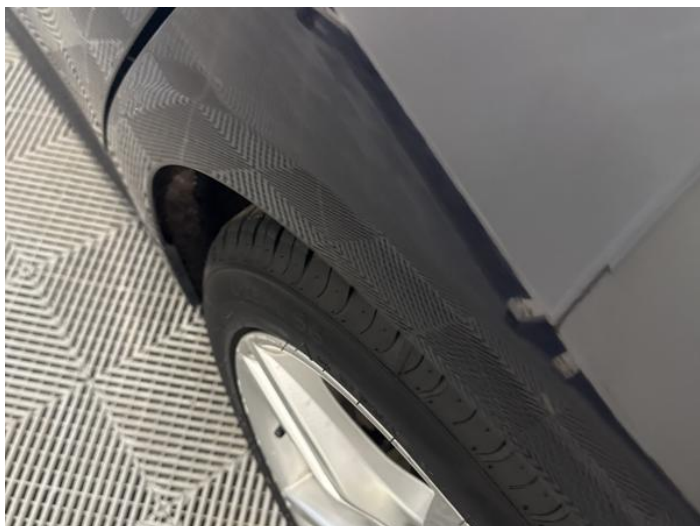
9: Qtr Panel nsr
Dented
2 Or Less UpTo 10mm

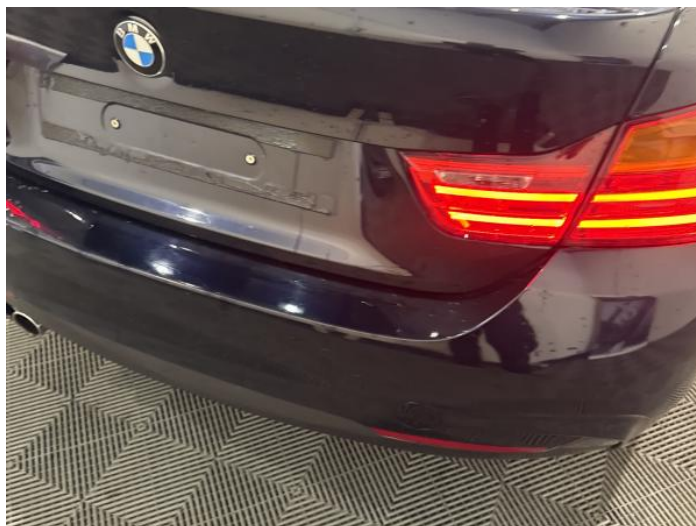
10: Bumper Rear
Chipped
Multiple Chips

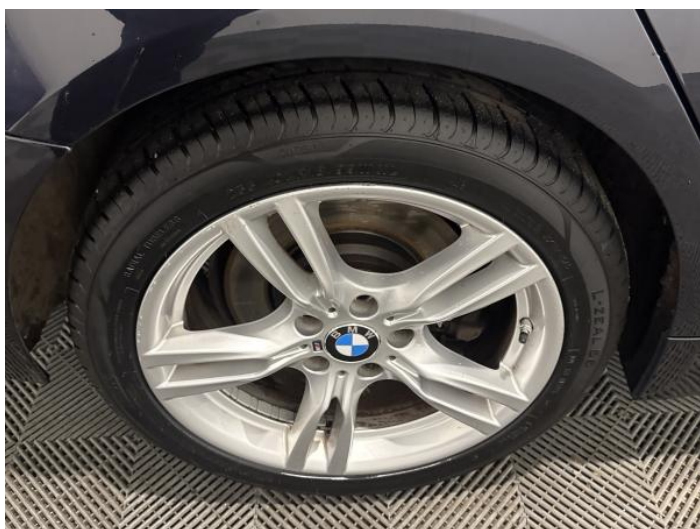
13: Wheel osr
Scratched
Over 50mm

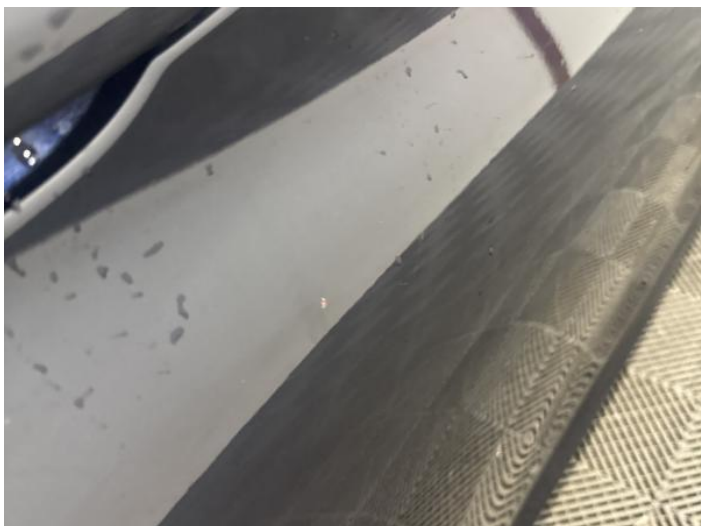
15: Door osr
Chipped
1 To 5

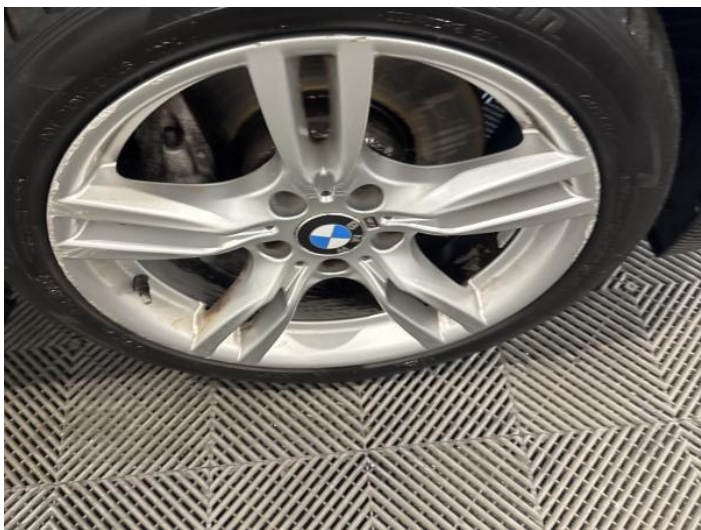
19: Wheel osf
Scratched
Over 50mm
