VEHICLE INSPECTION REPORT

Land Rover Range Rover Evoque 2.2 SD4 Dynamic 5dr Auto [Lux Pack]

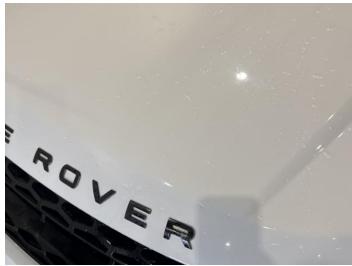
1: Bonnet Chipped 1 To 5

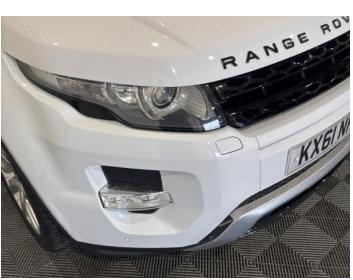
2: Bumper Front Chipped Multiple Chips

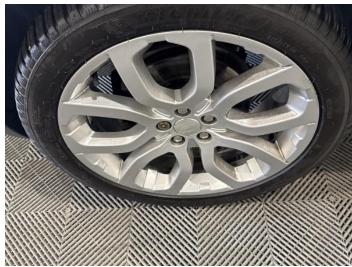
4: Wheel nsf Scratched Over 50mm

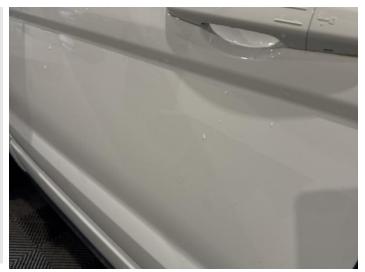
6: Door nsf Chipped 1 To 5

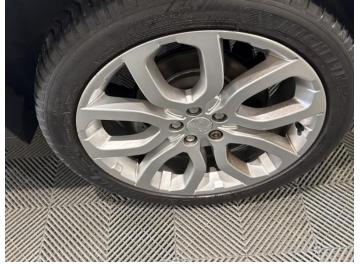
9: Wheel nsr Scratched Up To 50mm

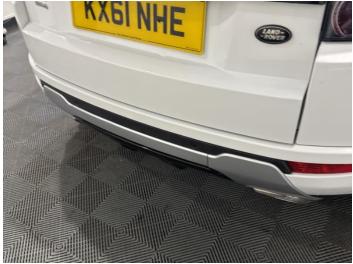
11: Bumper Rear ChippedMultiple Chips

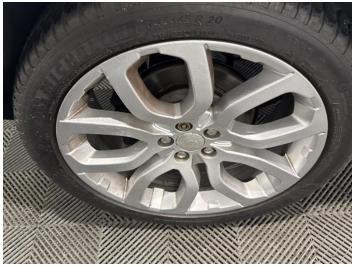
15: Wheel osr Scratched Up To 50mm

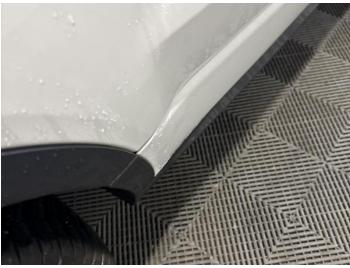
16: Door osr Dented Between 10mm + 30mm

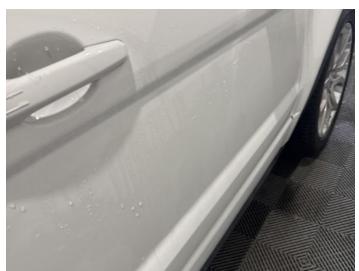
18: Door osfChipped1 To 5

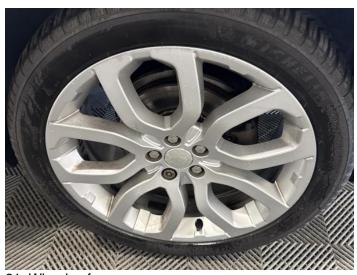
21: Wheel osf Scratched Over 50mm
