## **VEHICLE INSPECTION REPORT**

**GF71WJD**

### **Tesla Model 3 Standard Plus 4dr Auto**

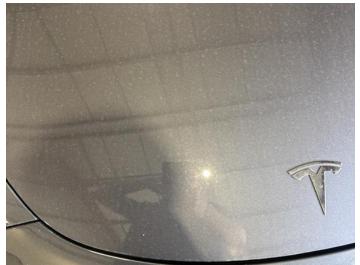
1: Bonnet Chipped 1 To 5

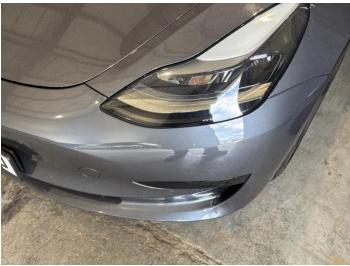
2: Bumper Front Chipped Multiple Chips

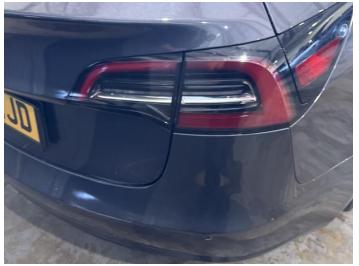
9: Bumper Rear Chipped Multiple Chips

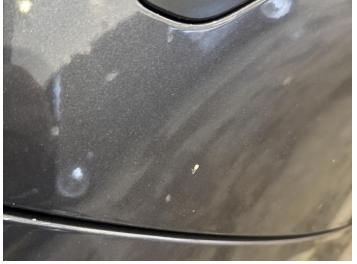
11: Door osrChipped1 To 5
