## **VEHICLE INSPECTION REPORT**

YS23NVC

### Nissan Qashqai 1.5 E-Power N-Connecta 5dr Auto

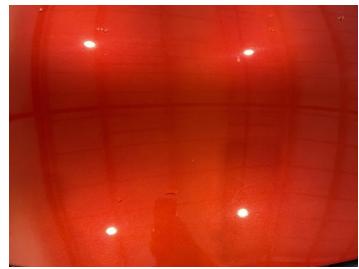
1: Bonnet Chipped 1 To 5

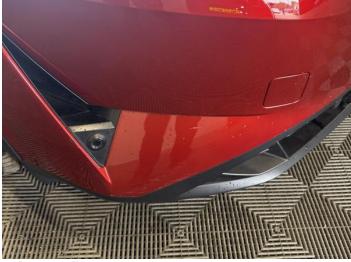
2: Bumper Front Scratched 25 to 100mm Thru Paint

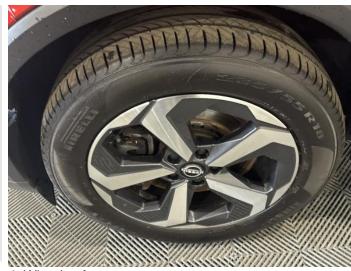
4: Wheel nsf Scratched Up To 50mm

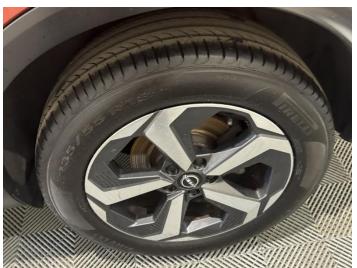
7: Wheel nsr Scratched Up To 50mm

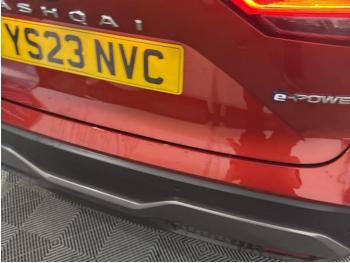
8: Bumper Rear Chipped Multiple Chips

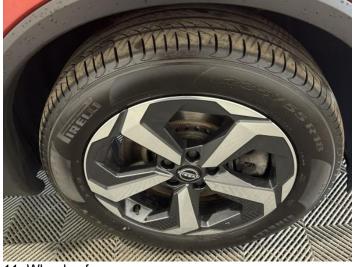
11: Wheel osf Scratched Up To 50mm
