VEHICLE INSPECTION REPORT

RK13VNJ

Audi A5 2.0 TDI 177 SE 5dr [5 Seat]

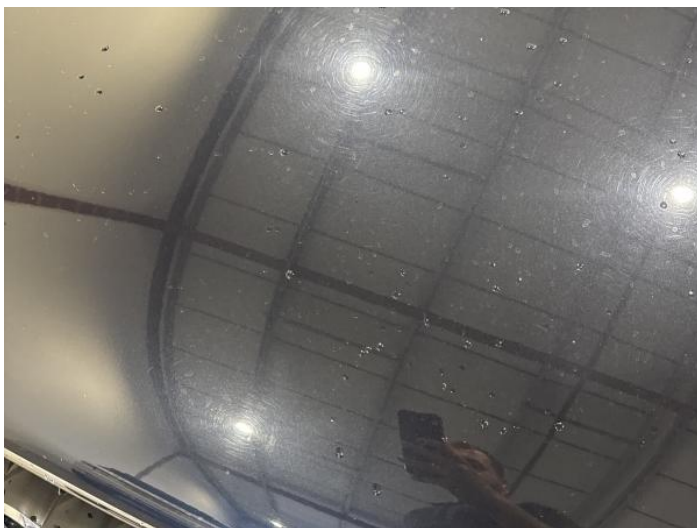
1: Bonnet
Chipped
1 To 5

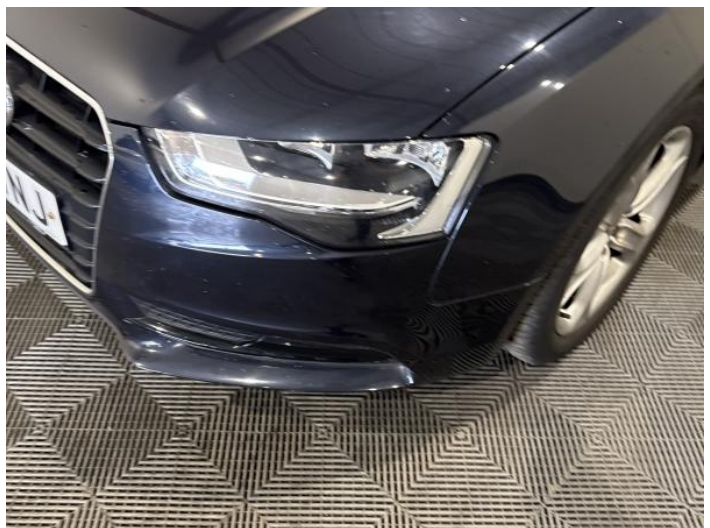
2: Bumper Front
Scratched
Over 100mm Thru Paint

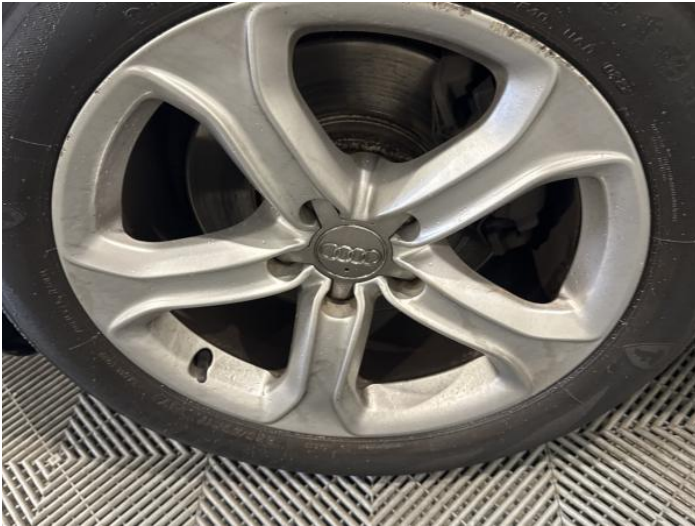
3: Wheel nsf
Scratched
Over 50mm

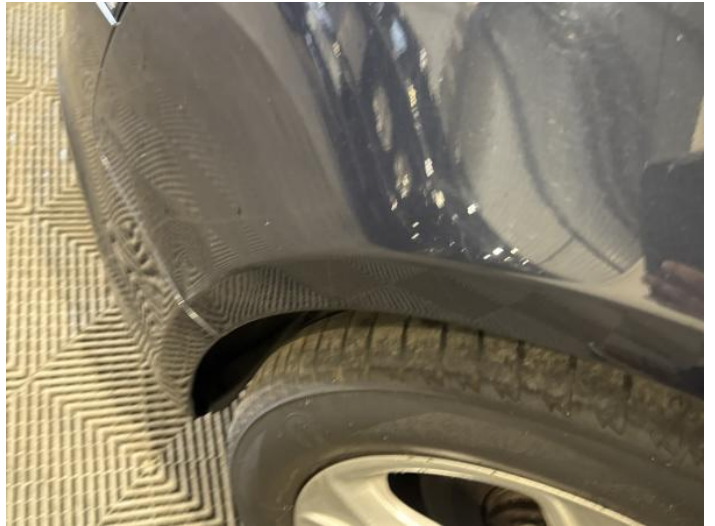
4: Wing nsf
Dented
With Paint Damage

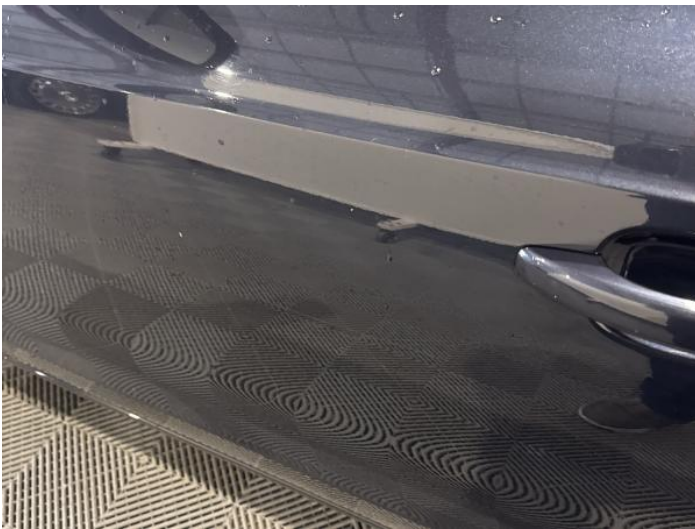
5: Door nsf
Chipped
1 To 5

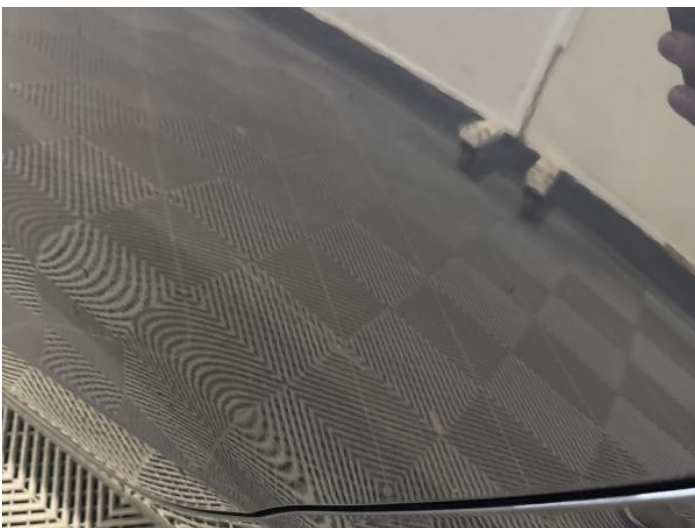
7: Door nsr
Scratched
Over 25mm Thru Paint

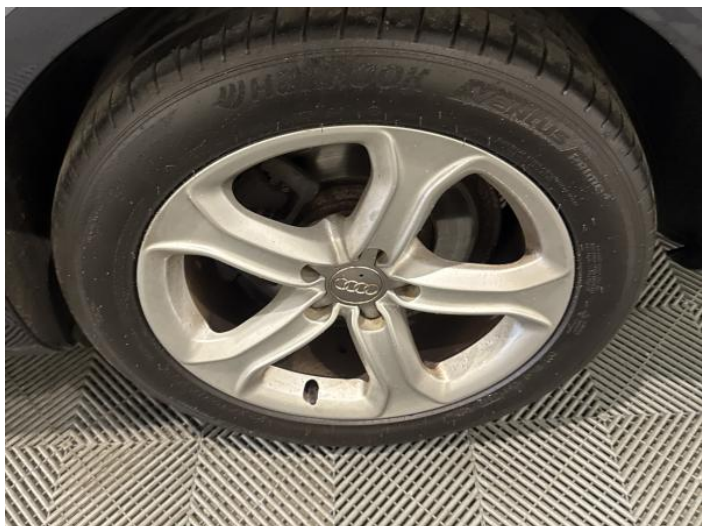
9: Wheel nsr
Scratched
Over 50mm

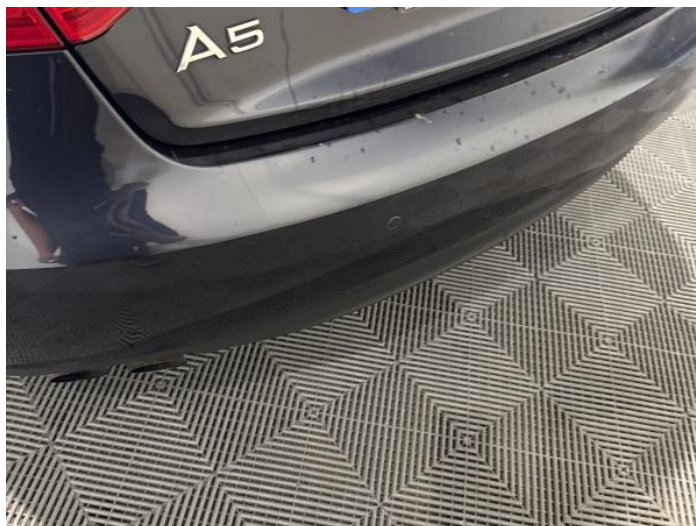
10: Bumper Rear
Chipped
Multiple Chips

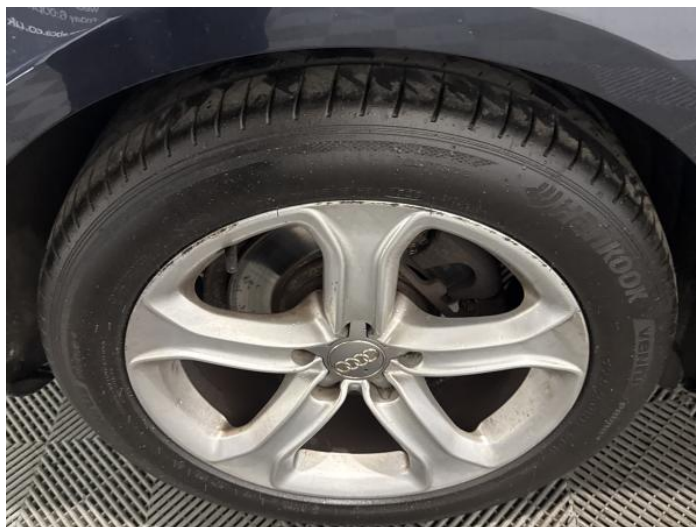
14: Wheel osr
Scratched
Over 50mm

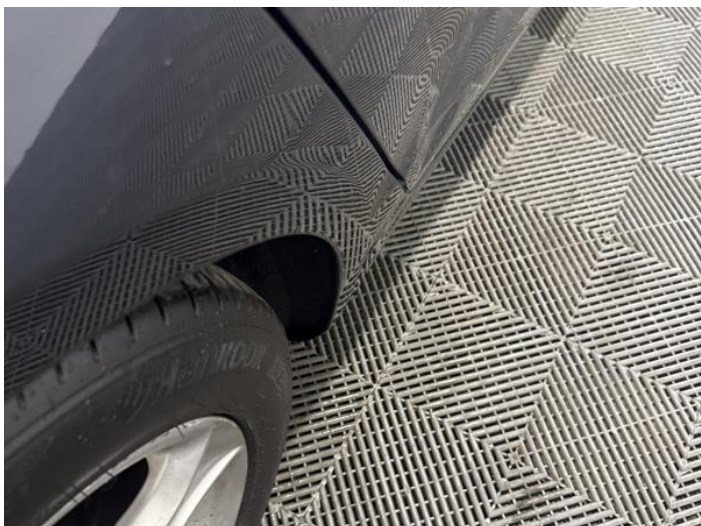
15: Qtr Panel osr
Dented
2 Or Less UpTo 10mm

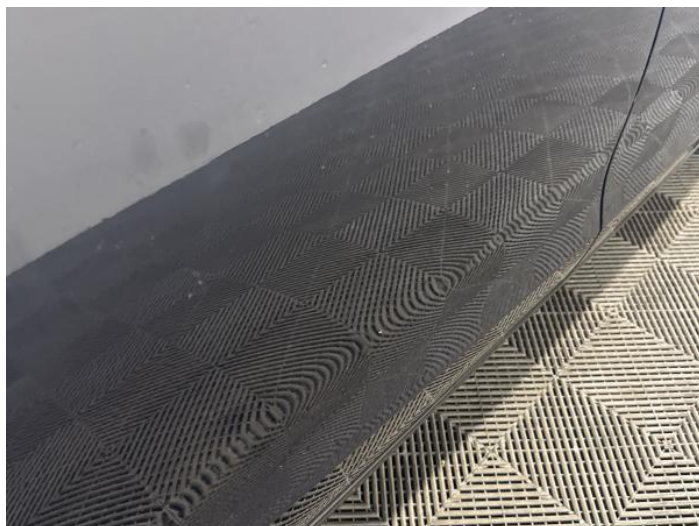
16: Door osr
Chipped
1 To 5

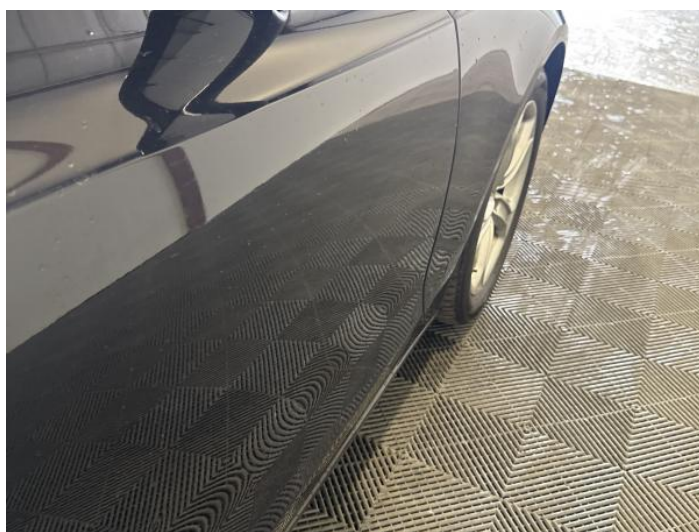
18: Door osf
Dented
2 Or Less UpTo 10mm

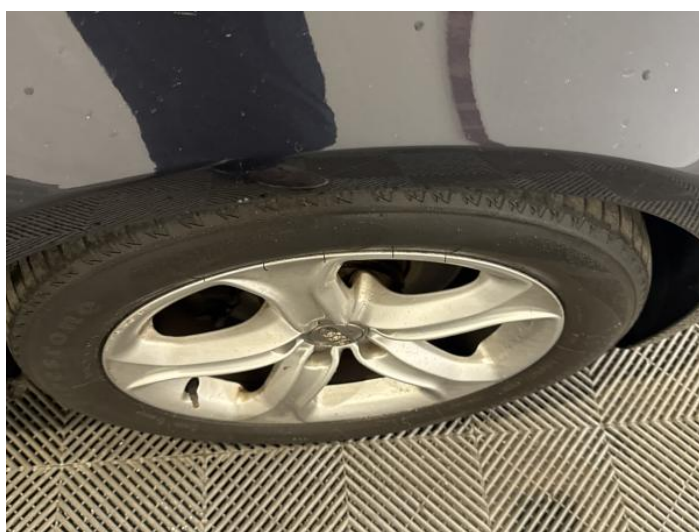
20: Wing osf
Chipped
1 To 5

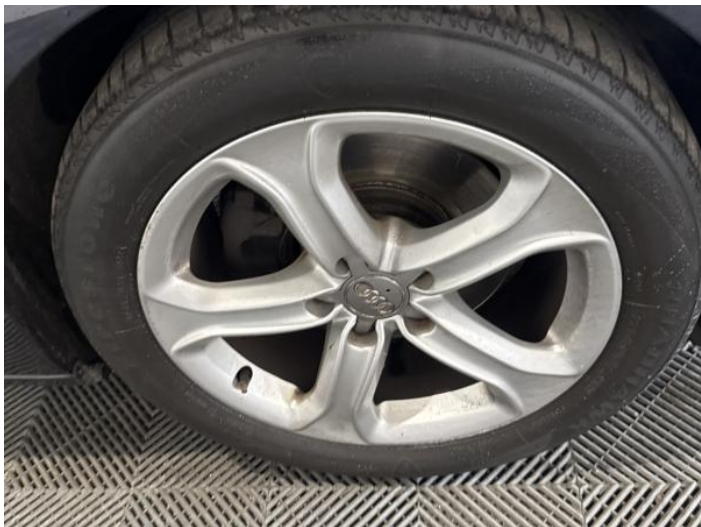
21: Wheel of
Scratched
Over 50mm
