VEHICLE INSPECTION REPORT

GU61RYO

Toyota Verso-S 1.33 Dual VVT-i TR 5dr

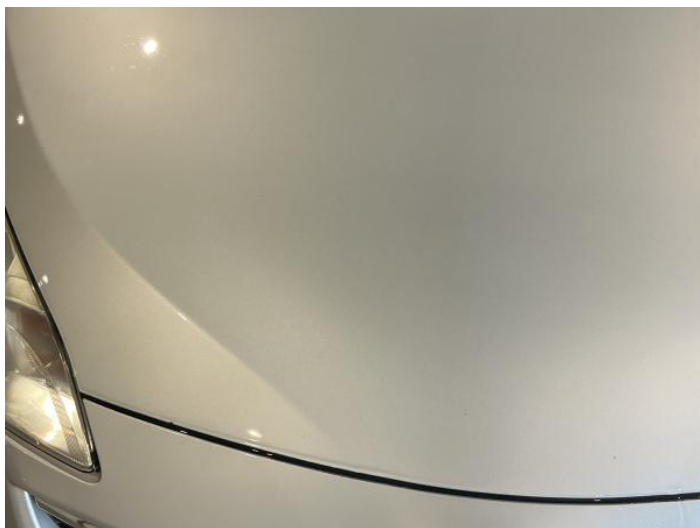
1: Bonnet
Chipped
1 To 5

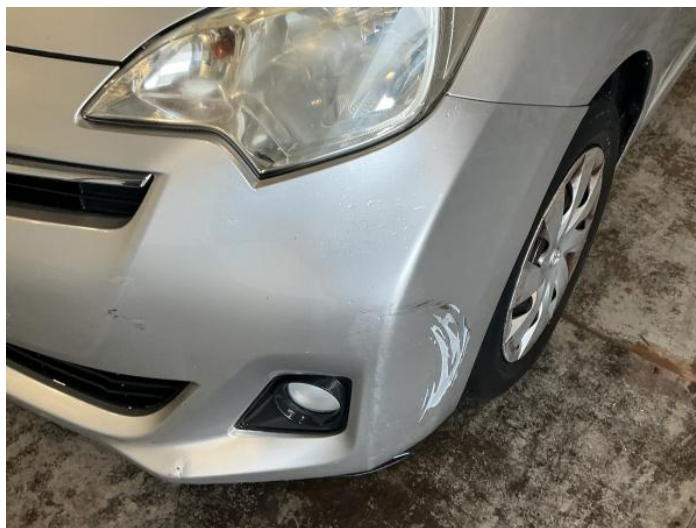
2: Bumper Front
Scratched
Over 100mm Thru Paint

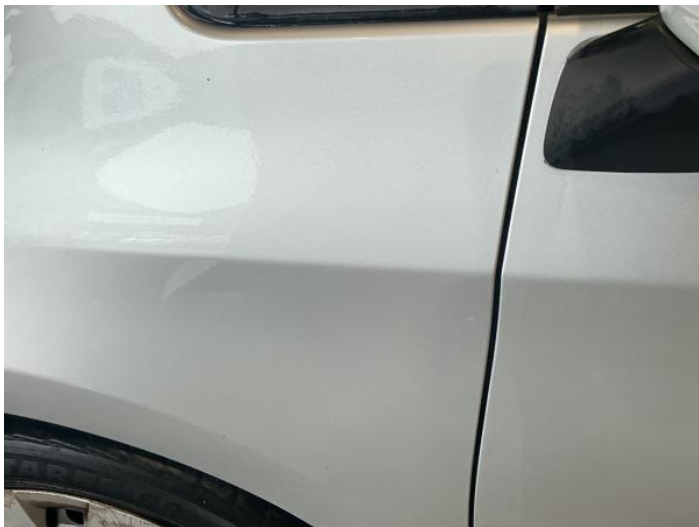
3: Wing nsf
Dented
Between 10mm + 30mm

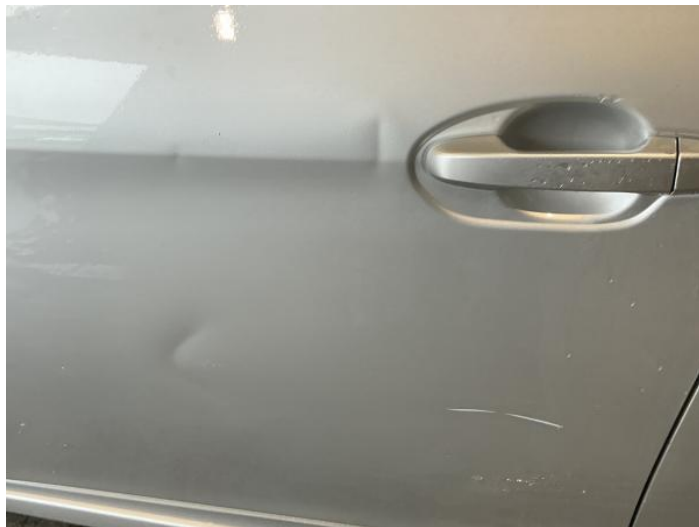
4: Door nsf
Dented
With Paint Damage

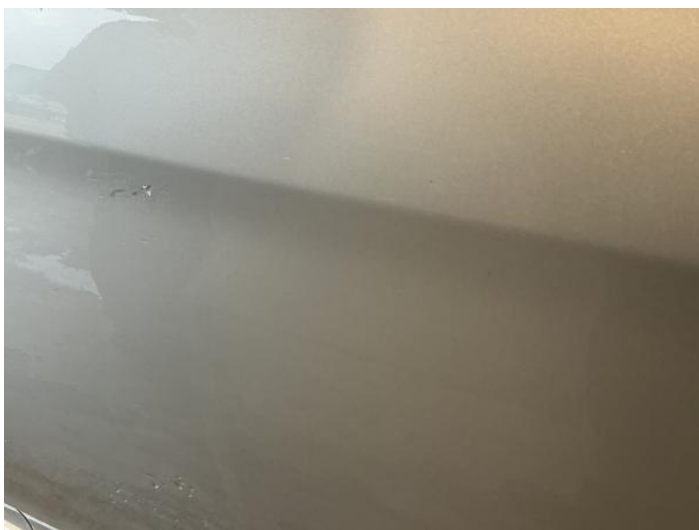
5: Door nsr
Chipped
1 To 5

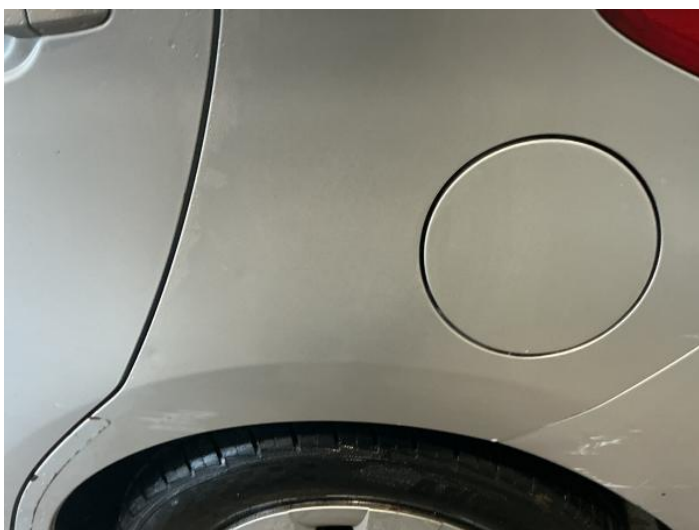
7: Qtr Panel nsr
Scratched
Over 25mm Thru Paint

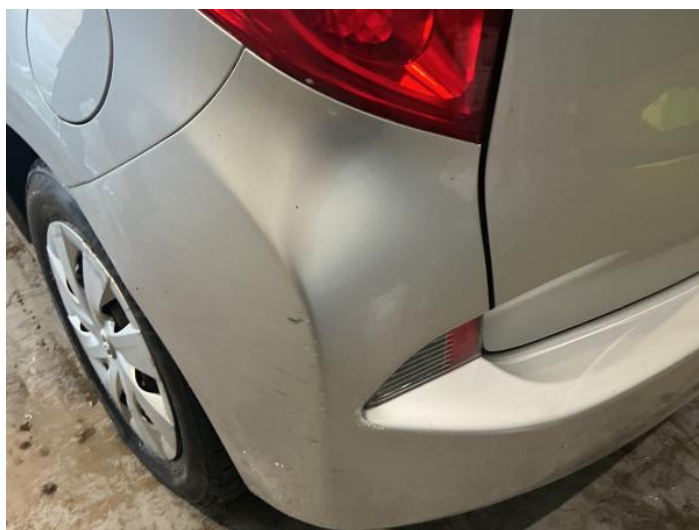
8: Bumper Rear
Scratched
Over 100mm Thru Paint

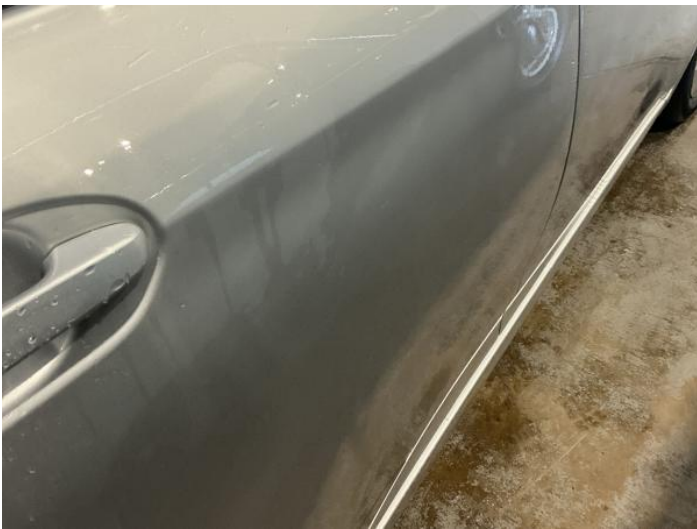
11: Door osr
Chipped
1 To 5

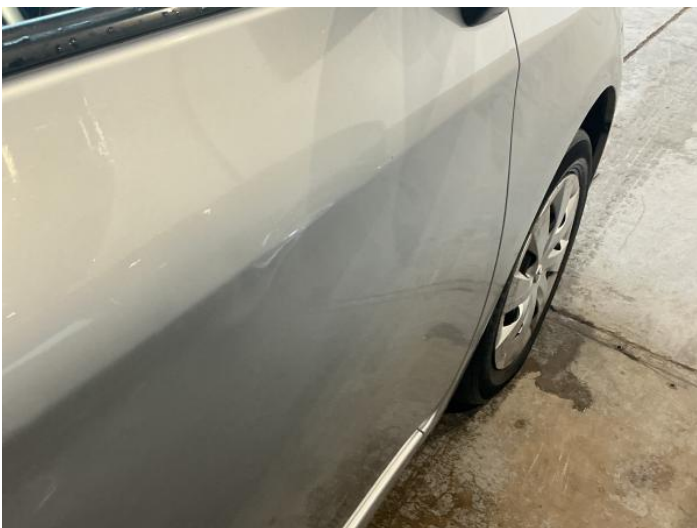
13: Door osf
Dented
Between 10mm + 30mm
