# VEHICLE INSPECTION REPORT

**LX65UXB**

## Vauxhall Mokka 1.4T SE 5dr Auto

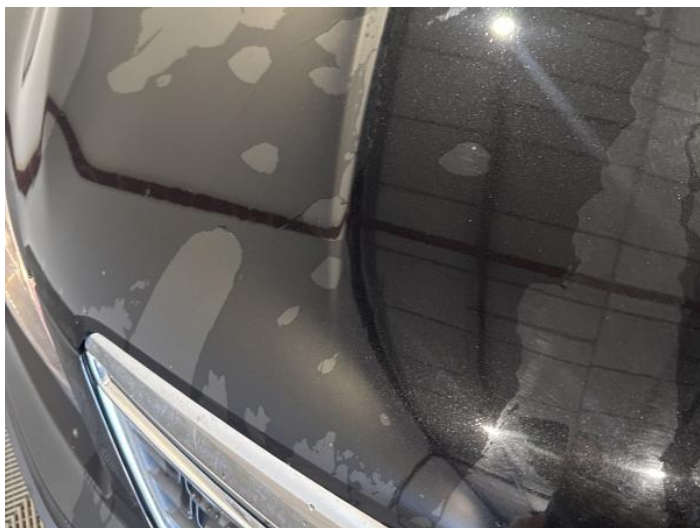
1: Bonnet  
Chipped  
1 To 5

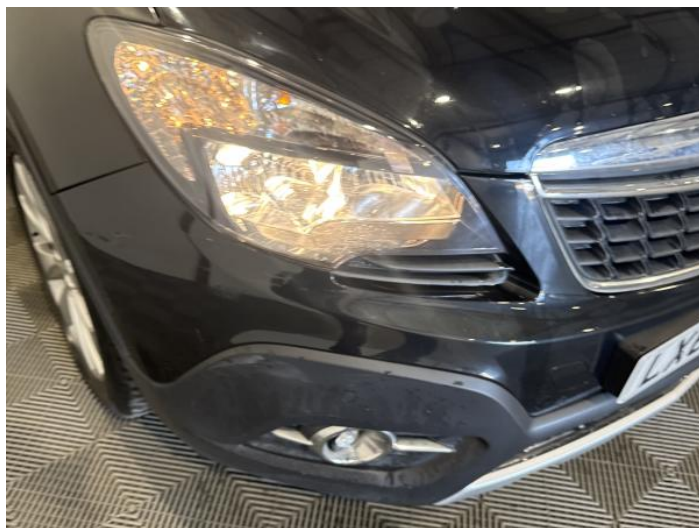
2: Bumper Front  
Scratched  
Over 100mm Thru Paint

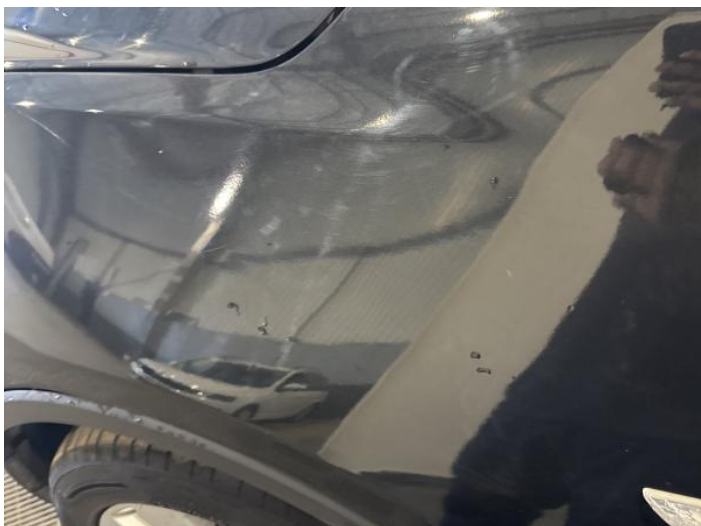
3: Wing nsf  
Chipped  
1 To 5

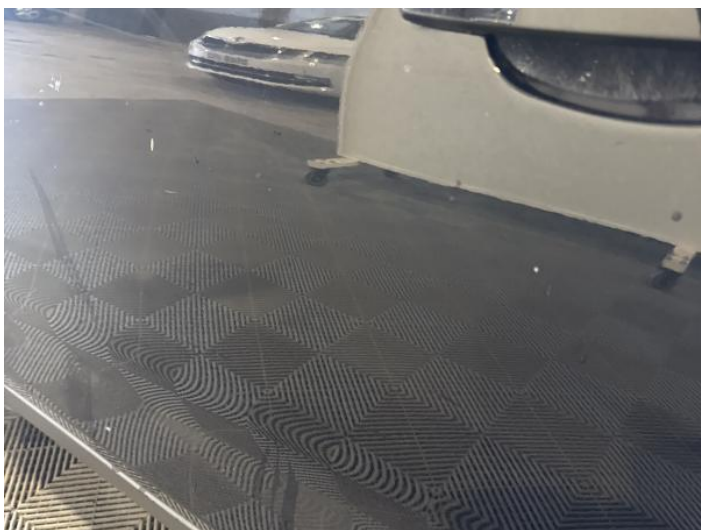
5: Door nsf  
Chipped  
1 To 5

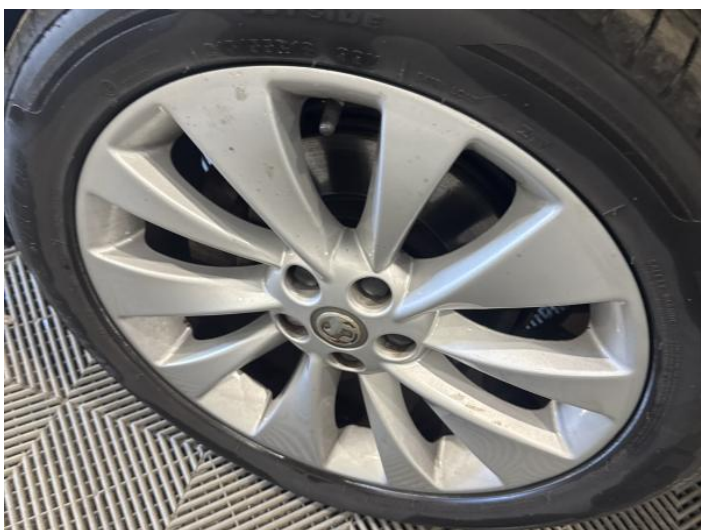
7: Wheel nsf  
Scratched  
Over 50mm

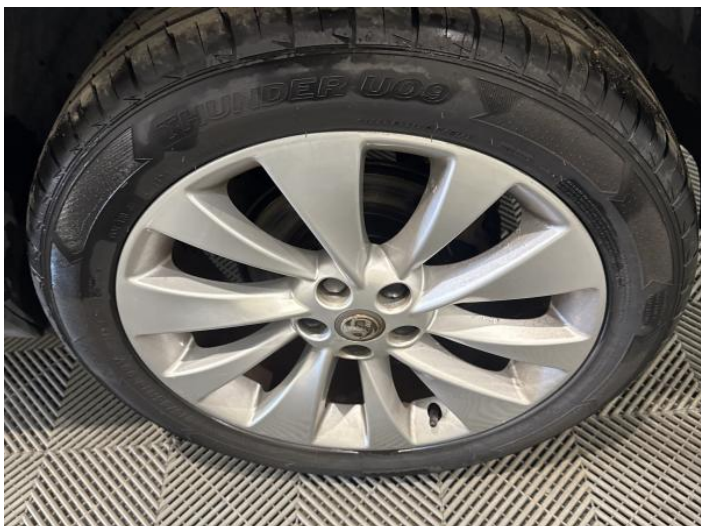
9: Wheel nsr  
Scratched  
Over 50mm

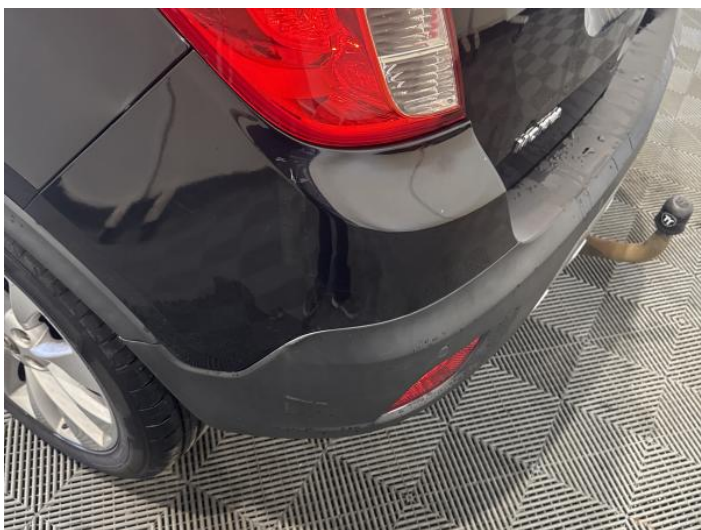
11: Bumper Rear  
Scratched  
Over 100mm Thru Paint

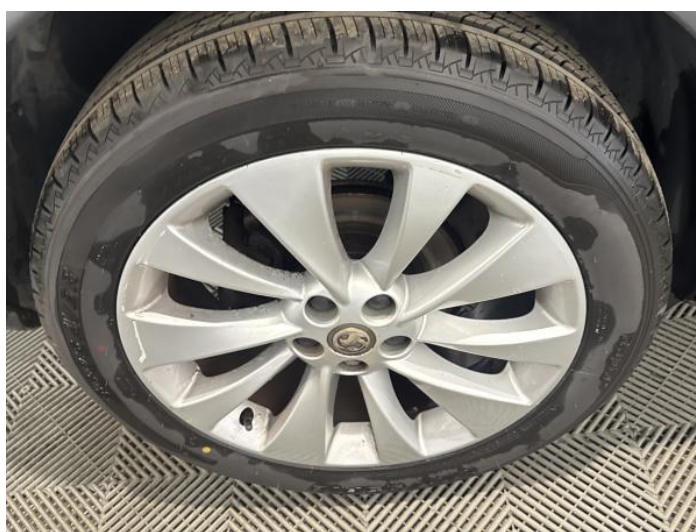
14: Wheel osr  
Scratched  
Over 50mm

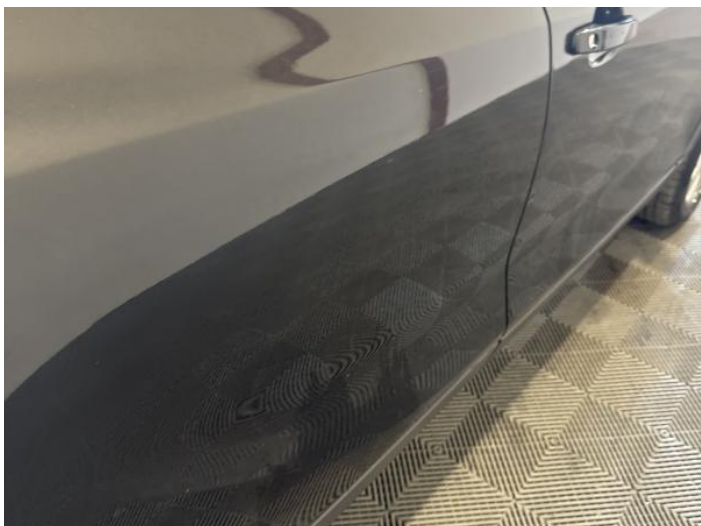
15: Door osr  
Chipped  
1 To 5

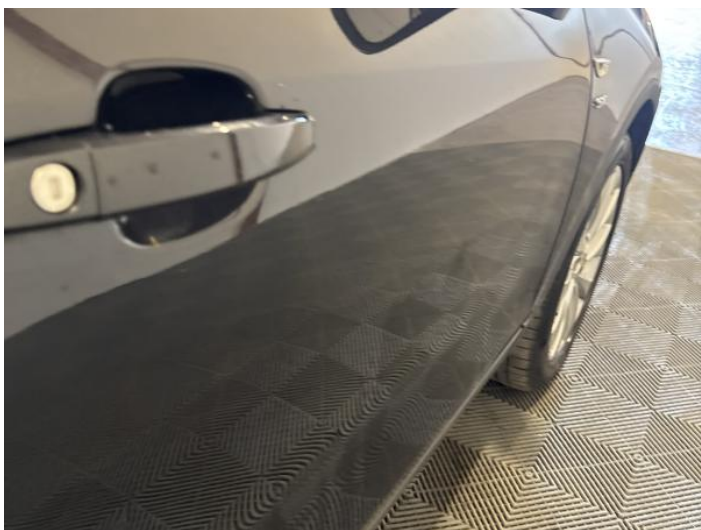
17: Door osf  
Chipped  
1 To 5

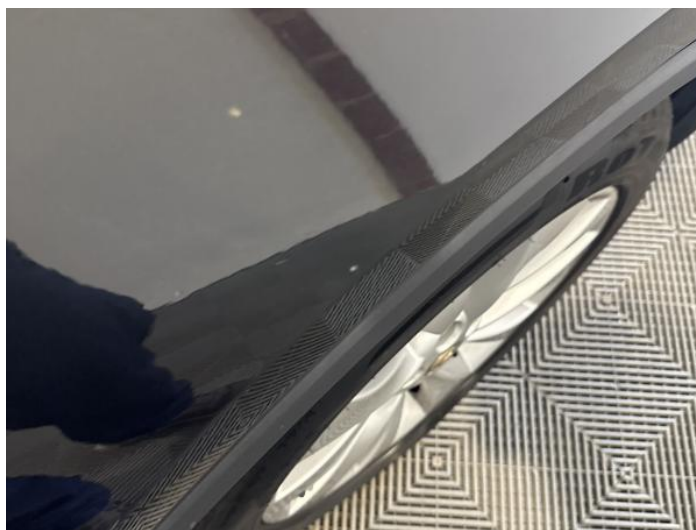
18: Wing osf  
Poor Previous Repair  
Poor Paint

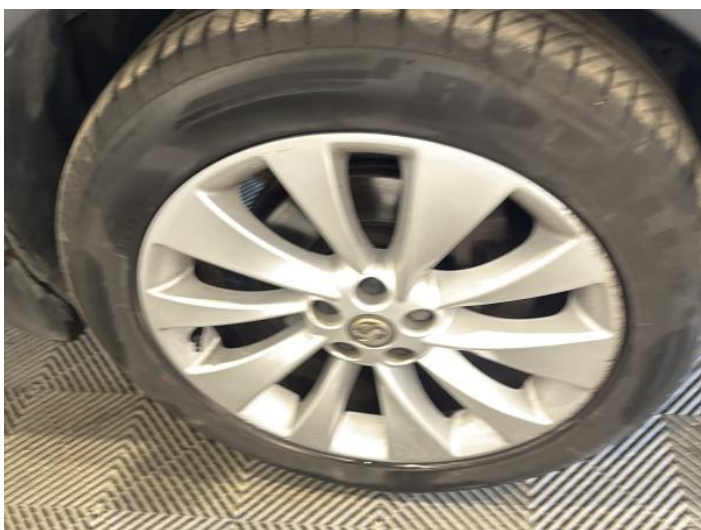
19: Wheel osf  
Scratched  
Over 50mm
