**VEHICLE INSPECTION REPORT**

# Vauxhall Corsa 1.2i 16V Design 5dr

#### Vehicle Inspection Report

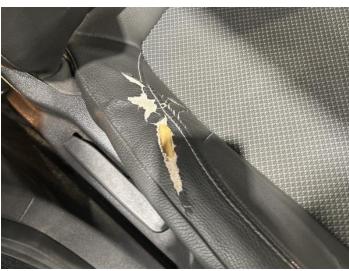
2: Seat Base Cover osf Holed Over 3mm

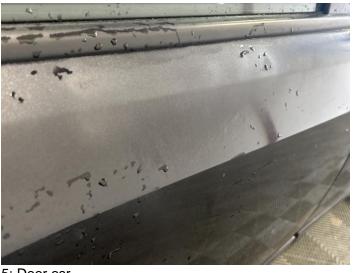
5: Door osr Poor Previous Repair Poor Paint

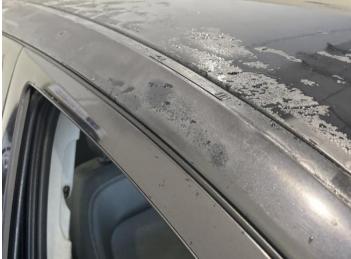
6: B Post os Poor Previous Repair Poor Paint

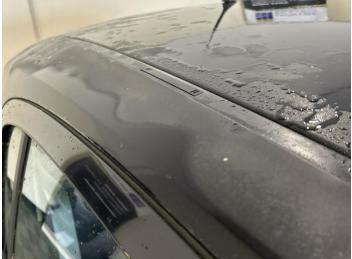
7: C Post os Poor Previous Repair Poor Paint

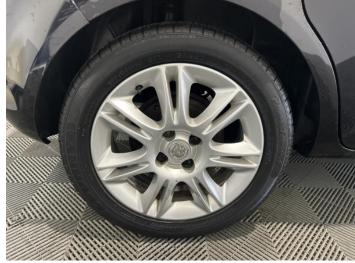
8: Wheel osr Scratched Up To 50mm

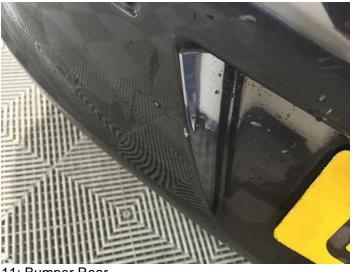
11: Bumper Rear Chipped 1 To 5

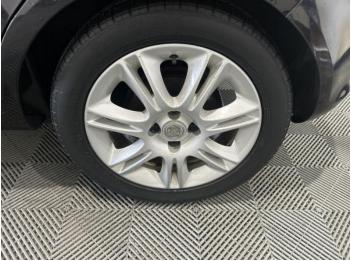
12: Wheel nsr Scratched Up To 50mm

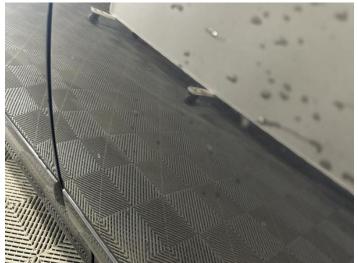
13: Door nsr Scratched Over 25mm Not Thru Paint

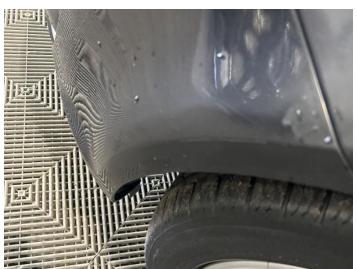
15: Wing nsf Poor Previous Repair Poor Paint

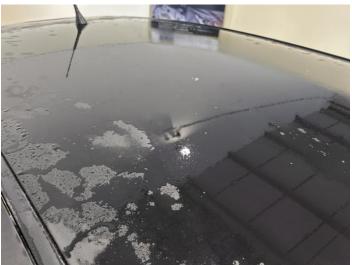
19: Roof Poor Previous Repair Poor Paint
