VEHICLE INSPECTION REPORT

HY67XUM

Dacia Sandero 0.9 TCe Laureate 5dr

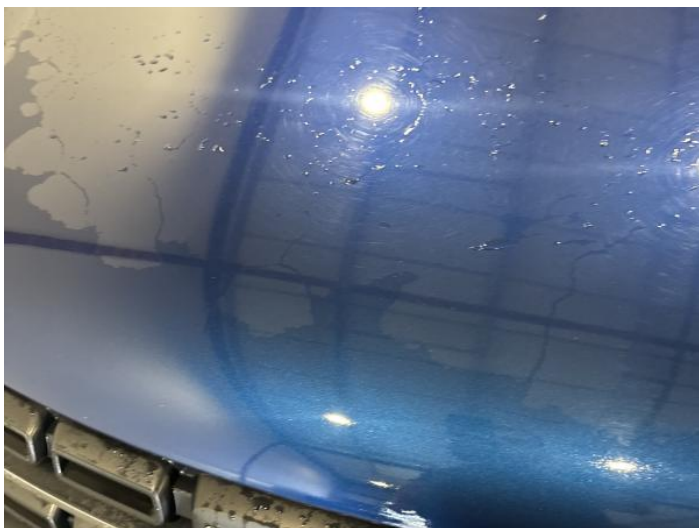
1: Bonnet
Chipped
1 To 5

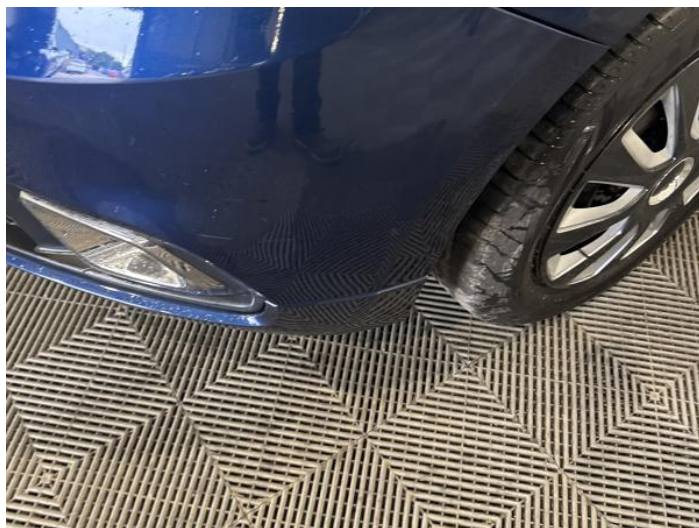
2: Bumper Front
Scratched
25 to 100mm Thru Paint

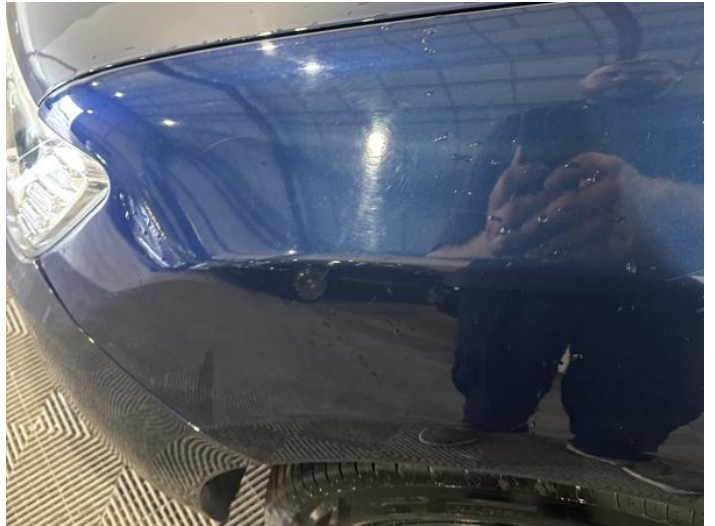
3: Bumper Front
Scratched
Over 25mm Not Thru Paint

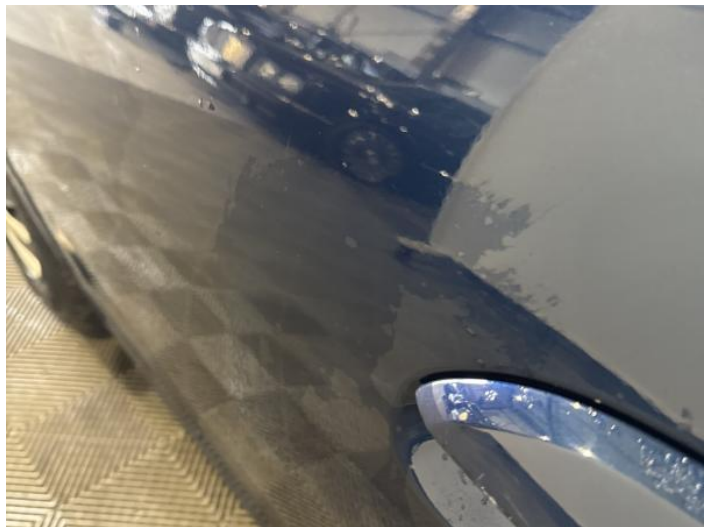
5: Wing nsf
Scratched
Over 25mm Not Thru Paint

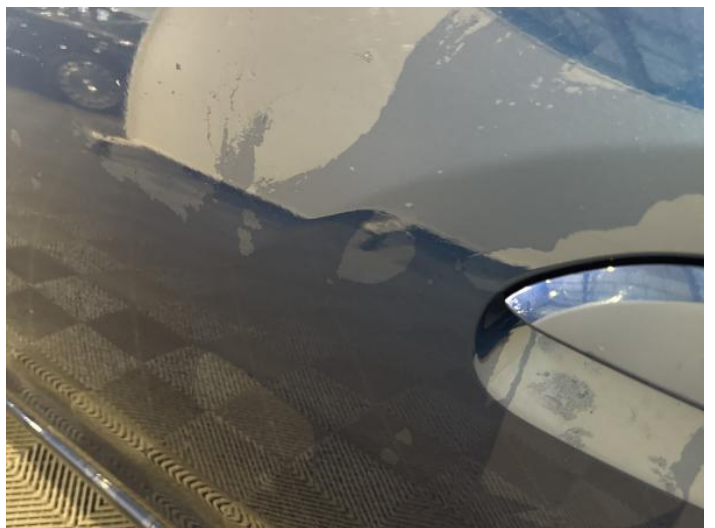
7: Door nsf
Scratched
Over 25mm Not Thru Paint

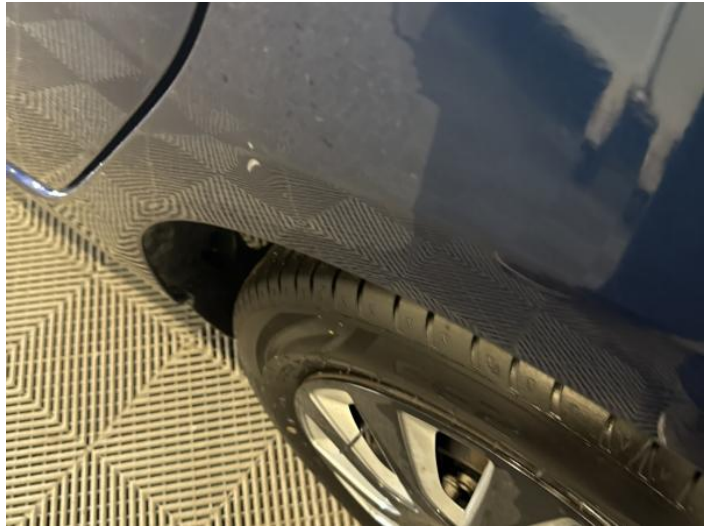
10: Qtr Panel nsr
Dented
Between 10mm + 30mm

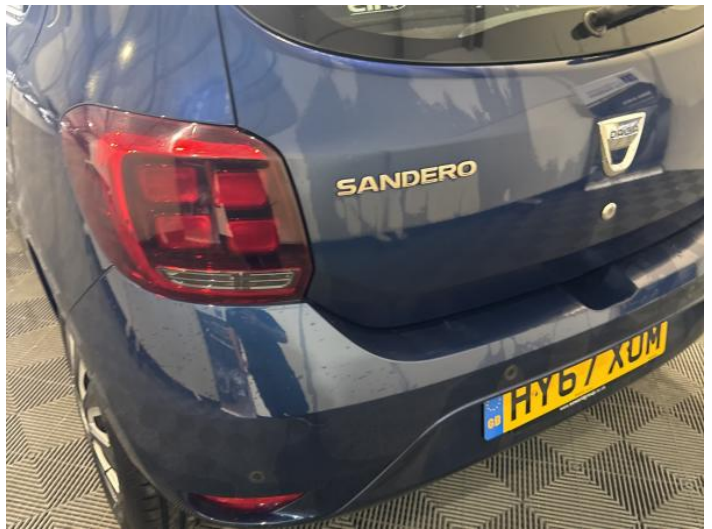
12: Bumper Rear
Scratched
25 to 100mm Thru Paint

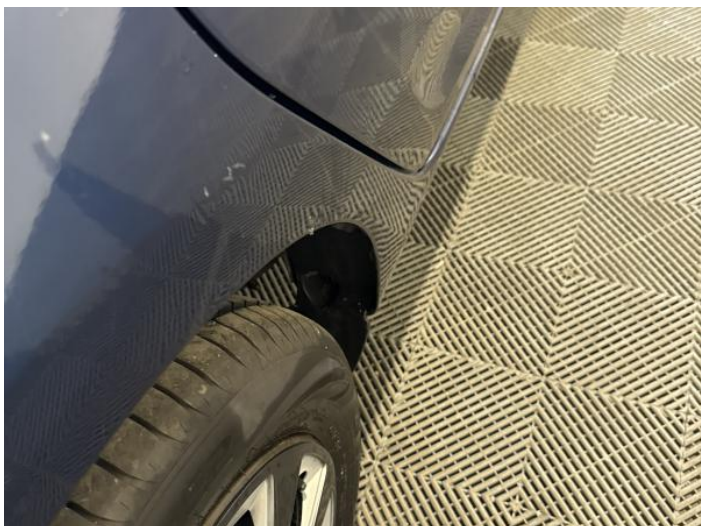
15: Qtr Panel osr
Dented
Between 10mm + 30mm

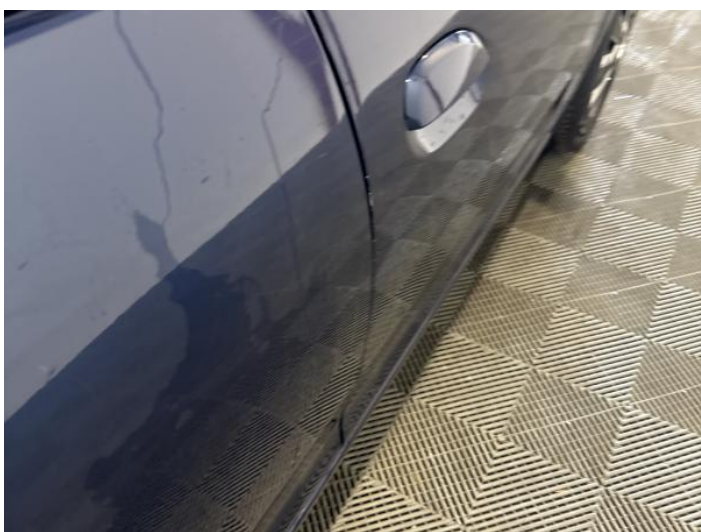
17: Door osr
Dented
Between 10mm + 30mm

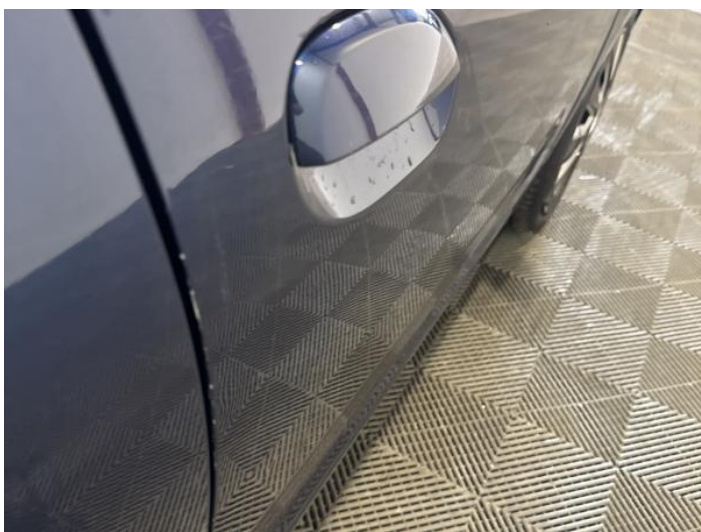
19: Door osf
Dented
Between 10mm + 30mm

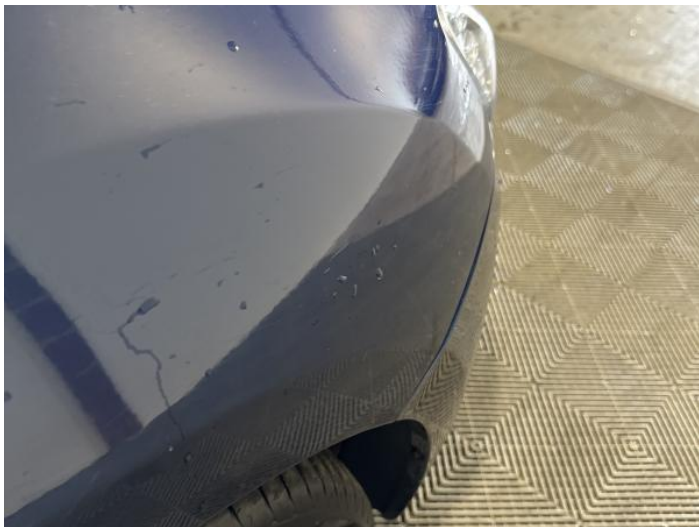
21: Wing osf
Dented
Between 10mm + 30mm
