VEHICLE INSPECTION REPORT

GM65MKP

Vauxhall Adam 1.2i Jam 3dr

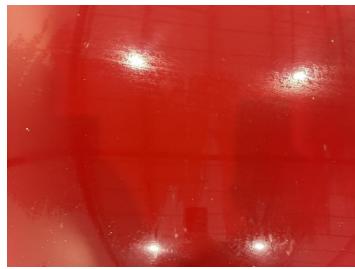
1: Bonnet Chipped Multiple Chips

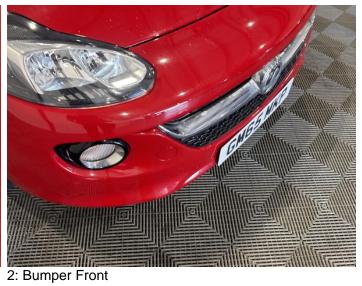
2: Bumper Front
Poor Previous Repair
Poor Paint

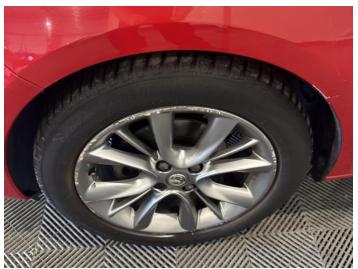
3: Wheel nsf Scratched Over 50mm

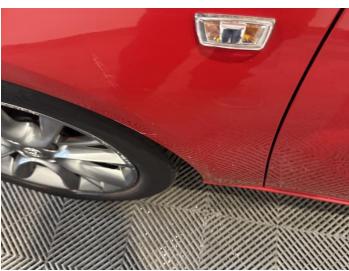
4: Wing nsf Dented With Paint Damage

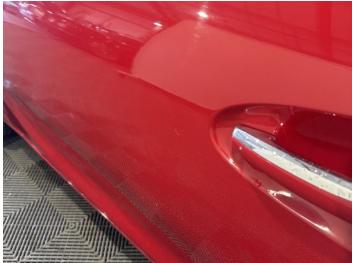
6: Door nsf Scratched Over 25mm Not Thru Paint

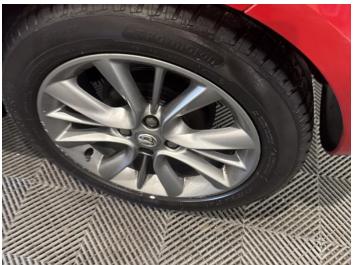
9: Wheel nsr Scratched Over 50mm

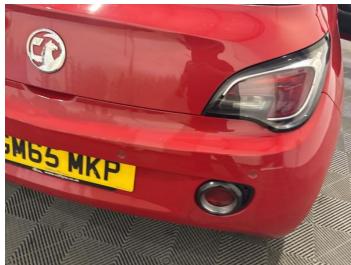
11: Bumper Rear Scratched Over 25mm Not Thru Paint

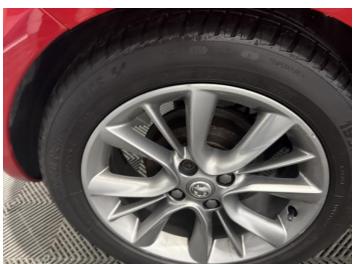
12: Wheel osr Scratched Over 50mm

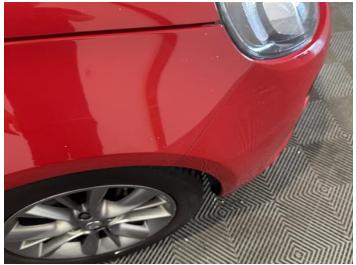
15: Wing osfChippedMultiple Chips

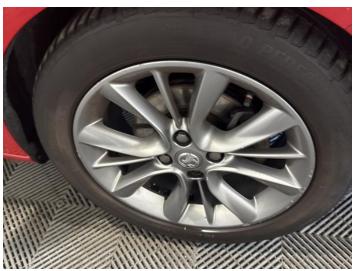
16: Wheel osf Scratched Up To 50mm

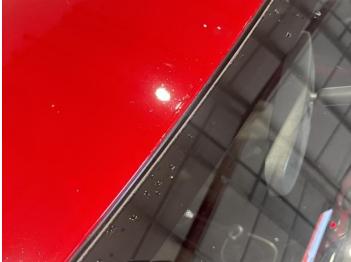
17: Roof Chipped 1 To 5
