VEHICLE INSPECTION REPORT

Mercedes-Benz GLA GLA 200 AMG Line Executive 5dr Auto

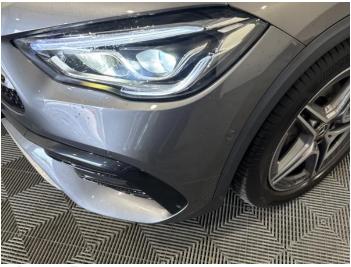
3: Bumper Front Scratched Over 25mm Not Thru Paint

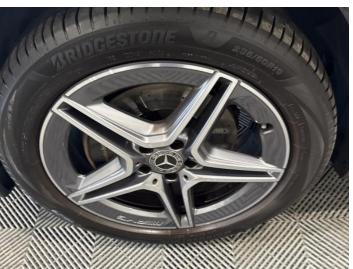
4: Wheel nsf Scratched Up To 50mm

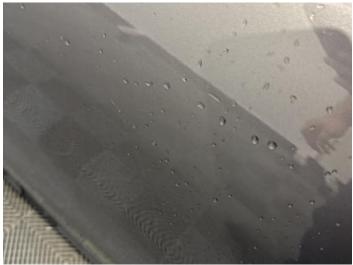
8: Door nsr Scratched Over 25mm Not Thru Paint

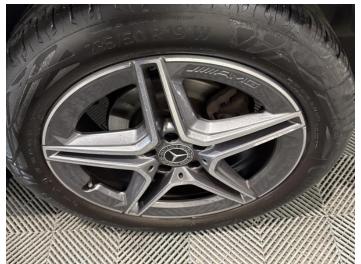
9: Wheel nsr Scratched Up To 50mm

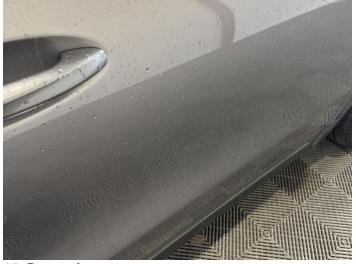
15: Door osf Chipped 1 To 5
