VEHICLE INSPECTION REPORT

GP19RVM

Ford Fiesta 1.0 EcoBoost 140 ST-Line 5dr

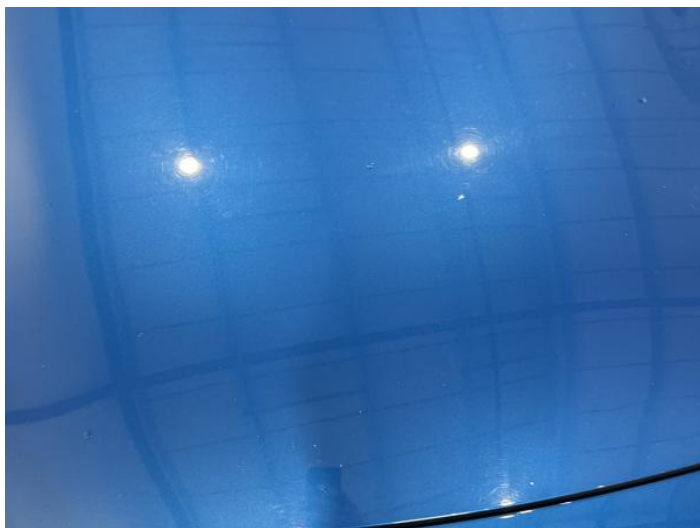
1: Bonnet
Chipped
1 To 5

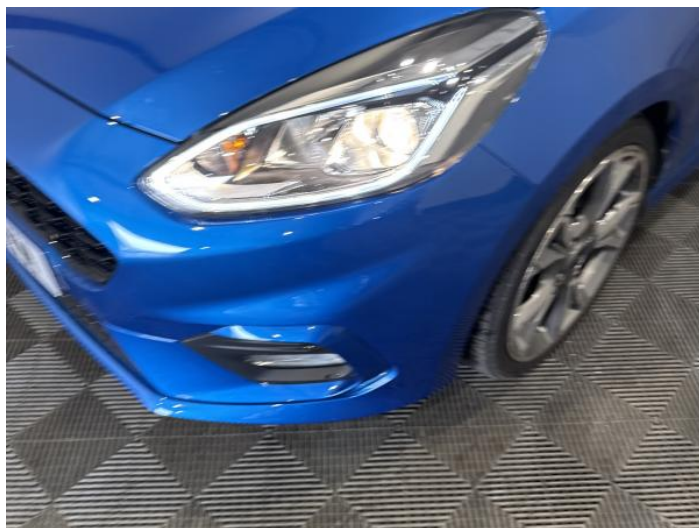
2: Bumper Front
Chipped
Multiple Chips

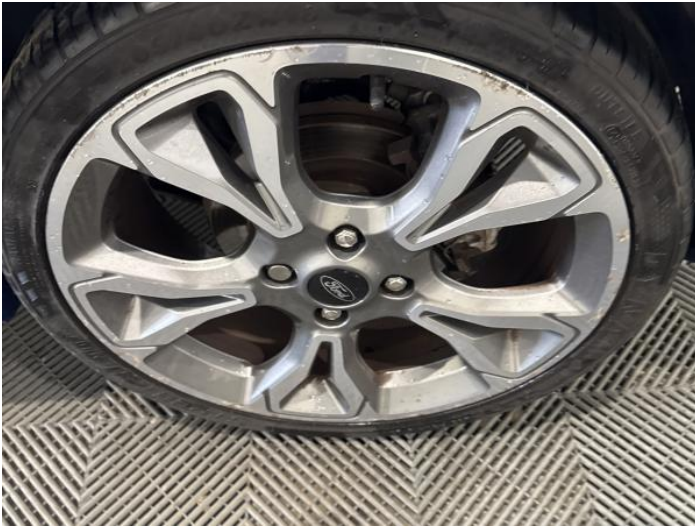
9: Wheel nsr
Scratched
Over 50mm

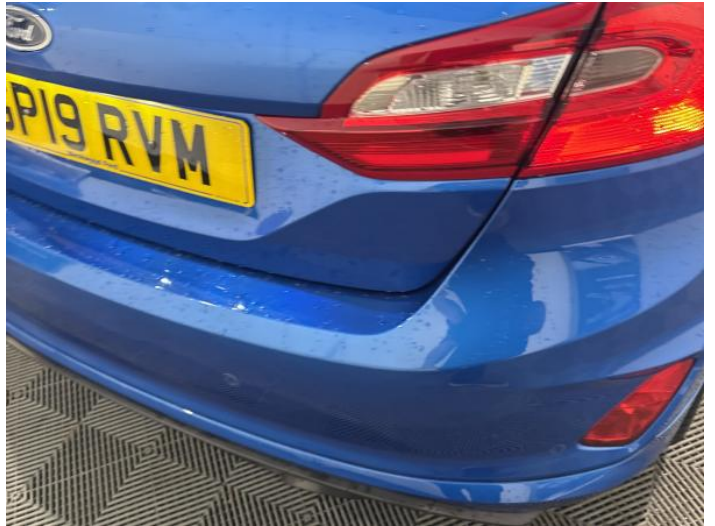
10: Bumper Rear
Chipped
Multiple Chips

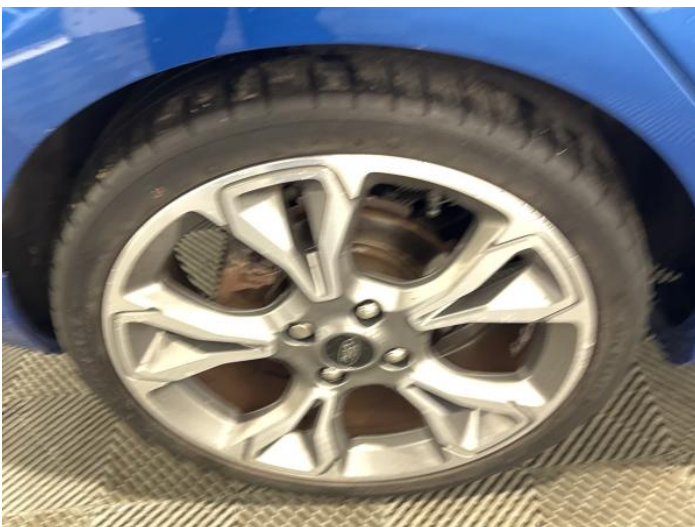
13: Wheel osr
Scratched
Over 50mm

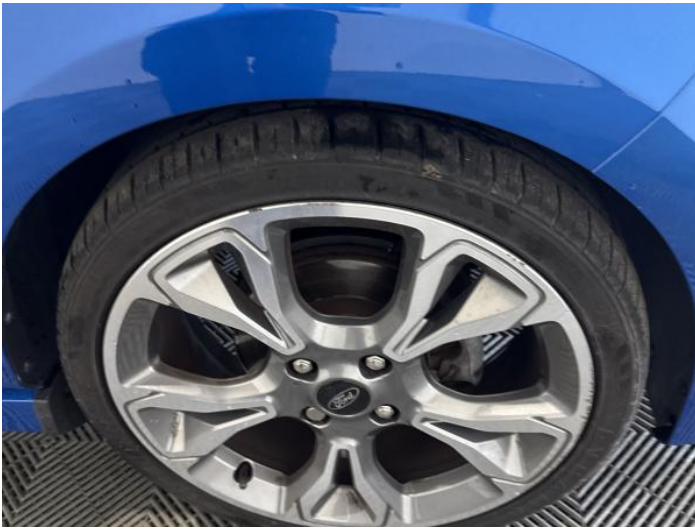
17: Wheel osf
Scratched
Over 50mm

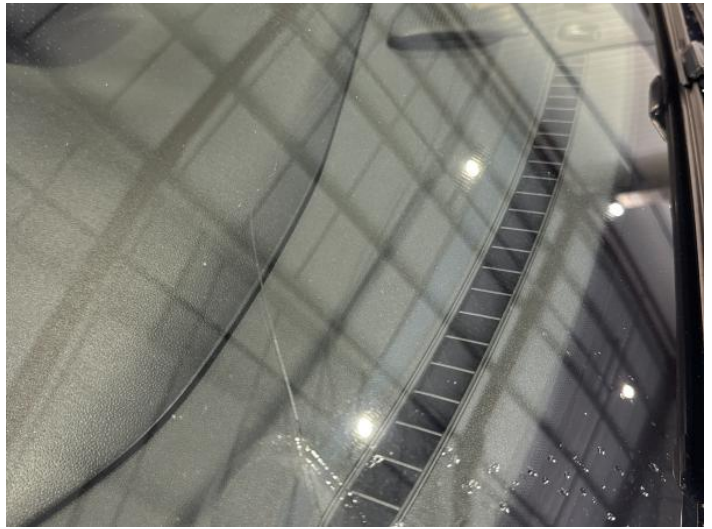
18: Screen Front
Cracked
Replace
