VEHICLE INSPECTION REPORT

BD09OSE

Ford C-Max 1.6 Zetec 5dr

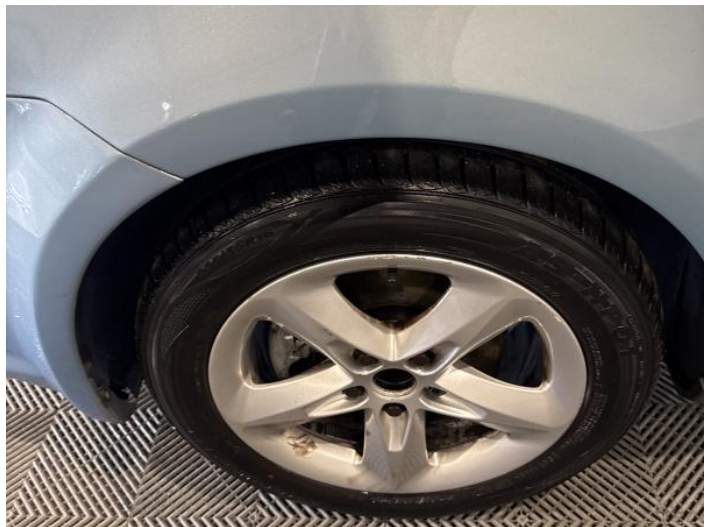
4: Wheel nsf
Scratched
Over 50mm

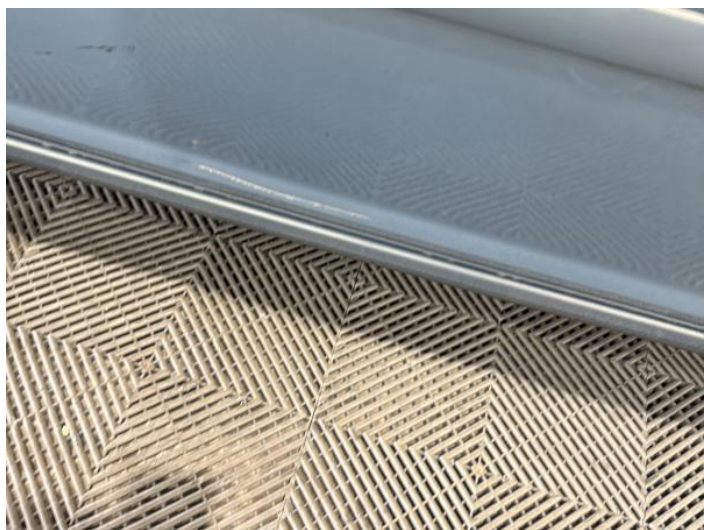
6: Door nsf
Dented
With Paint Damage

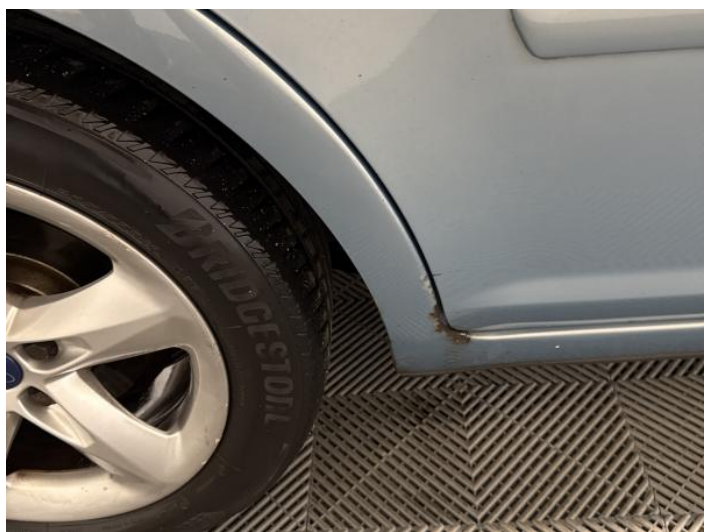
14: Qtr Panel osr
Rusted
Over 5mm

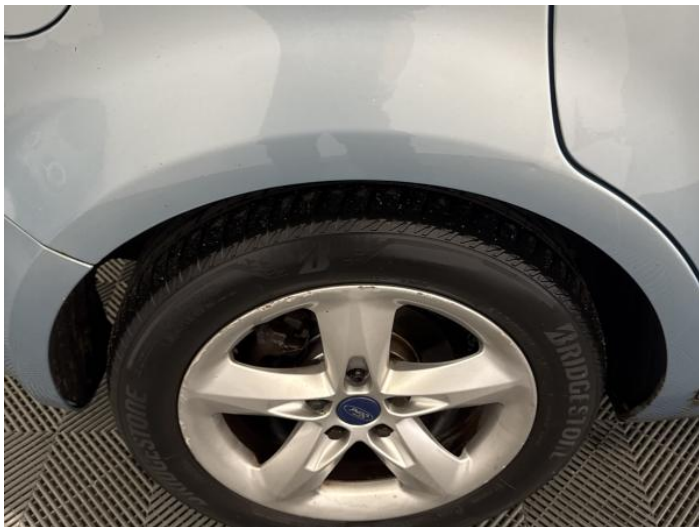
15: Wheel osr
Scratched
Over 50mm

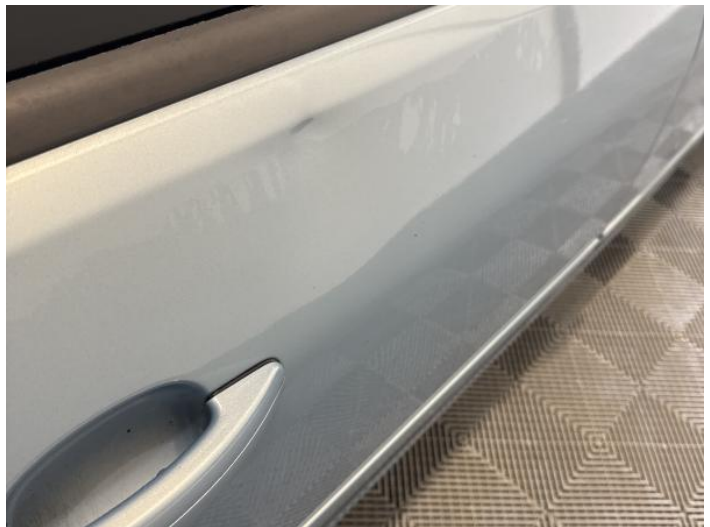
16: Door osr
Dented
Between 10mm + 30mm

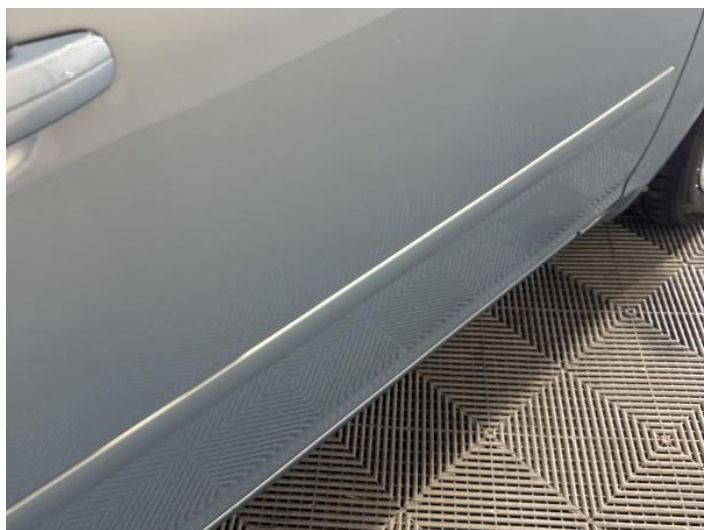
18: Door osf
Chipped
1 To 5
