VEHICLE INSPECTION REPORT

FX16DLU

Kia Sorento 2.2 CRDi KX-4 5dr Auto

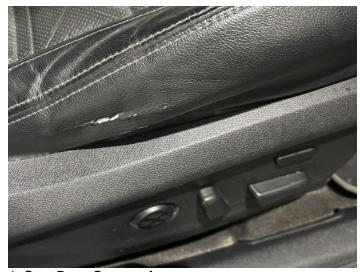
1: Seat Base Cover osf Torn Over 3mm

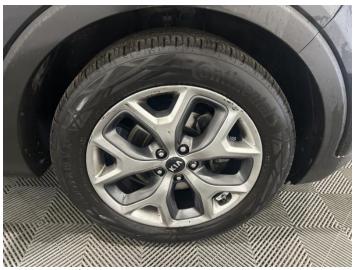
2: Wheel osf Scratched Over 50mm

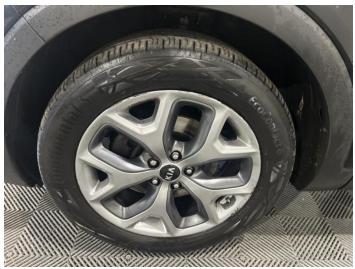
3: Wheel nsf Scratched Over 50mm

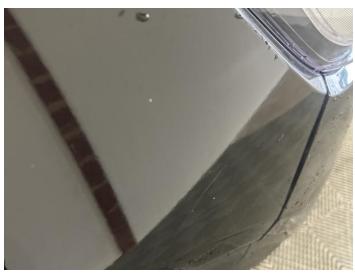
4: Wing osf Chipped 1 To 5

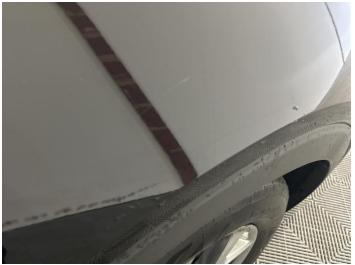
5: Wing osf Scratched Over 25mm Not Thru Paint

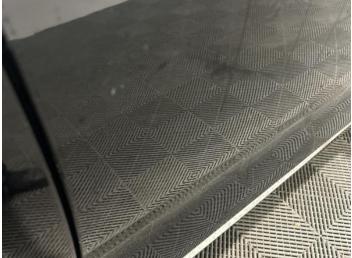
6: Door osf Chipped 1 To 5

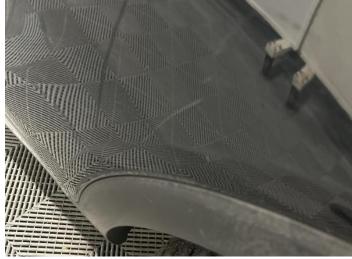
7: Door nsr Scratched Over 25mm Not Thru Paint

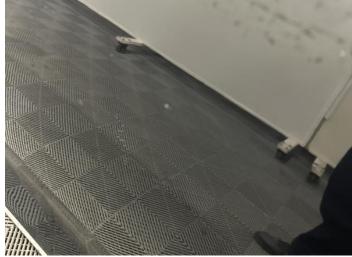
8: Door nsr Chipped 1 To 5

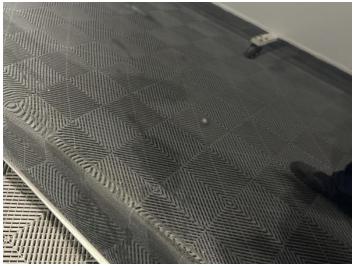
9: Door nsf Chipped 1 To 5

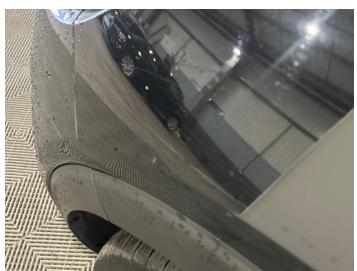
10: Wing nsfScratchedOver 25mm Not Thru Paint

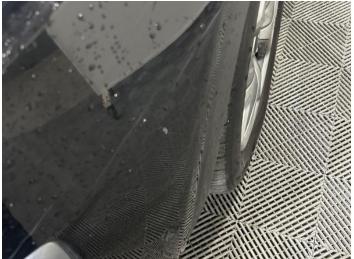
11: Bumper FrontScratchedOver 25mm Not Thru Paint

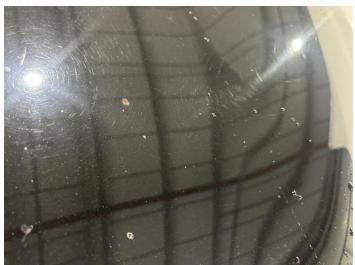
12: BonnetChipped1 To 5
