# **VEHICLE INSPECTION REPORT**

LY08PFU

## Vauxhall Corsa 1.4i 16V Club 5dr Auto [AC]

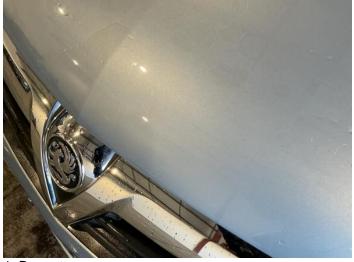
1: Bonnet Chipped 1 To 5

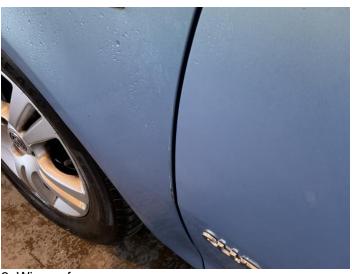
2: Wing nsf Scratched Over 25mm Thru Paint

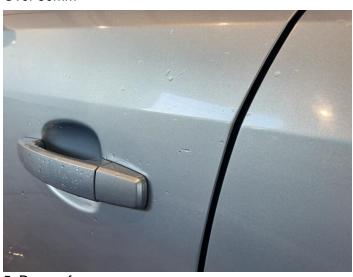
5: Door nsf Chipped Edge Chip

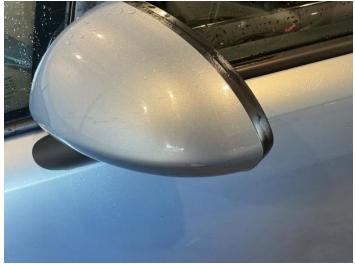
4: Door Mirror Assy nsf Scratched (Painted) Over 25mm Thru Paint

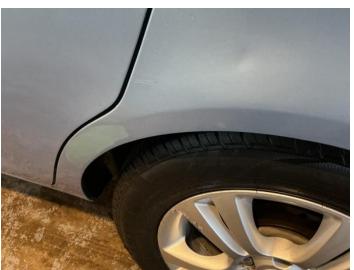
6: Qtr Panel nsr Poor Previous Repair Poor Paint

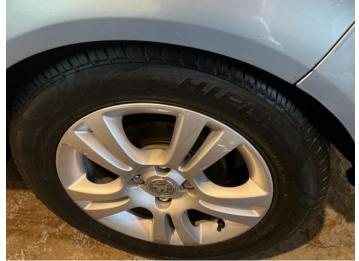
7: Wheel nsr Scratched Over 50mm

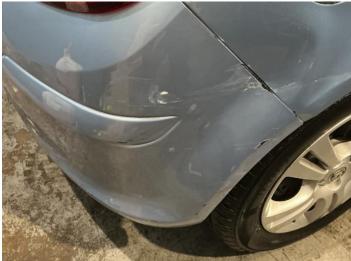
8: Bumper Rear Scratched Over 100mm Thru Paint

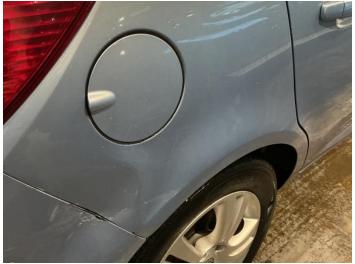
9: Qtr Panel osr Dented With Paint Damage

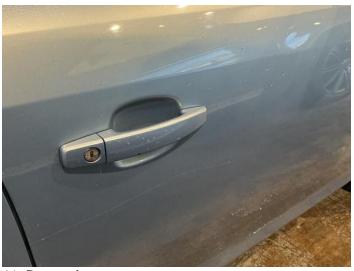
11: Door osf Scratched Over 25mm Thru Paint

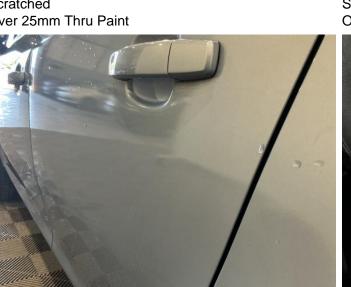
13: Door nsr Poor Previous Repair Rippled UpTo 30%

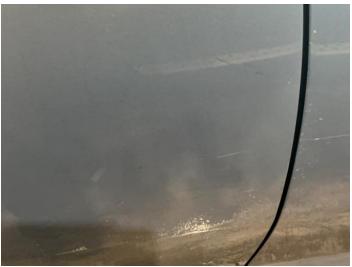
10: Door Moulding osr Scratched (Painted) UpTo 25mm Thru Paint

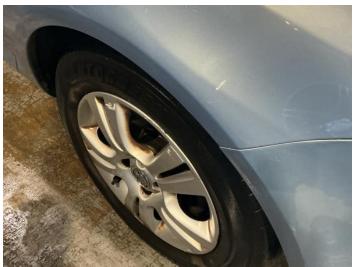
12: Wheel osf Scratched Over 50mm

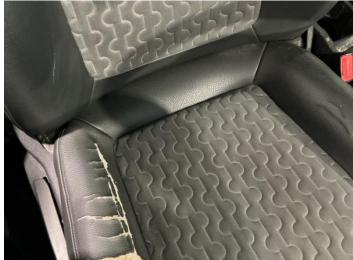
14: Seat Base Cover osf Scuffed Over 25mm
