VEHICLE INSPECTION REPORT

GD54HFY

Toyota Avensis 2.0 VVT-i T Spirit 5dr Seq Auto

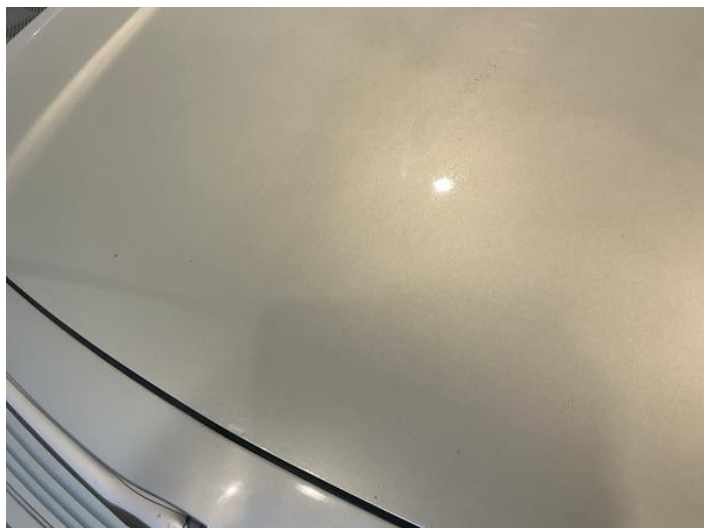
2: Bonnet
Chipped
1 To 5

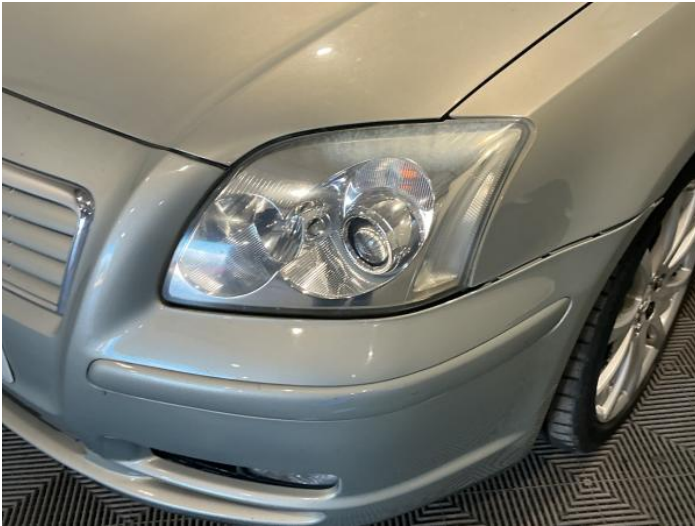
3: Bumper Front
Scratched
Over 100mm Thru Paint

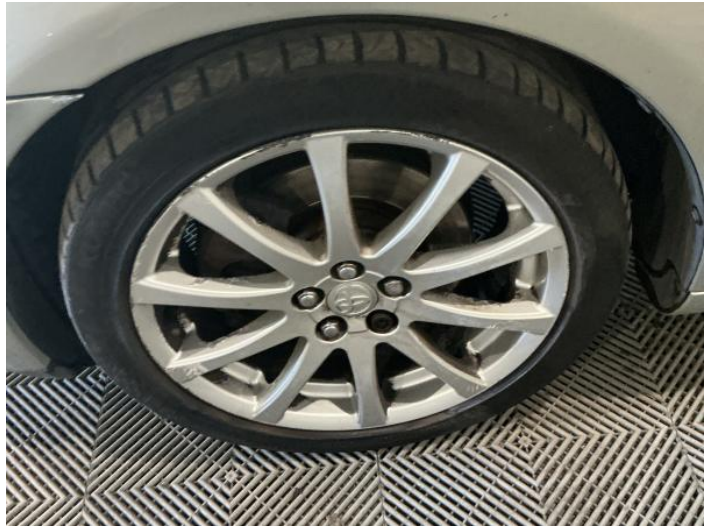
4: Wheel nsf
Scratched
Over 50mm

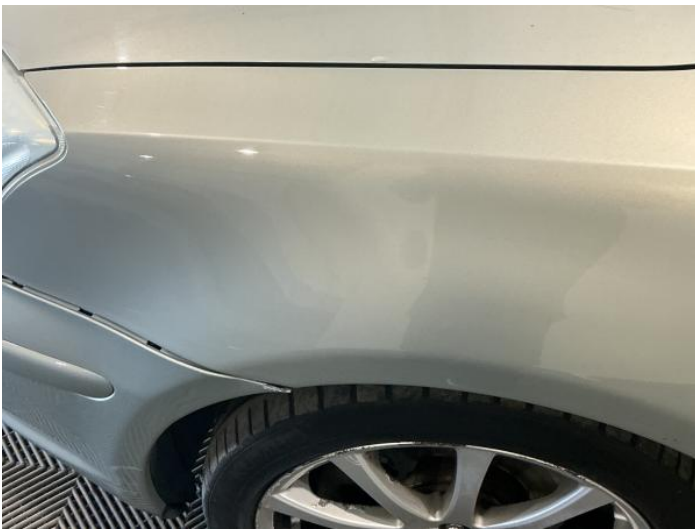
5: Wing nsf
Chipped
1 To 5

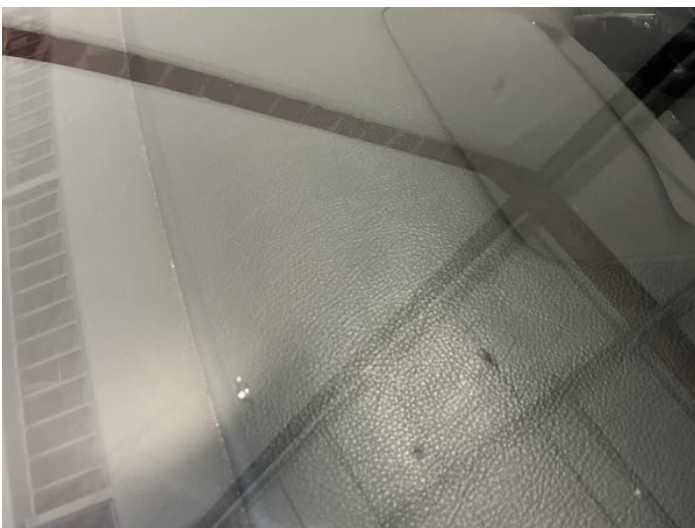
7: Screen Front
Chipped
UpTo 10mm

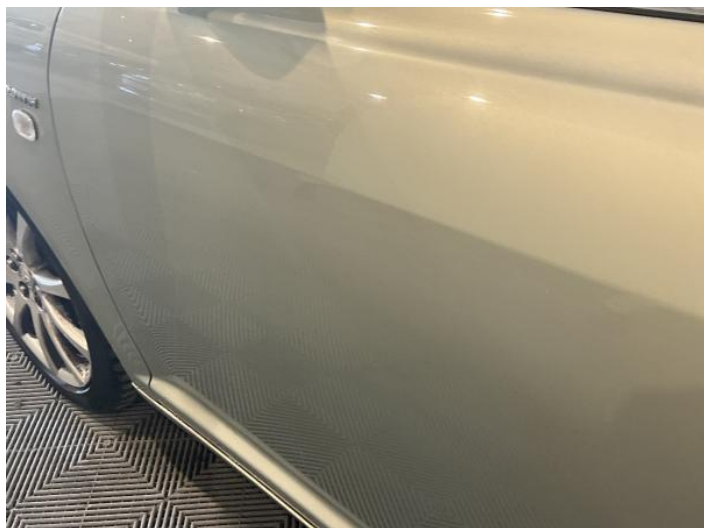
8: Door nsf
Dented
Between 10mm + 30mm

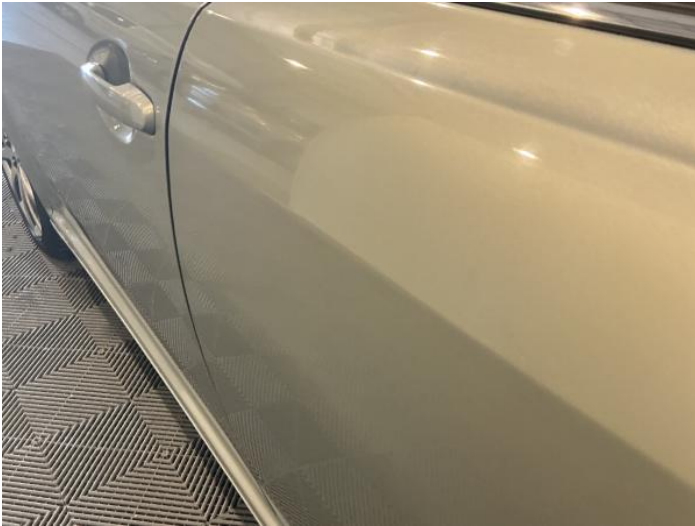
9: Door nsr
Dented
Over 30mm

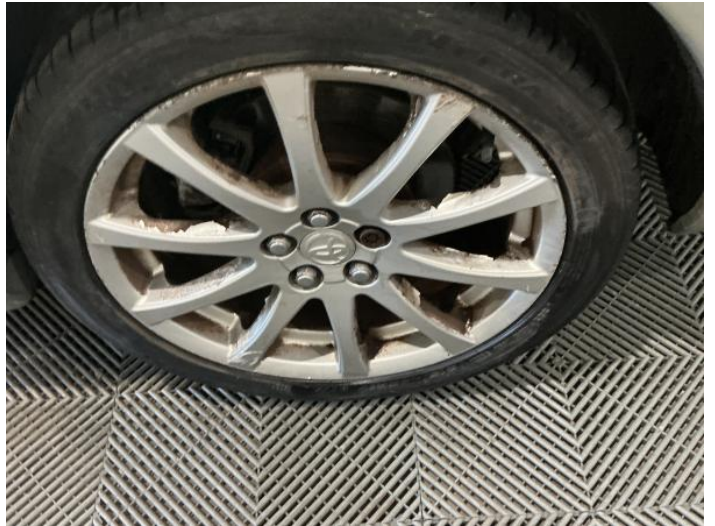
10: Wheel nsr
Scratched
Over 50mm

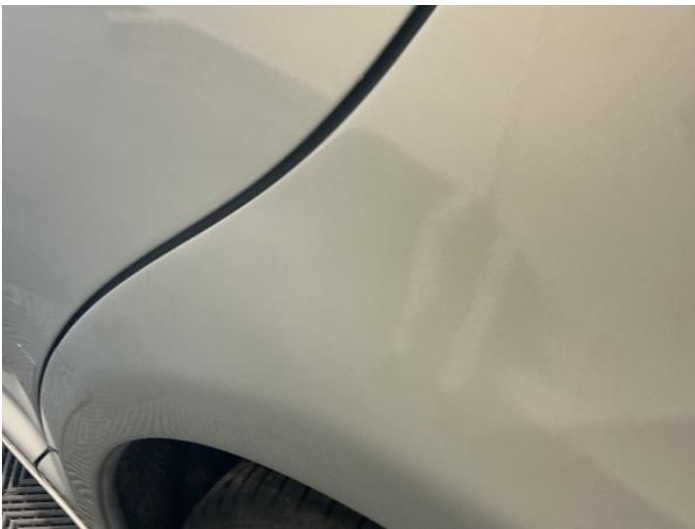
11: Qtr Panel nsr
Chipped
1 To 5

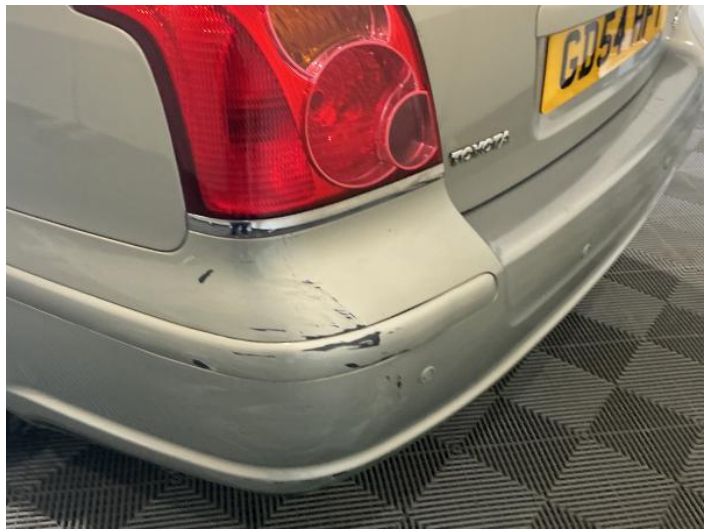
12: Bumper Rear
Scratched
Over 100mm Thru Paint

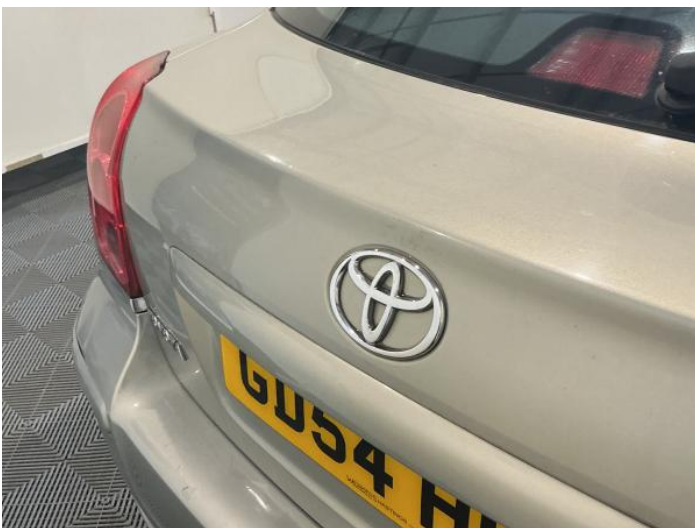
13: Boot Lid
Dented
2 Or Less Up To 10mm

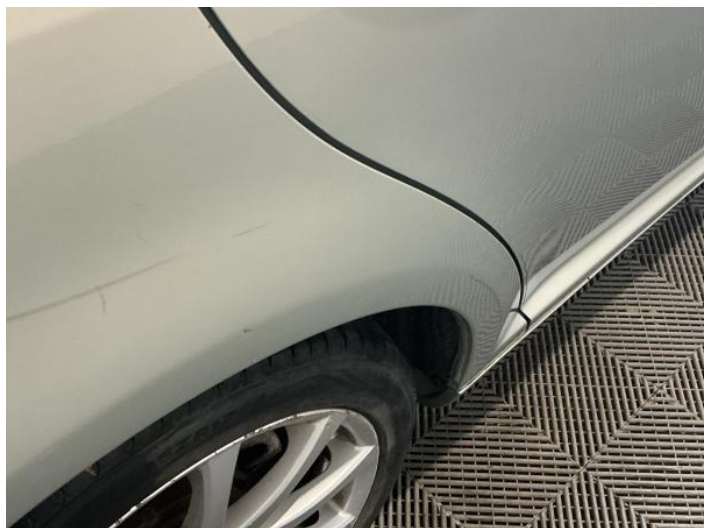
14: Qtr Panel osr
Chipped
1 To 5

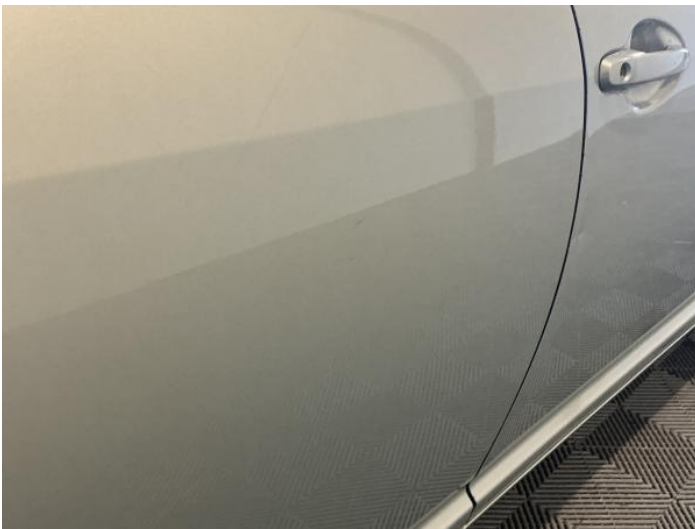
17: Door osr
Chipped
1 To 5

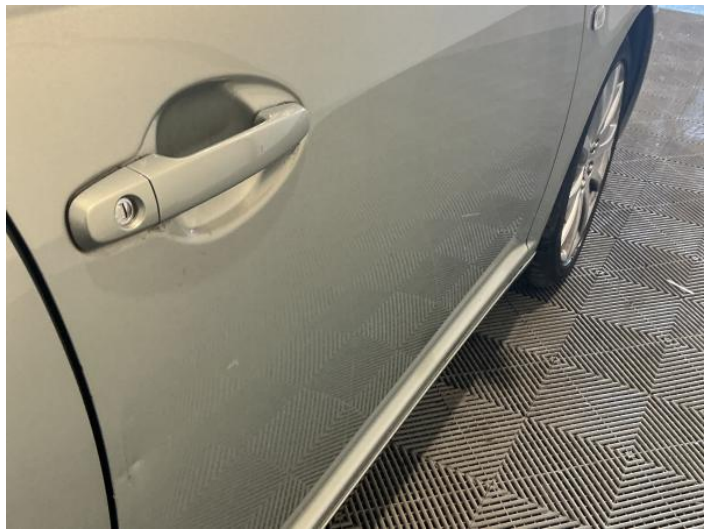
18: Door osf
Dented
Between 10mm + 30mm

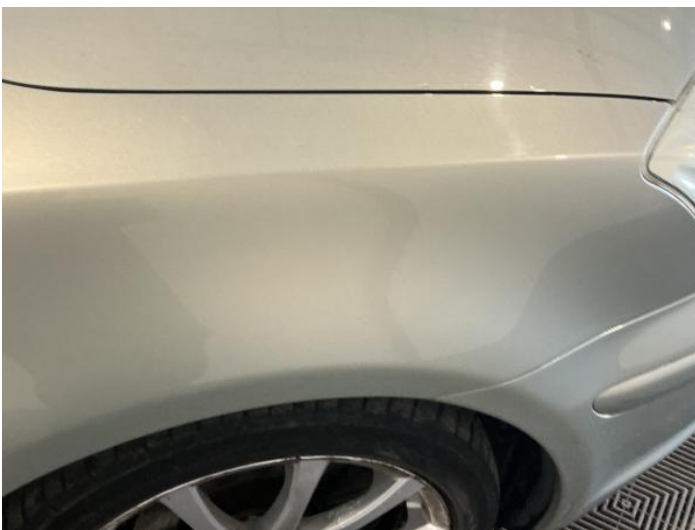
19: Wing osf
Chipped
1 To 5

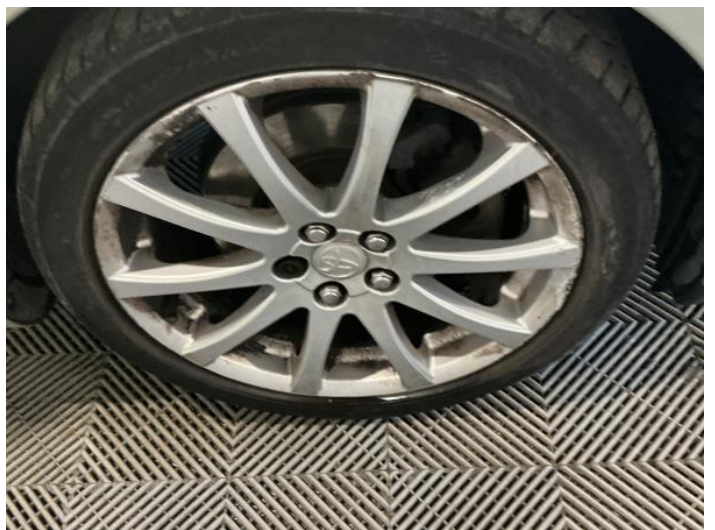
20: Wheel osf
Scratched
Over 50mm
